THE MILLBANK PENITENTIARY: EXCAVATIONS AT THE TATE GALLERY (NOW TATE BRITAIN), CITY OF WESTMINSTER

SUMMARY

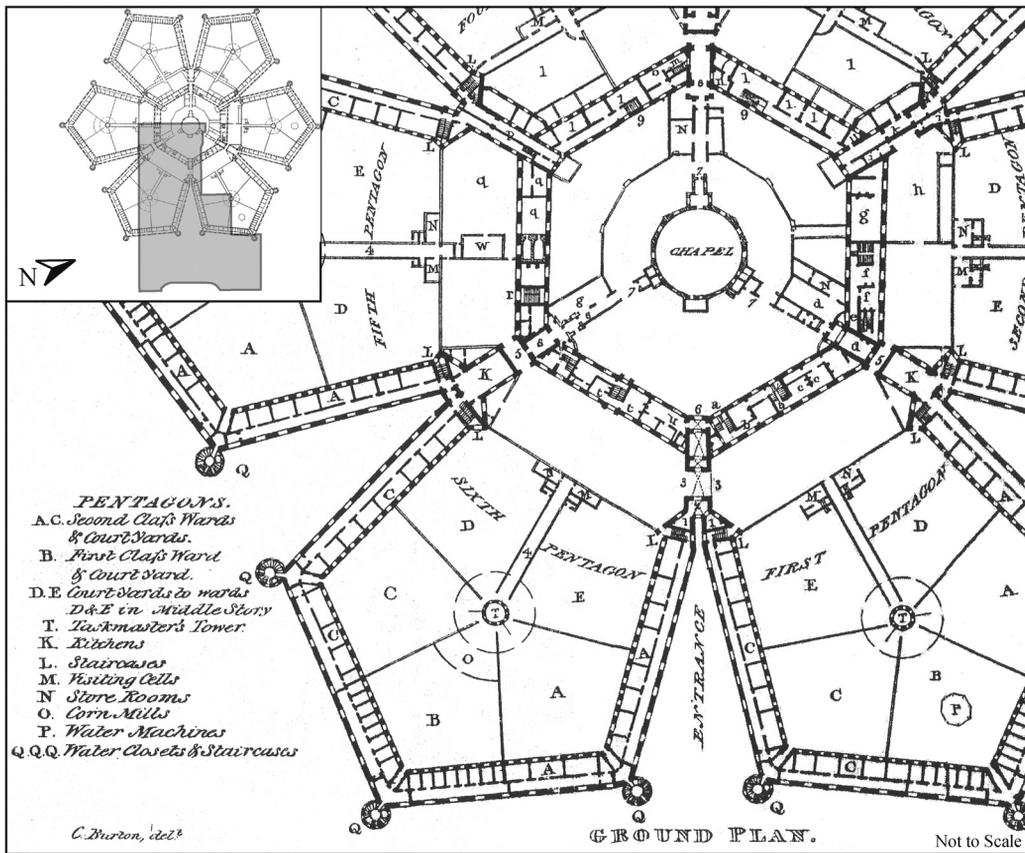
Fig 2. Millbank Penitentiary from 'An Account of the Millbank Penitentiary', George Holford, 1828. Insert shows Tate Gallery layout overlying prison plan

The Penitentiary; as it is still commonly called, looks on London maps like a six-pointed star fort [Fig 2]. The central point is the chapel (circular building), with open space around it, covering more than half an acre. A narrow building, three storeys high, forming a hexagon, surrounds the chapel, with which it is connected at three points by covered passages. The chapel and the hexagon create the centre circle from which several bastions of the star-fort radiate. Each of these salients is pentagon in shape, of which six lie at opposite sides of the hexagon. The pentagons are the prisoners' cells, while the inner space in each is about two-thirds of an acre containing airing yards, grouped round a tall central watch-tower. The ends of the pentagon join the hexagons at certain points called junctions. The whole space equals about seven acres and something more than that amount is included between them and the

The inner hexagon did not contain prisoner cells but housed the offices of the Governor as well as numerous civilian offices which would have been occupied by the surgeon, clerks, matrons, messengers, chaplain, laundry, bake house and storerooms. Unlike the cells within each pentagon which were located in a single line on the inside of the range, with the passageway around the outside, the internal layout of the inner hexagon was organised with rooms grouped into small blocks with an associated passageway (Fig 2) (Brodie *et al* 2002, 60).

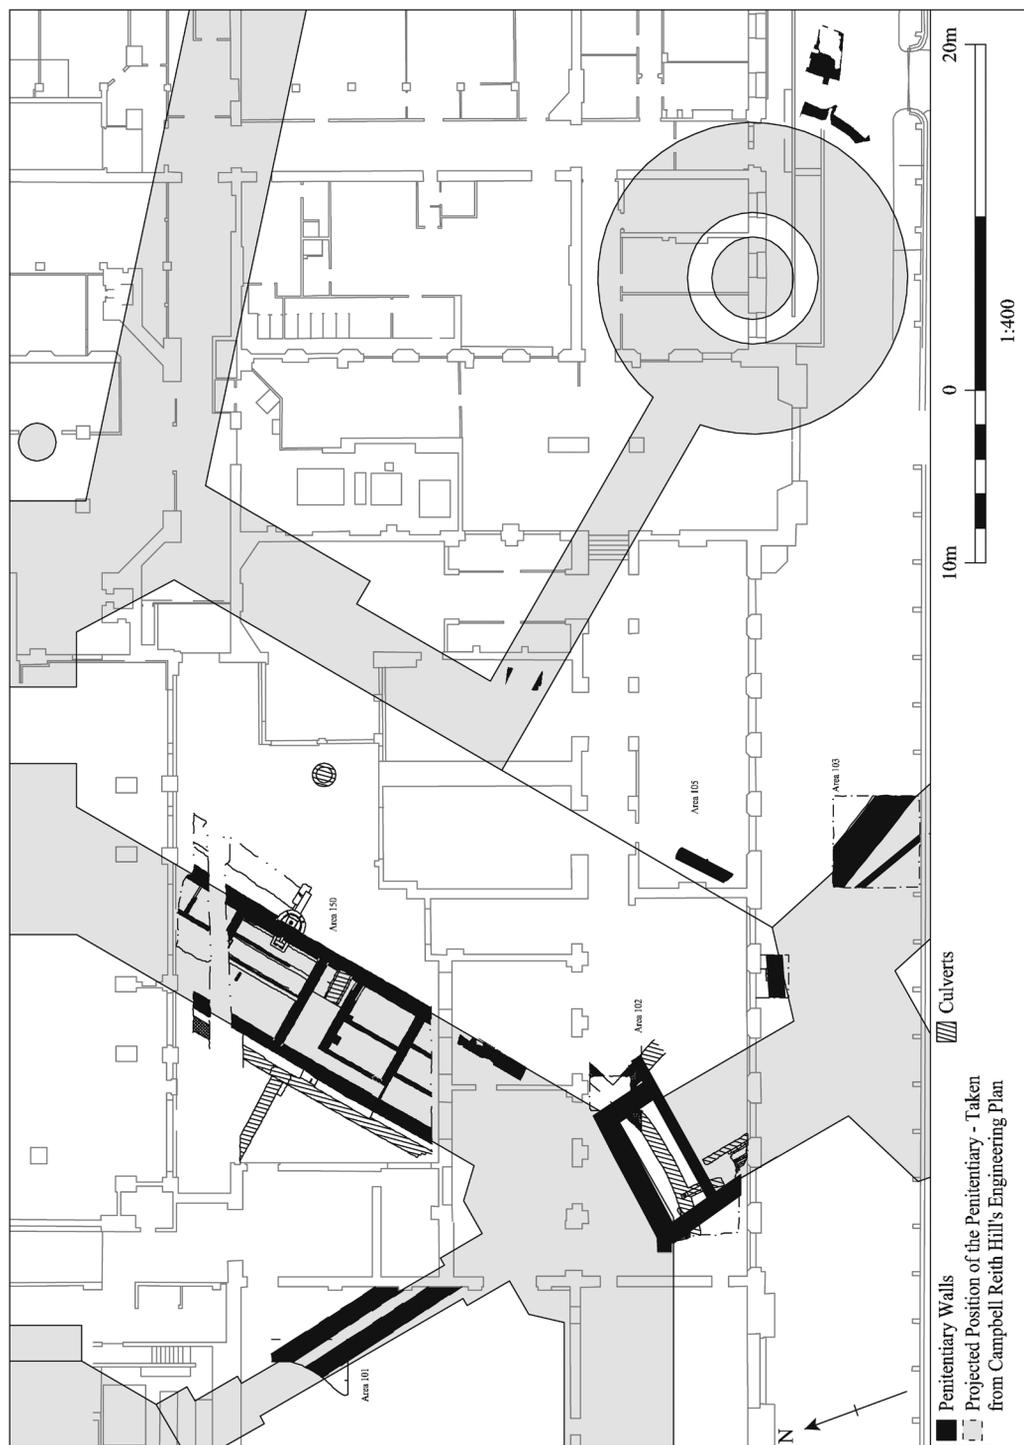
Fig 3. Detailed plan showing all planned archaeological features

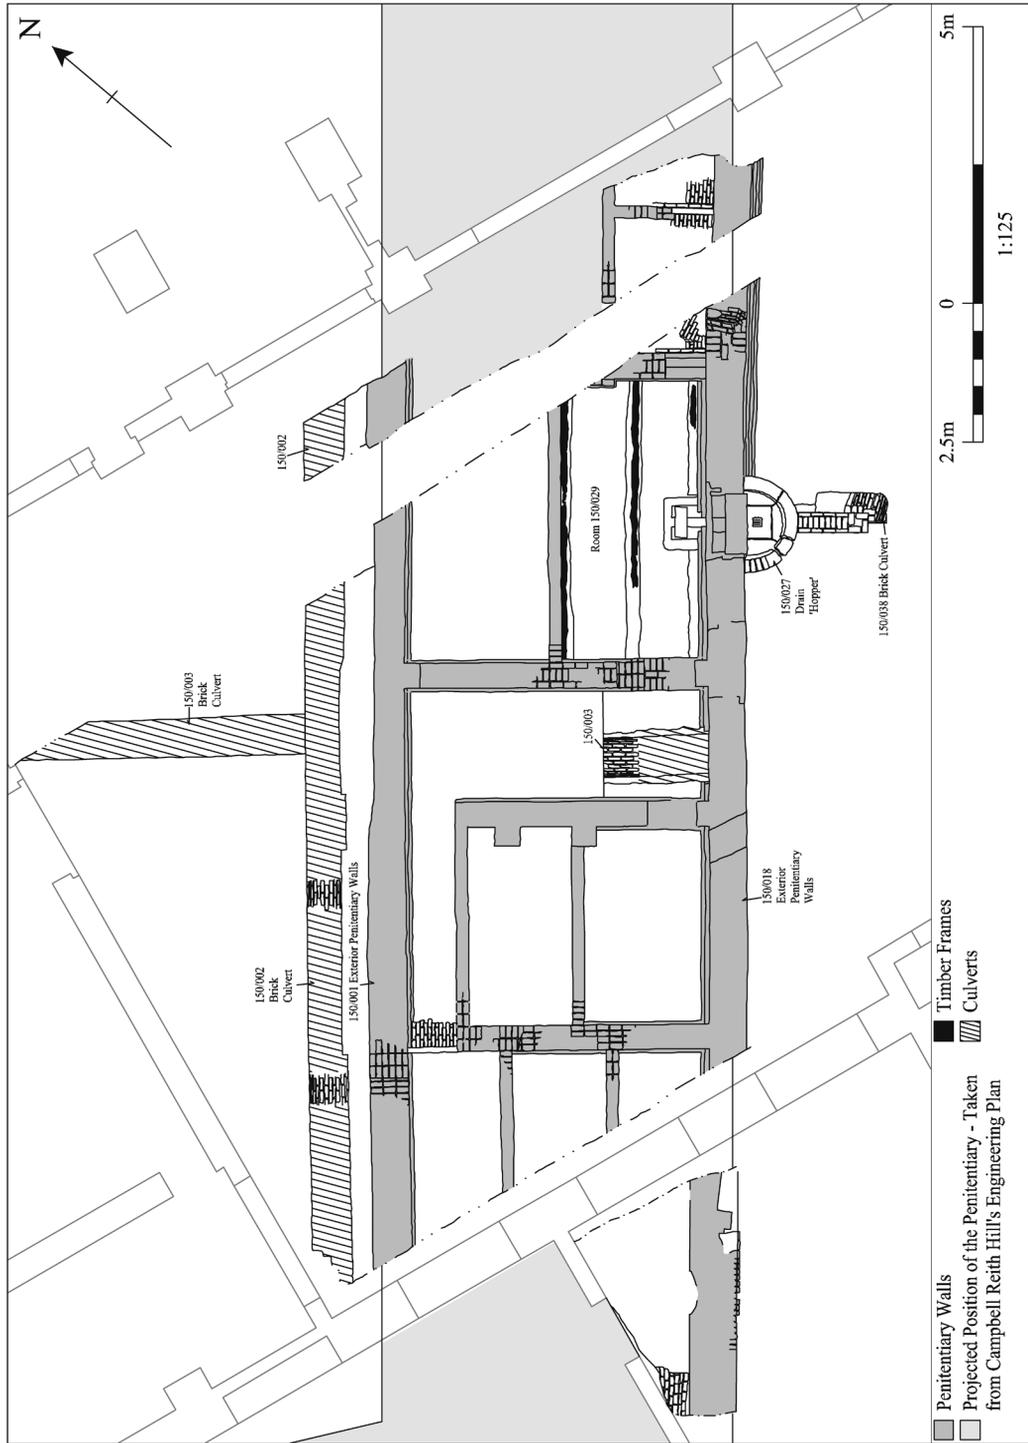
Fig. 5. Excavation Area 150, showing the internal remains of the inner hexagon

The open area excavation (Area 150) revealed the most complete remains relating to the superstructure of the prison — part of the inner hexagon surrounding the central chapel (Fig 5). External walls [150/001]

and [150/018], measuring 15.80m and 16.60m respectively, ran parallel to each other, approximately 6m apart. The walls were constructed of red bricks (100 x 215 x 70mm), laid in English bond and bonded by yellow and white sand and lime mortar. The walls were 0.65–0.7m thick, widening to 0.7m and 0.83m at the base, and survived 0.84–1.5m high.

The design and construction of the internal space of the penitentiary was guided by the ideas of supervision, control and reform of the prisoners through solitary reflection, isolation and strong Christian practices. The passages were narrow, the cells were solitary and barren, hard labour was employed through water machines and treadmills in the corn mills, and church sermons and religious guidance were strictly enforced. Unfortunately the archaeological works on site did not reveal any of the cells or the later larger workrooms and associated rooms, which might have expanded our knowledge of the internal layout of the pentagons. Only the internal arrangements of the inner hexagon which housed offices were observed in the open area excavation (Fig 5).

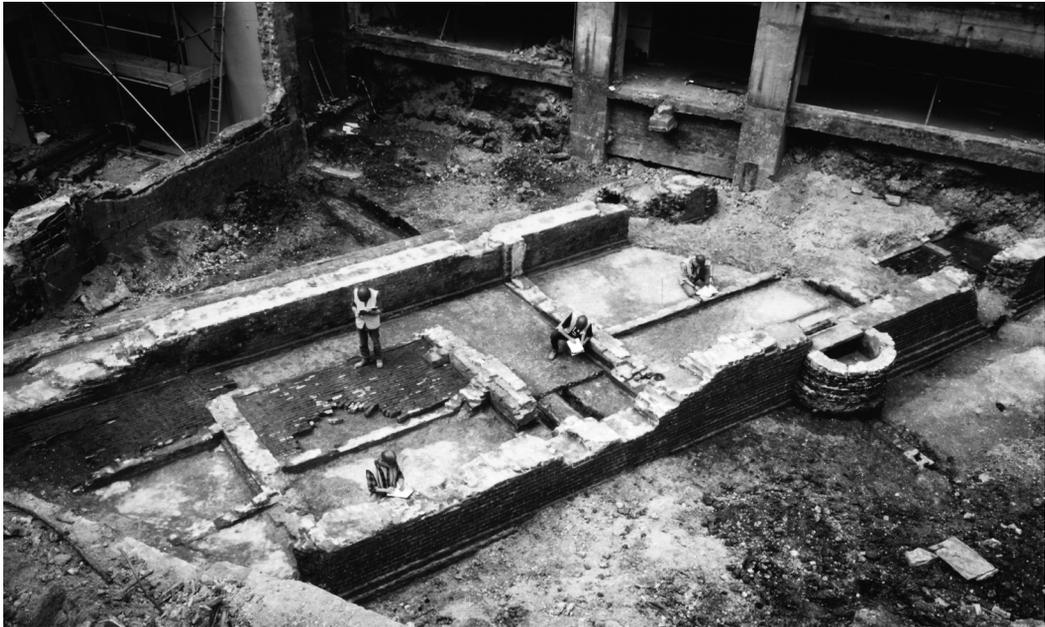
Fig 6. Excavations of the inner hexagon

The space between the two large exterior walls was sub-divided by brick walls into small rooms and a passageway (Fig 6). Thick (0.44m wide), load-bearing walls

braced the structure between the two external walls, whilst individual rooms were formed by thinner (0.22m) partition walls. With the exception of one room, all of the floors, including those of the corridor, were composed of brick. In places, the floor had been removed, probably during the demolition of the prison, exposing a thin bedding layer of sand. This brick flooring was also observed in a watching-brief south of the excavation area, which exposed more of the inner hexagon. In this area, room [150/029] did not contain any of the brick flooring. In its place were the remains of three wooden floor joists, measuring 5.0m by 0.20m. The joists were set into shallow trenches, approximately 0.03m deep, which ran the length of the 5.0m by 2.6m room. The joists probably represent either the foundations of timber flooring (which might suggest that this room was for someone of importance) or a framework for a staircase. The prison plan (Fig 2) indicates the presence of a staircase in the approximate location of the excavation; however the absence of any further structural remains means that the purpose of the timber frame is uncertain. A brick structure excavated towards the southern edge of the room could have supported a stone slab onto which a stove or heater may have been installed to provide heat for the room. However no evidence of any soot or ash was recorded, which might have been expected in a room containing a stove. It seems more likely that this feature had a structural function, possibly relating to the timber joists.

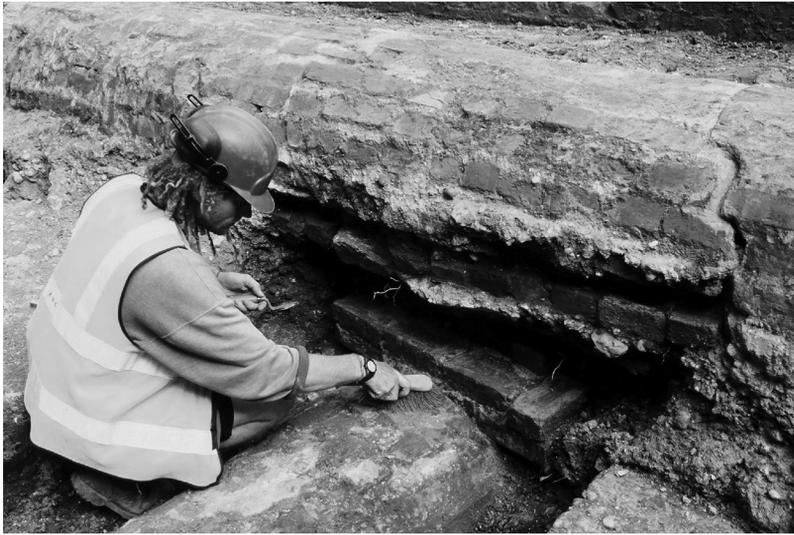
Fig 7. Intercutting culverts 150/002 and 150/003

Drainage was very important on this site due to its proximity to the River Thames. The management of water and sewage from the penitentiary was controlled by a network of brick culverts that would have drained the water and sewage away from the structure into a large moat which was constructed around the entire penitentiary. Evidence of the culvert network was revealed in several of the phases of work on site. An east-west-aligned brick culvert [29/015]/[150/002] was recorded in both Test Pit 29 and the open area excavation; this was 16m long, 0.6m wide and 0.7m deep. A similar culvert [150/003] ran north-south through the excavation area crossing beneath [150/002] (Fig 7). Both culverts were constructed using a double layer of bricks and were circular in section. At the crossover point between the two culverts, a square-shaped conduit probably allowed drainage from [150/002] into [150/003]. These culverts possibly formed a drainage 'ring' around the inside of the inner hexagon, removing waste water and possibly sewage away from the penitentiary. A second possible drainage 'ring' was recorded in watching-brief Area 102 (Fig 8). Culverts [102/011] and [102/012] were joined together to form a T-junction where culvert [102/012] drained into culvert [102/011]. A third and later circular brick culvert [102/015], recorded to the south of the T-junction, would have drained into [102/012]. Culvert [102/012] continued to the north and was recorded in the excavation area as [105/038] outside the inner hexagon. This 'ring' would probably have formed the second group of culverts in the network, constructed around the outside of the inner hexagon.

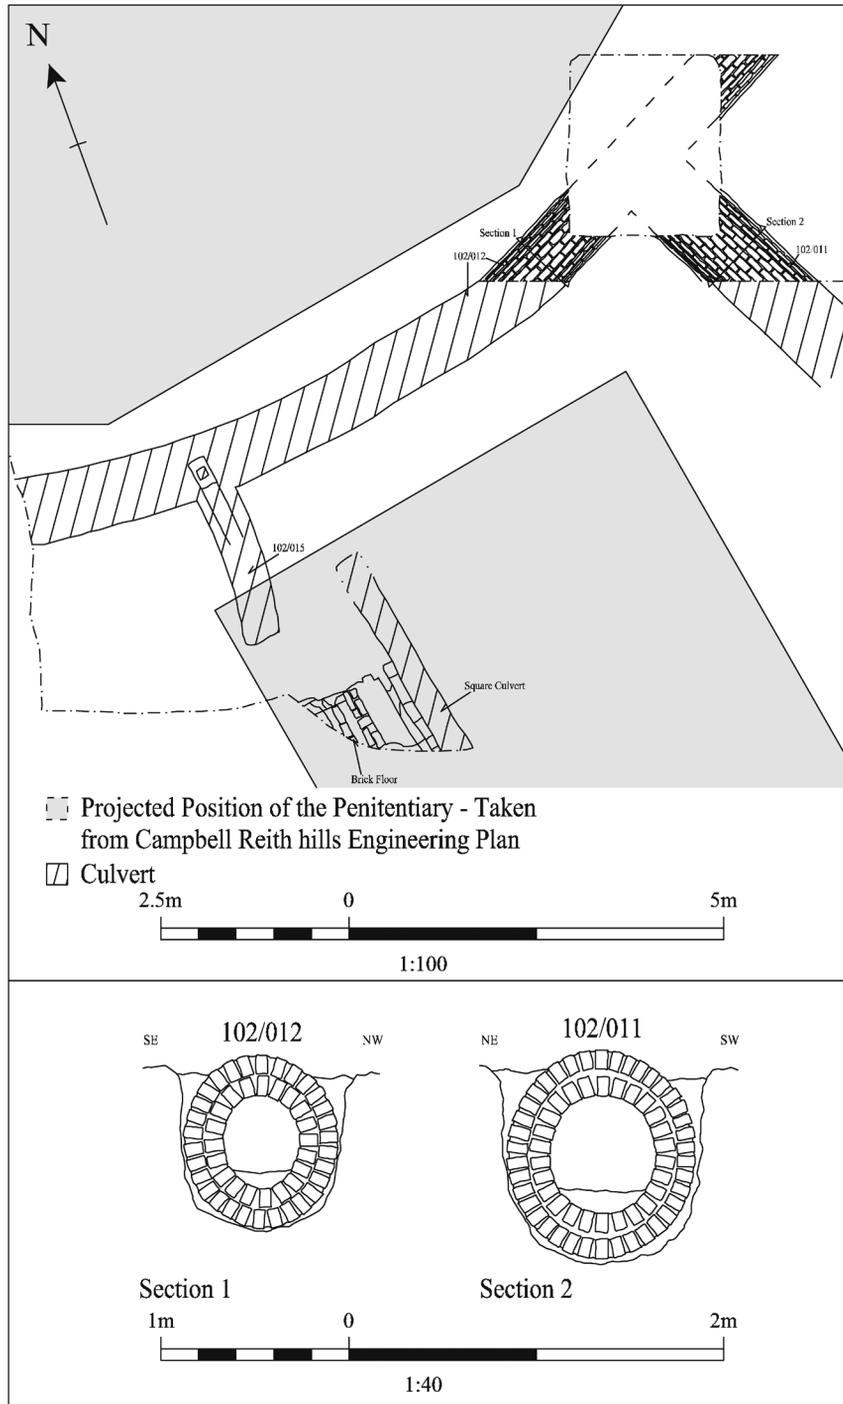
Fig 8. Plan and section of intercutting culverts
