MIDDLE SAXON AND LATER ARCHAEOLOGICAL REMAINS IN WHITEHALL

Paw Jorgensen

SUMMARY

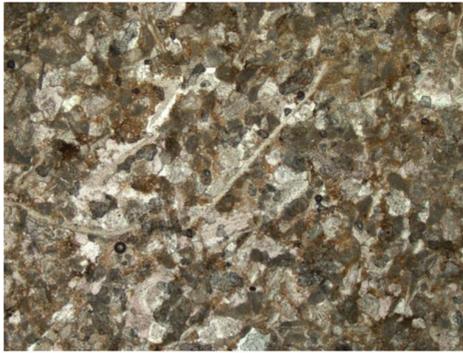
a) Orange-yellow ashlar Caen stone WQH07 [161]

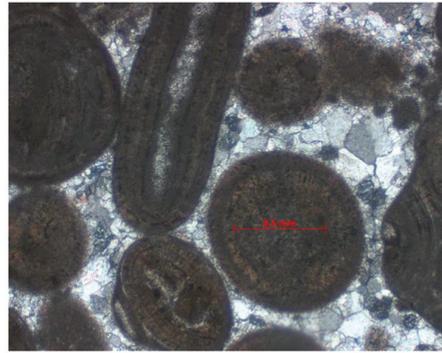
c) Corsham oolite (outcrop sample) KH122

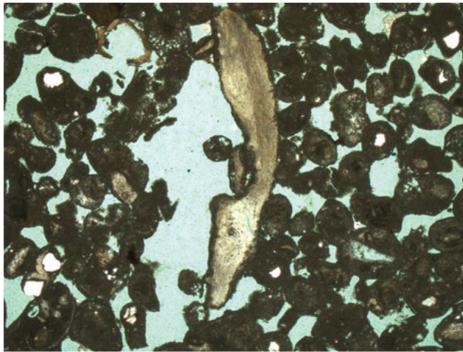
b) Portland Whit Bed (outcrop sample) KH82

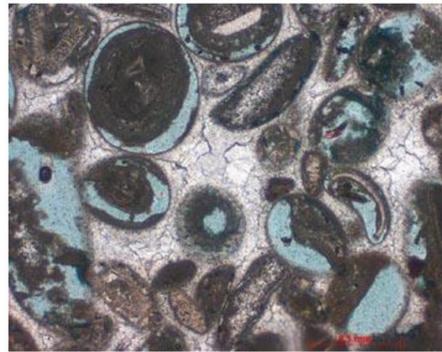
d) Coombe Down oolite (outcrop sample) KH98
