# Timber Building Techniques in London c.900–1400

AN ARCHAEOLOGICAL STUDY OF WATERFRONT INSTALLATIONS  
AND RELATED MATERIAL

London & Middlesex Archaeological Society  
Special Paper 15

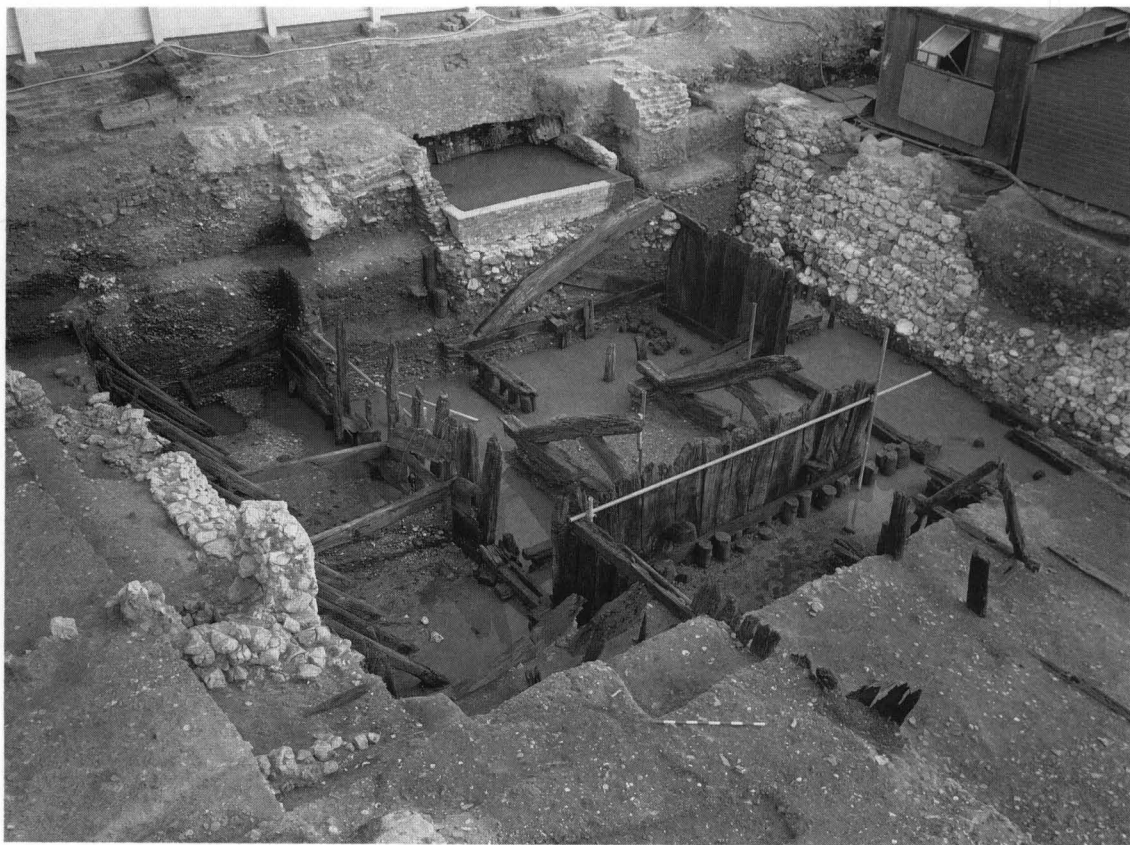
*2. A sequence of vernacular structures exposed on the Trig Lane site in 1975, looking south-east. The front braces of late 13th-century TL3 revetment can be seen on the north edge of site, partially obscured by the chalk wall. In front of that is reverse face of 14th-century back-braced TL7 revetment which was later extended westwards by stave-built TL10 structure; the 10 x 100mm scale rests on infill material thrown in behind it. The partially dismantled TL11 revetment (supported by scaffolding) extended the waterfront in c.1380, and was replaced in c.1440 by stone river wall to south.*

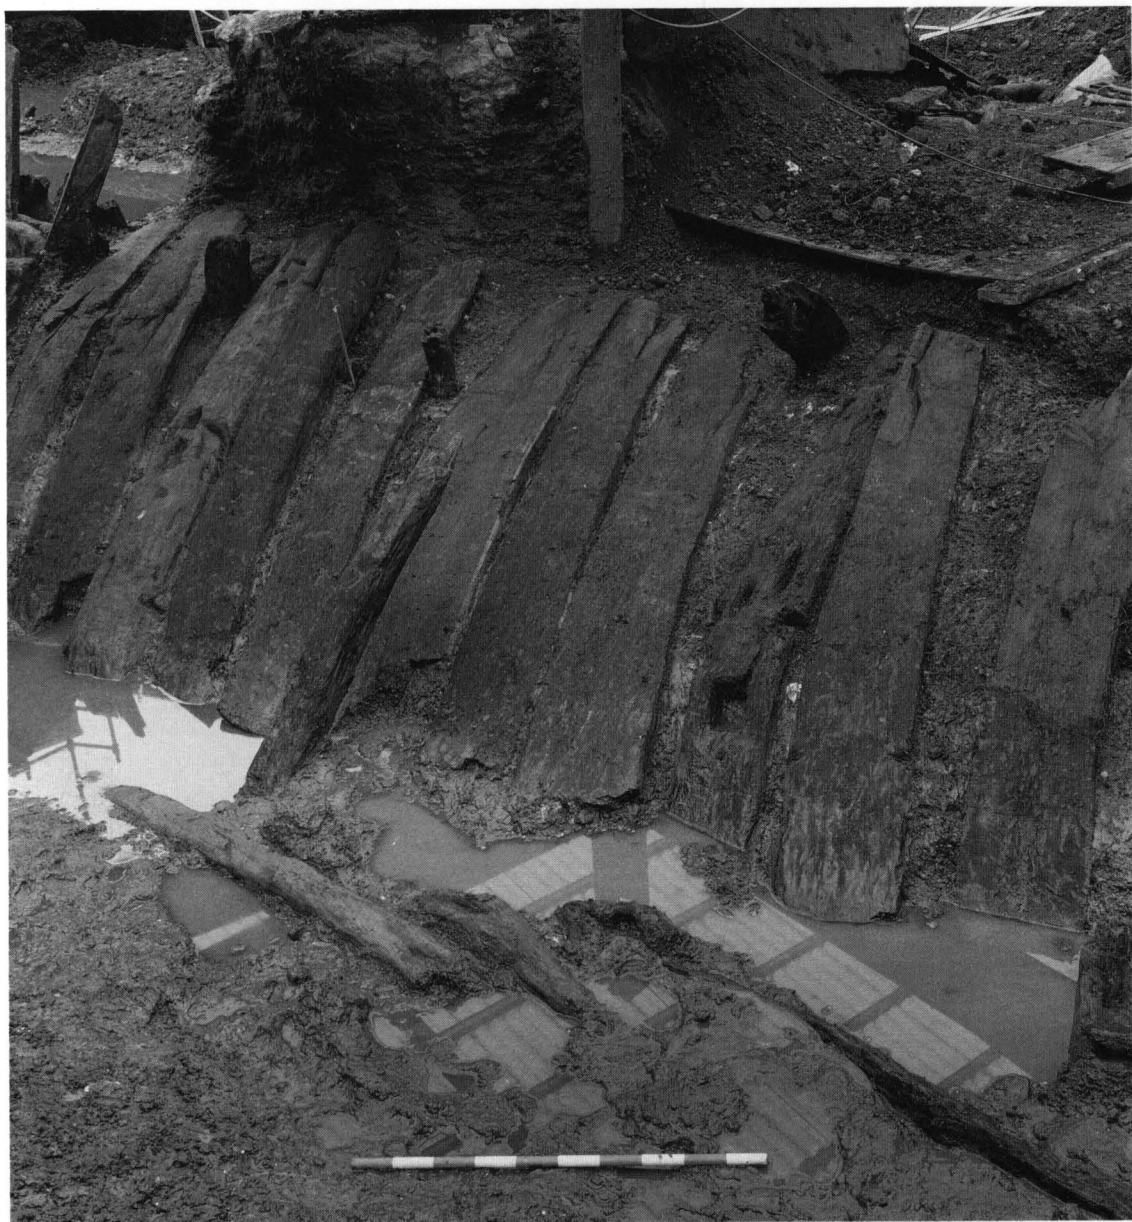
13. Billingsgate Lorry Park: the landward face of the collapsed staves from the BG3 structure, looking south-east. Scale 10 x 100mm.

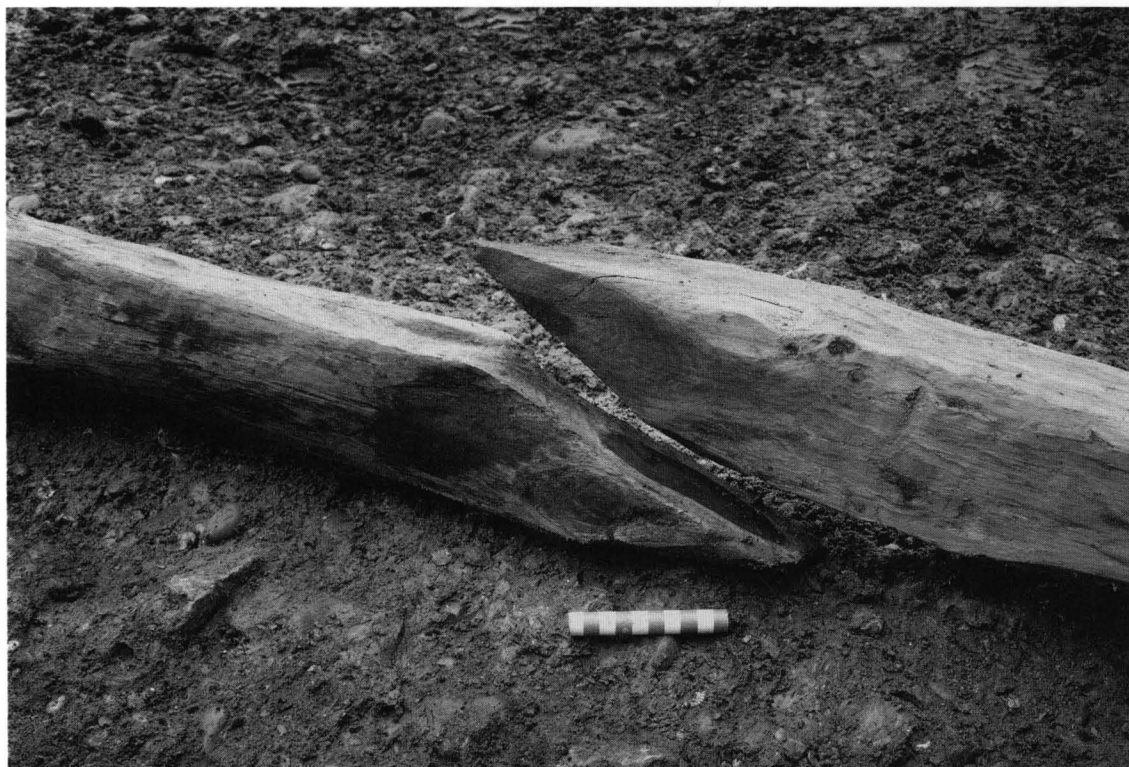
19. Below: Billingsgate Lorry Park. Detail of the BG12 structure, looking south-east. The 10 x 10mm scale lies next to the junction of two members which formed the plate retaining the feet of the front braces; cf. Fig 17.

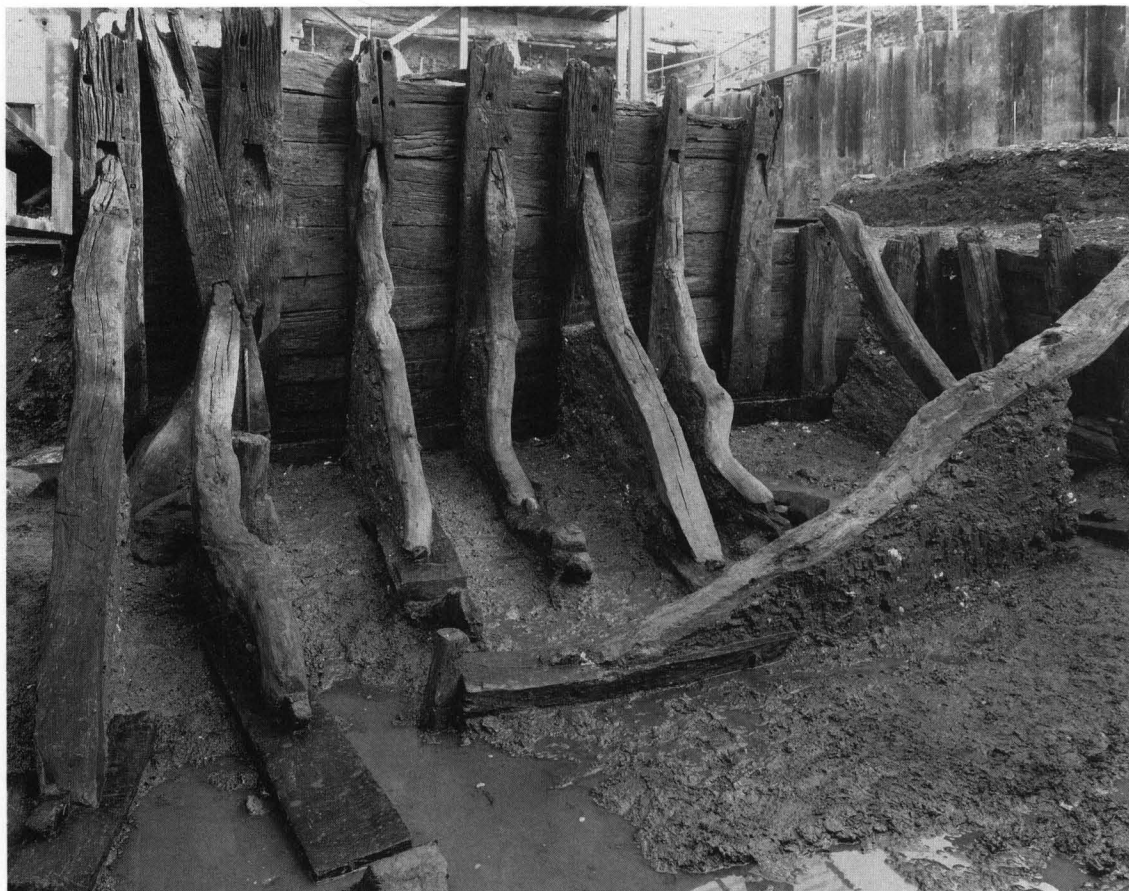
*20. Billingsgate Lorry Park. A general view of BG14 revetment surviving virtually to full height, looking north. The structure incorporates squared posts tenoned into a squared baseplate, but the braces are all roundwood branches.*

An additional post and brace to the west end of the surviving section (see Fig 20) is interpreted as a later repair.

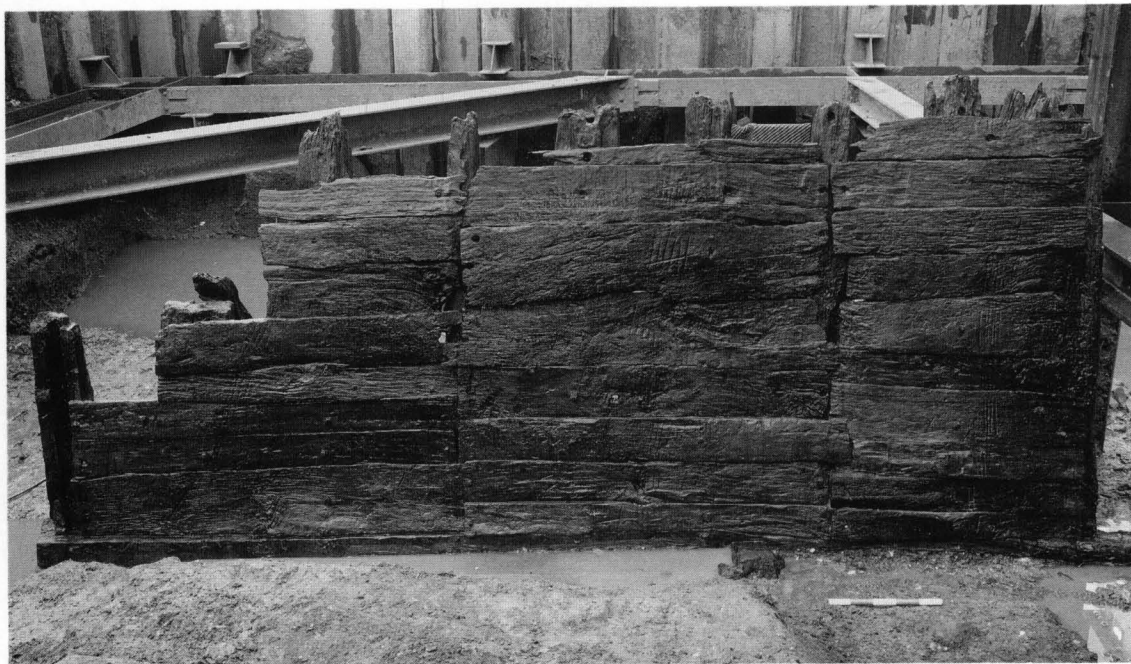
22. Above: Billingsgate Lorry Park. Reverse (landward) face of BG14 revetment cladding, looking south. The unenhanced assembly marks (cf. Fig 23) show that it was prefabricated; scale 5 x 100mm.

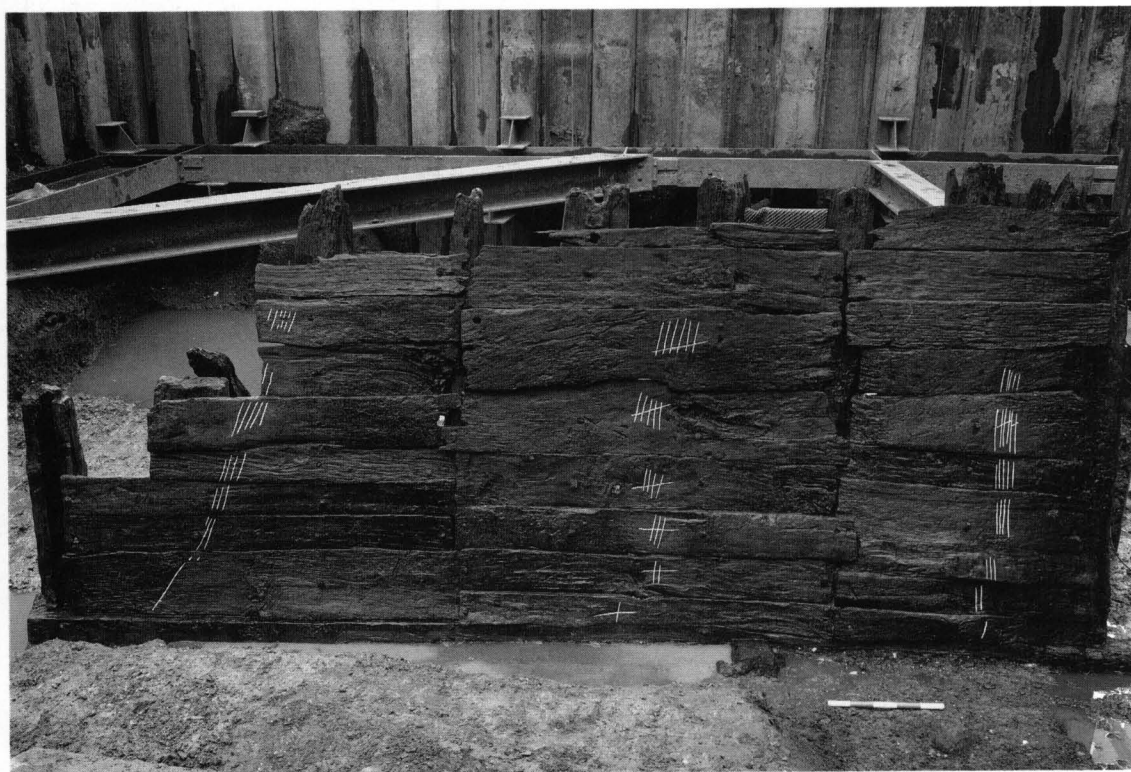
23. Below: Billingsgate Lorry Park. BG14 revetment cladding as on Fig 22, but with the assembly marks enhanced with chalk.

The cladding comprised up to ten runs of sawn planking up to 2m long, 0.36m wide and 30mm thick, laid horizontally edge to edge and pegged onto the north face of the posts. Three discrete sections of cladding were identified by different sets of assembly marks incised on the north face, demonstrating that the structure had been prefabricated. Roman numerals were not used, every run of planking simply being marked with the number of strokes that corresponded to its level. The marks on each 1.8m-wide section were differentiated: units in the east were incised diagonally, unlike the vertically-set ones to the west, while the central ones had an additional stroke scored horizontally across them.

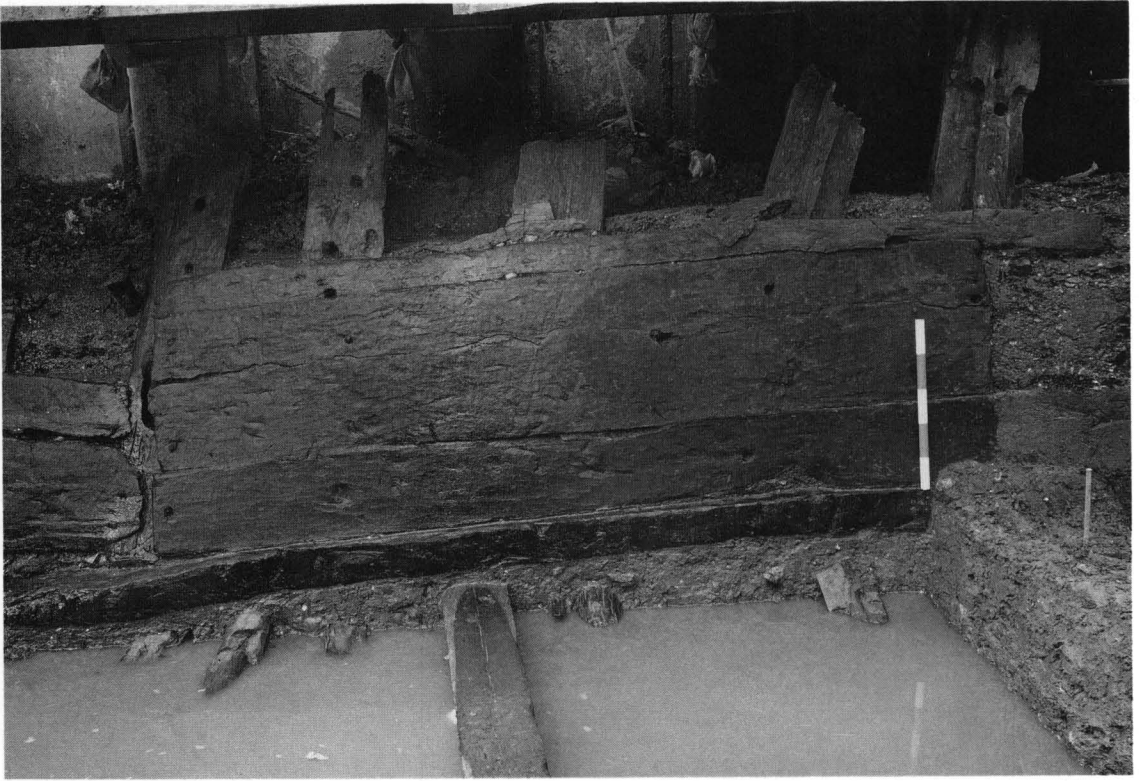
25. Billingsgate Lorry Park: landward (north) face of BG16 revetment excavated on the edge of the sheet-piled southern limit of excavation. The 5 x 100mm scale stands on baseplate into which posts were set. Note rebates on two posts in west (right), showing that they were reused timbers (cf. Fig 24).

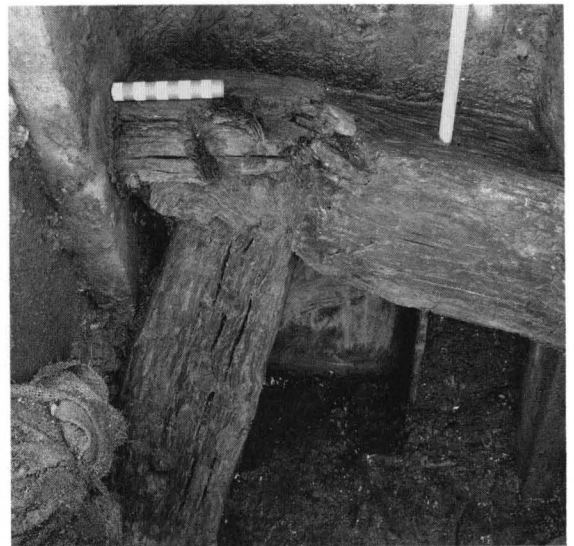
26. Right: Billingsgate Lorry Park. Detail of displaced top-plate from BG16 revetment, disturbed by sheet piling (cf. Fig 24). The 10 x 10mm scale rests on the top-plate, which has a mortise cut in it to accommodate rough tenon on the head of the (once) vertical post.

A point of particular interest is the survival of decayed fragments thought to represent part of a wallplate, with pegged mortises in the underside to accommodate the heads of the principal posts. The posts were supported by diagonally-set front braces, the feet of which were tenoned into subsidiary baseplates on the foreshore to the south, as in the BG14 structure.

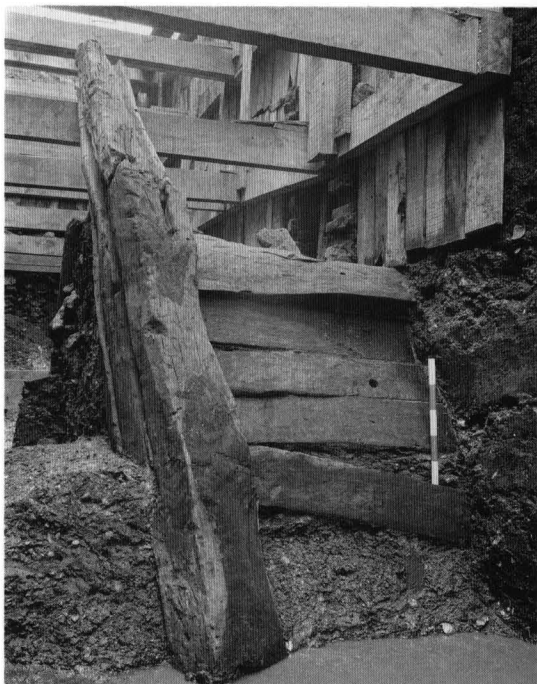
33. Seal House: part of SH2 structure, looking south. The 5 x 100mm scale rests on the foreshore upon which the structure was built: the main post to east (left) of scale is earthfast. The plank cladding is set into grooves cut in the edge of the post.

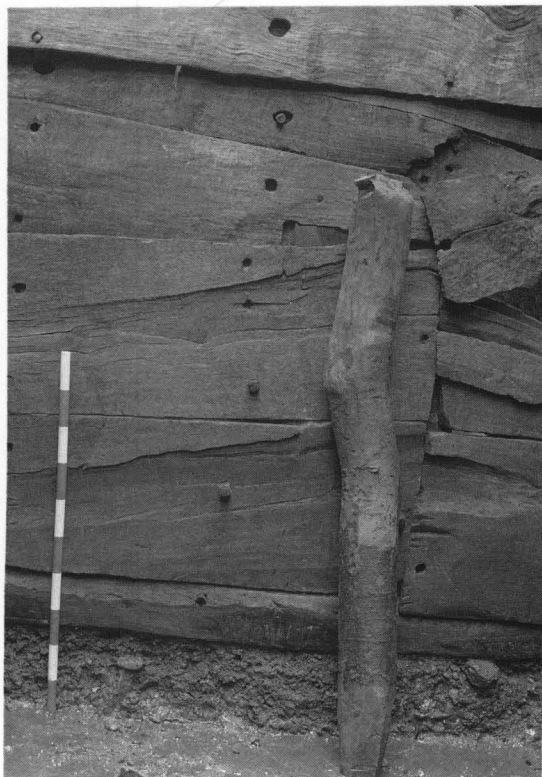
36. Seal House: landward face of SH4 revetment, looking south. The 10 x 100mm scale rests against the plank cladding which has been pegged to the revetment posts.

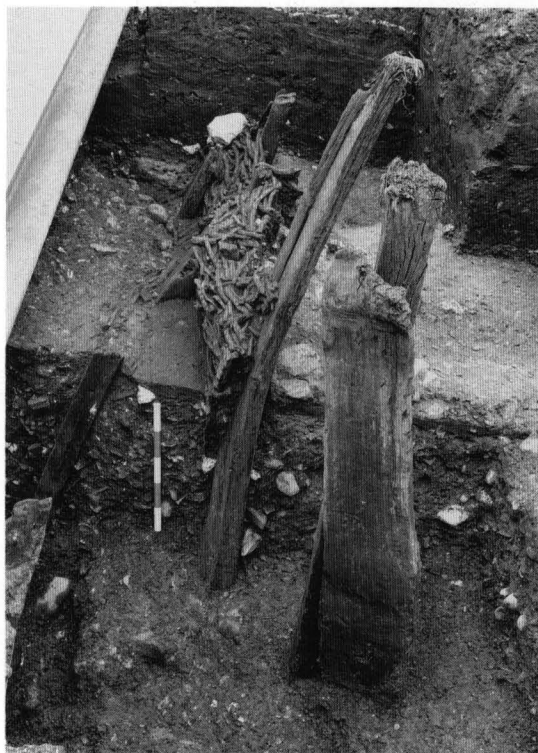
43. *Thames Exchange: detail of TX2 stave structure, looking east. The 5 x 100mm scale stands against a section cut through the foreshore into which the free-standing earthfast stave to the south was set. It was subsequently secured with wattle-work woven around it.*

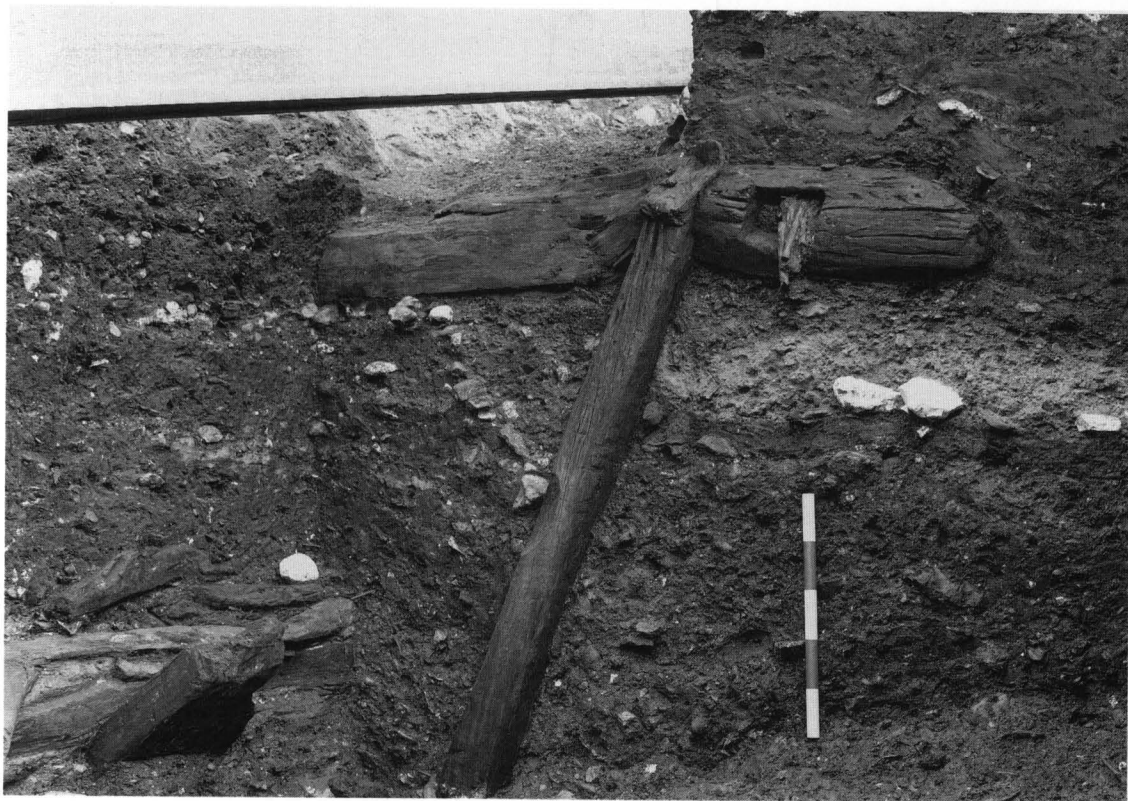
44. *Thames Exchange, 11th-century Structure TX2: a) plan: north to left (see Fig 38); b) side elevation as found. Note the chalk, peat and foreshore horizons demonstrating that the southern line of staves was free-standing.*

for these staves, in the form of front or back braces, and there seems to have been no contemporary dumping behind them. Similar waterlaid deposits accumulated both north and south of this wattle and stave structure, and a tamped chalk surface was also recorded on both sides of it. Taken together, the evidence suggests that the staves formed a free-standing wall, rising up to 2.5m proud of the contemporary foreshore, providing additional protection for the revetment to the north.

*Dendrochronological summary:* Of the 12 samples from the TX2 structure, four were dated, three had sapwood, and one also had bark (2303): a felling date in the winter of 1066/7 is indicated (Figs 9, 39).

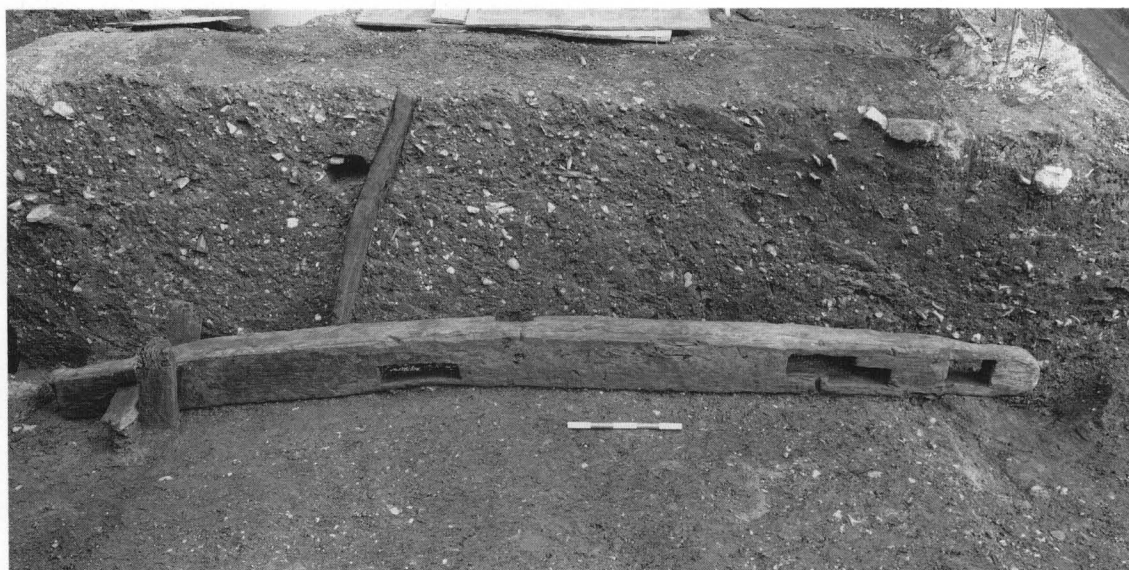
47. Above: Thames Exchange. Back braces from Structure TX3, looking east. The 5 x 100mm scale rests within the infill deposits behind the revetment. Note the rectangular hole cut in the southern end of the back brace to the south of the scale, marking the position of the robbed cladding.

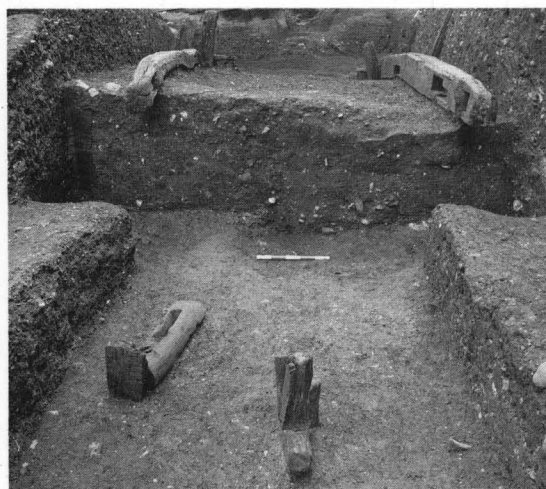
48. Thames Exchange: remains of Structure TX3, looking north. The 5 x 100mm scale rests on the foreshore to the north of which are the lower dumps which had been retained by revetment cladding, secured by the horizontal back braces seen lying within the half-excavated infill material. In the foreground, a trench has been cut through the foreshore deposits, revealing piles and a baseplate which presumably secured the feet of braces supporting the revetment.

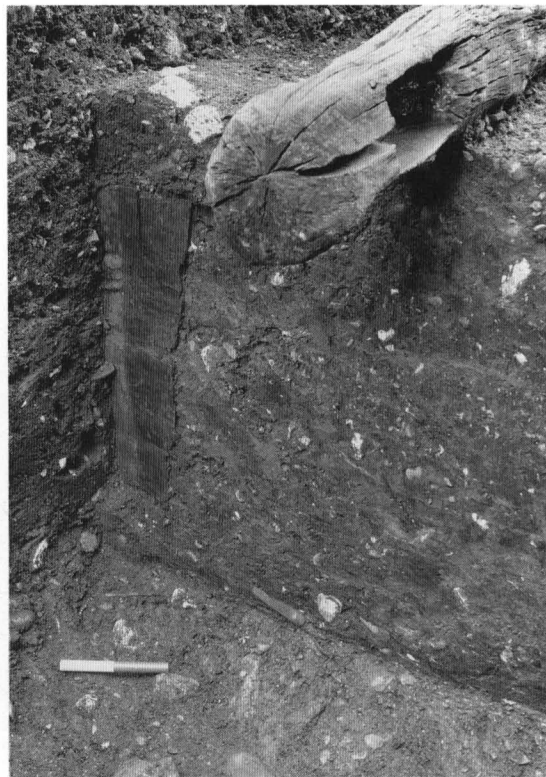
49. Below: Thames Exchange, detail of TX3 revetment, looking north-west. The 2 x 100mm scale rests on the foreshore south of the dumped material behind the revetment. Note traces of timber on the vertical face of the dumps, and the hole in the protruding southern end of the back brace to accommodate a lockbar retaining the cladding.

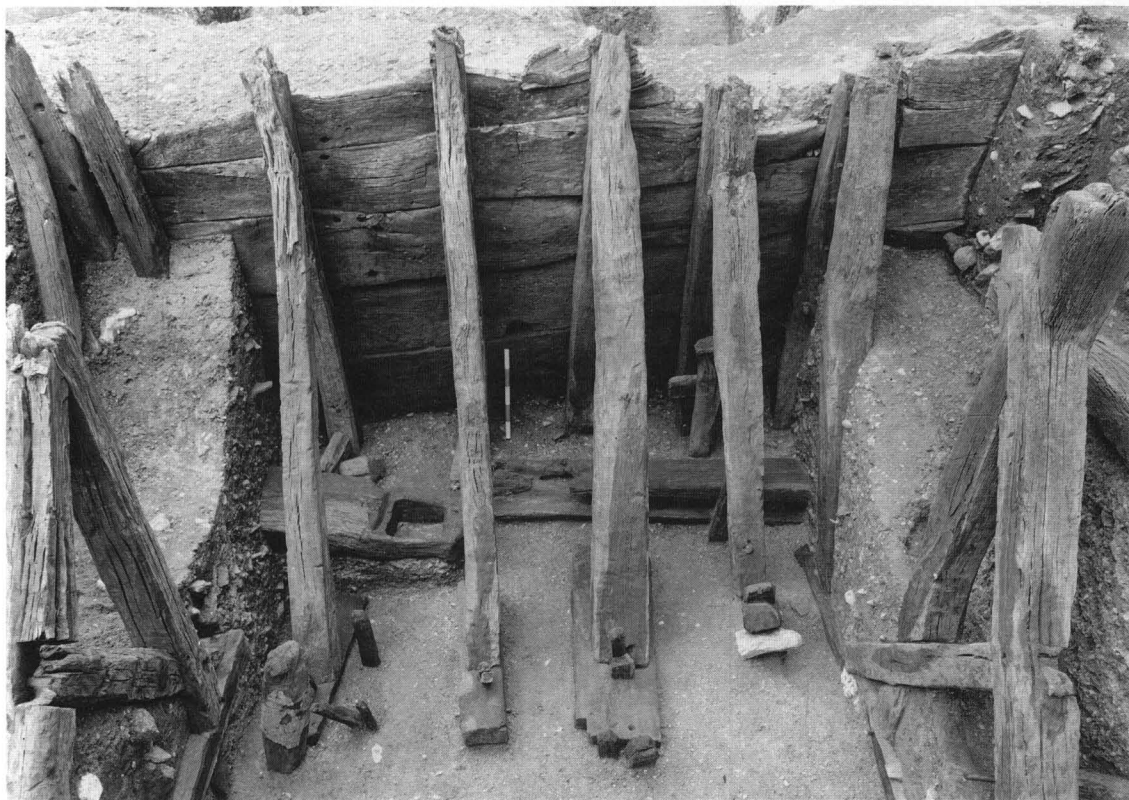
50. *Thames Exchange: the riverward face of TX4 revetment, looking north. The 5 x 100mm scale stands on the primary foreshore, resting against the plank cladding retained by earthfast posts. In the centre of the photo, foreshore deposits which accumulated against the revetment have been excavated, exposing the feet of the front braces. In the foreground are the remains of the TX5 river stair trestles.*

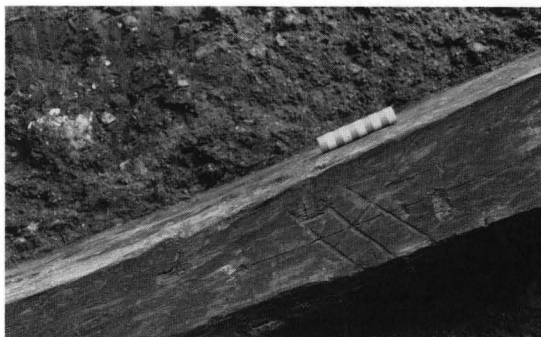
52. Thames Exchange: detail of TX4 revetment back brace, looking east. The 10 x 10mm scale rests on a squared timber above an incised assembly mark (cf. Fig 51c).

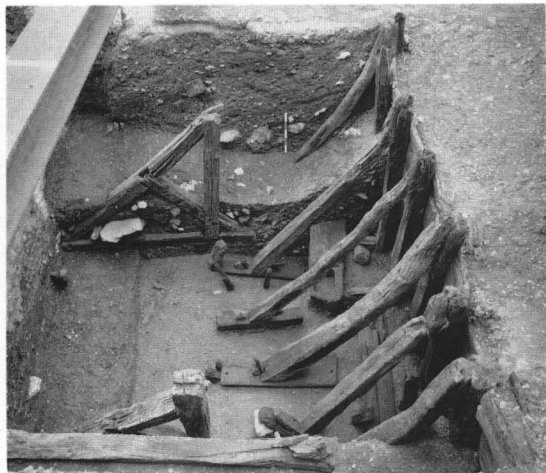
54. *Thames Exchange: part of the 13th-century waterfront, looking east. The 5 x 100mm scale stands on the foreshore which accumulated against the face of the TX4 revetment, to right, surviving almost to full height. In centre of area, a trench has been cut down to the base of the TX5 jetty trestle, erected in the open river to the south of the revetment.*

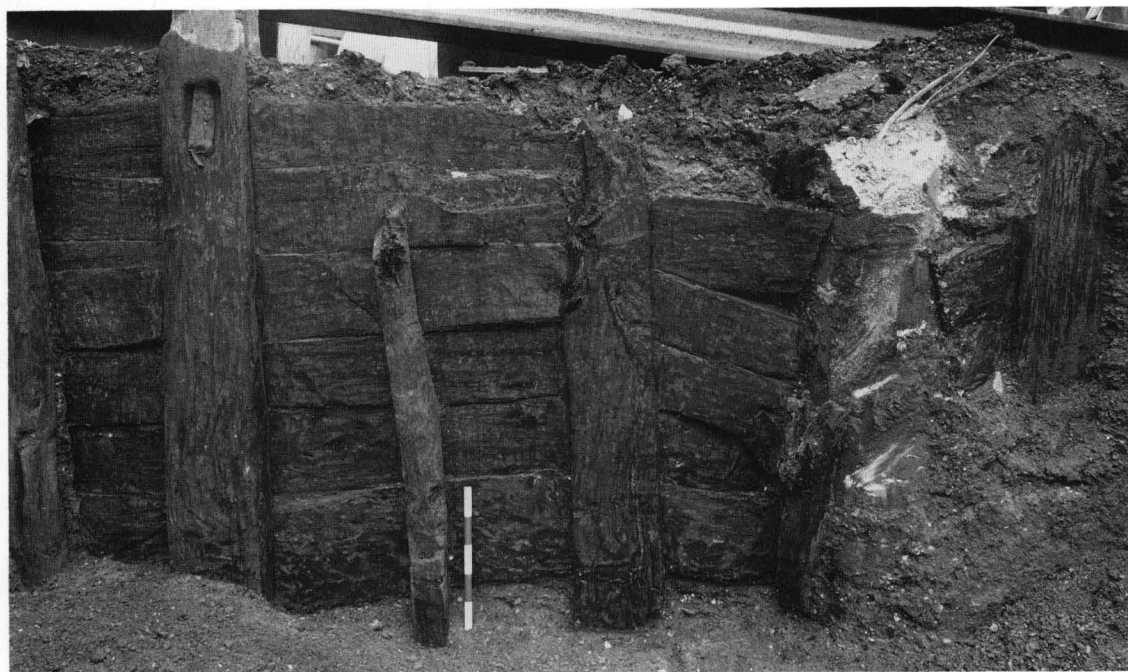
58. Left: Thames Exchange (see Fig 38e). Riverward face of late 12th-century TX7 revetment looking north, exposed and hurriedly cleaned during contractors' ground reduction work. The 5 x 100mm scale stands on the primary foreshore into which the structure's earthfast posts were set.

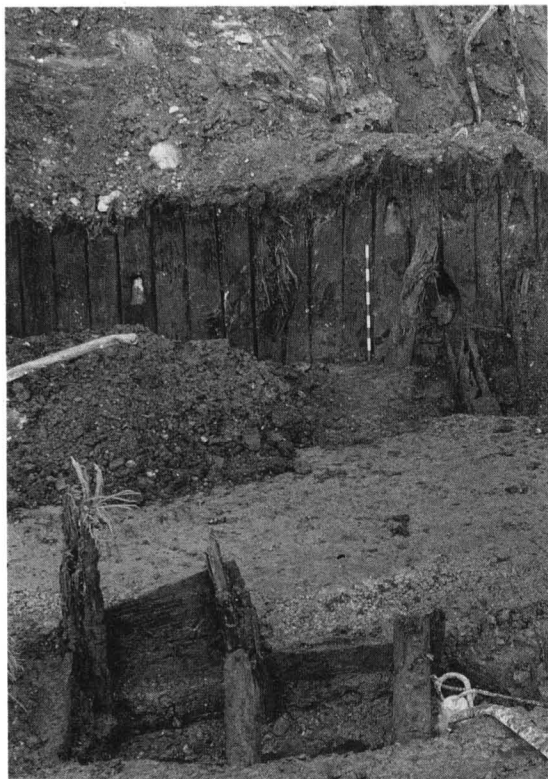
65. Sunlight Wharf: south (riverward) face of stave-built TL1 structure, against which the 10 x 100mm scale rests, exposed during contractors' ground reduction programme. The waterfront was subsequently advanced in the 13th century with the erection of TL2, the post and plank revetment partially exposed in the foreground, next to the submersible pump.

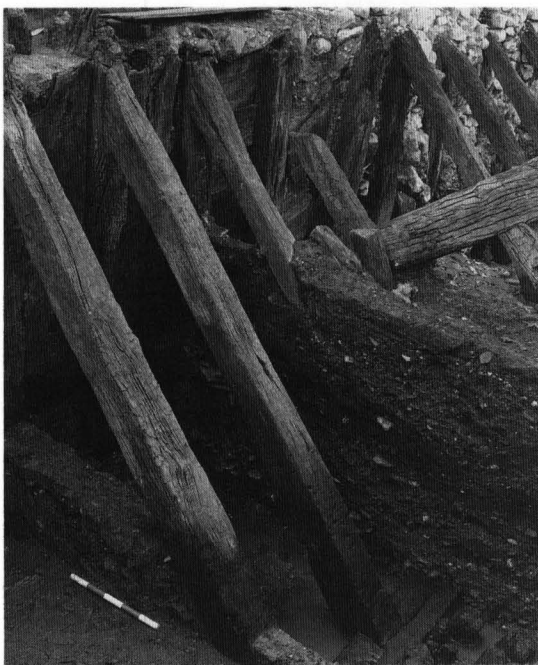
70. Above: Trig Lane. Two squared front braces from TL3 revetment, looking north-east. The 5 x 100mm scale rests on the foreshore upon which the principal baseplate was laid, just visible to left (north). Note the bird's-mouth abutment on the foot of the brace, where it meets the partially-exposed subsidiary baseplate.

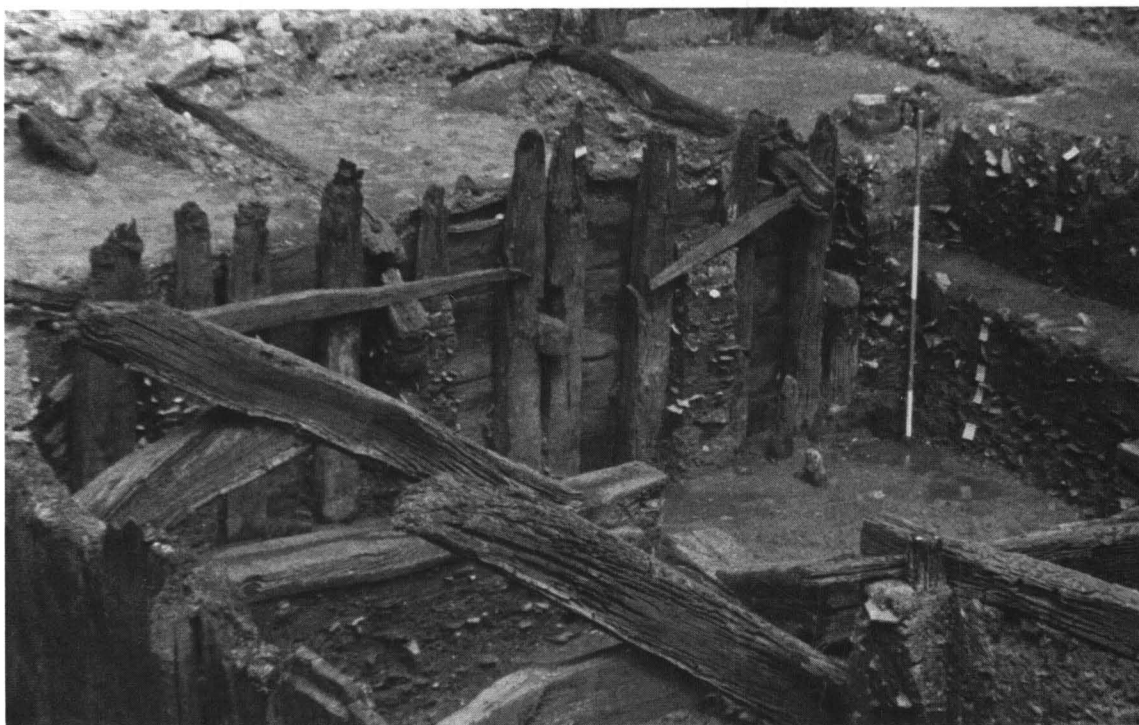
73. Below: Trig Lane, front (riverward) face of the post and plank TL7 revetment, looking north-east, with triangular back braces of the later TL11 structure visible in foreground. The 4 x 500mm scale stands at the east end of the exposed section of the back-braced TL7 structure. This was supported with lockbars which passed through the protruding southern ends of the pile-retained anchor beams (cf. Fig 15).

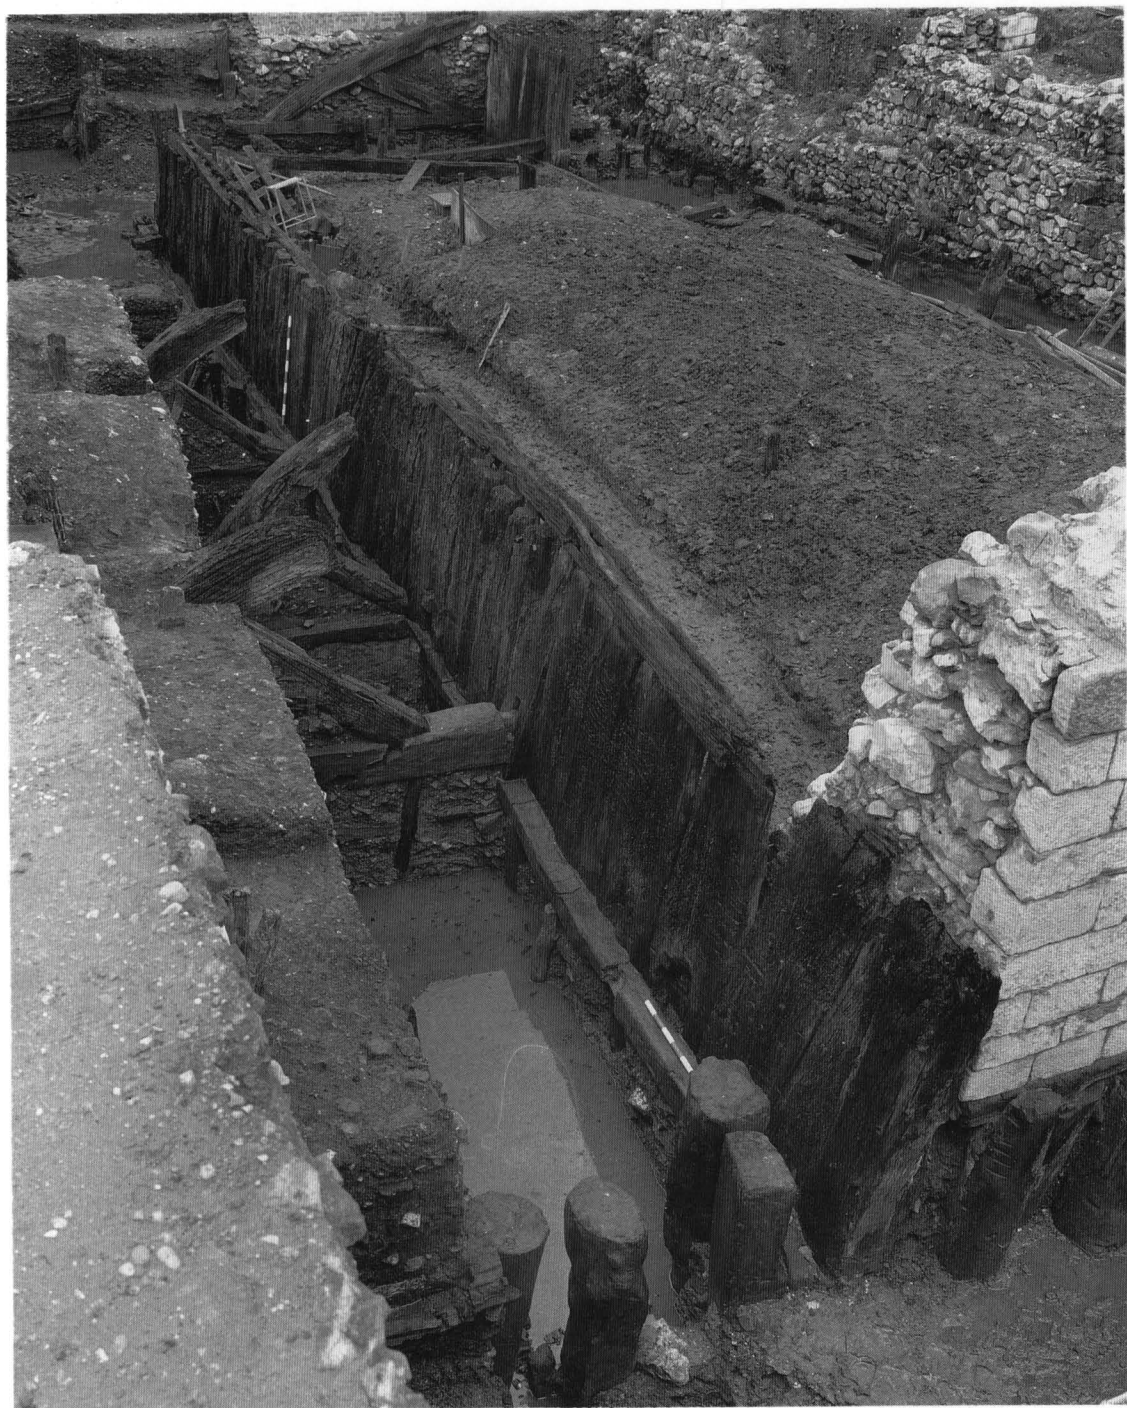
76. Trig Lane: north (landward) face of TL10 revetment, looking east. The horizontal 5 x 100mm scale rests on the grooved baseplate into which the staves were set: three triangular back braces which supported the 16m-long stave wall from behind have been partially exposed in the trench cut through the infill deposits.

The back-braced TL10 revetment ran east-west across the site on the same alignment as the TL7 structure (Milne & Milne 1982, 26-9). It incorporated six baseplates joined together with edge-halved scarfs with square vertical butts, into which 45 staves were set in a continuous squared groove.

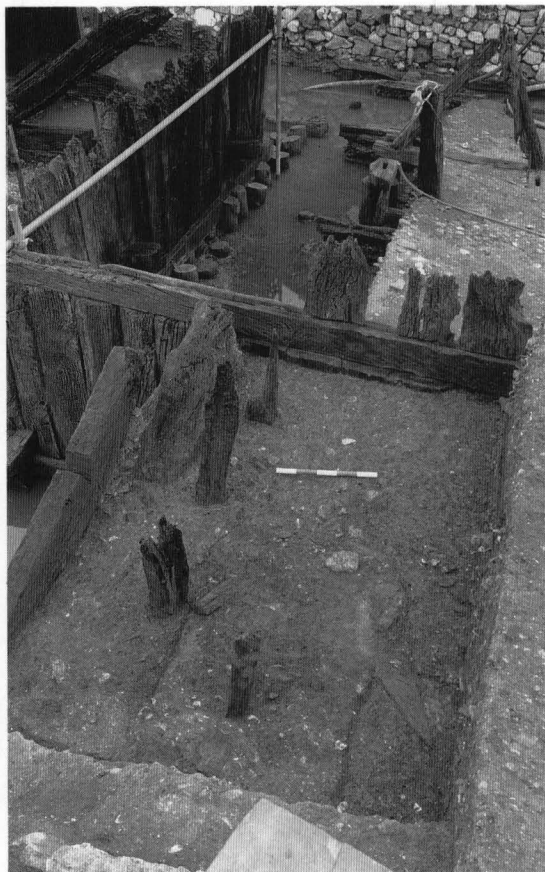
81. Trig Lane: general view of part of the bipartite TL10/G12 revetment, looking south. The 5 x 100mm scale rests on an excavated horizon within infill deposits dumped to north of (behind) the stave-built 14th-century TL10 revetment. Over the top of the stave wall sits a grooved baseplate, part of the 15th-century G12 revetment, into which a line of vertical planks were set, of which the remains of three can be seen.

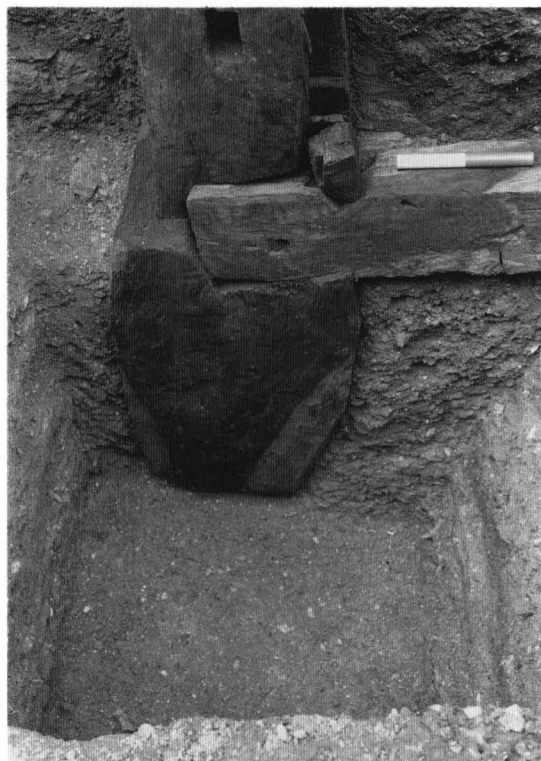
84. *Thames Exchange: detail of early 13th-century TX4 revetment, showing the base of an earthfast post exposed in a trench cut through the foreshore deposits. The 2 x 100mm scale rests on a back brace which is joined to the post with a pegged notched lap joint.*

notched lap joints have been found in over 30 buildings more or less securely dated from the mid 12th to the early 14th century, but none of these are considered to be vernacular (Hewett 1973). The 13th-century London revetment (Fig 84) is therefore of especial interest, since at least some of the examples were *secret notched laps*, ie the notch was obscured by a small rebate on the foot of the brace when in position. A variety of forms of the same joint in the same structure is not unusual: six variations of the notched lap were recorded in the Blackfriars roof at Gloucester, for example, where the choice was 'influenced by the stresses expected and by the vagaries and imperfections of individual timbers' (Rackham *et al* 1978, 117).

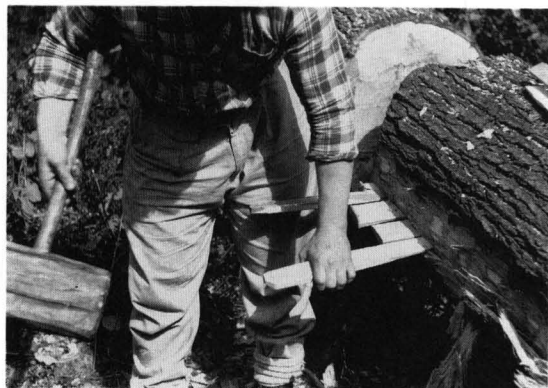
99. Converting timber using Saxon methods: cleaving halved timbers from a medium-sized oak standard with hardwood wedges.

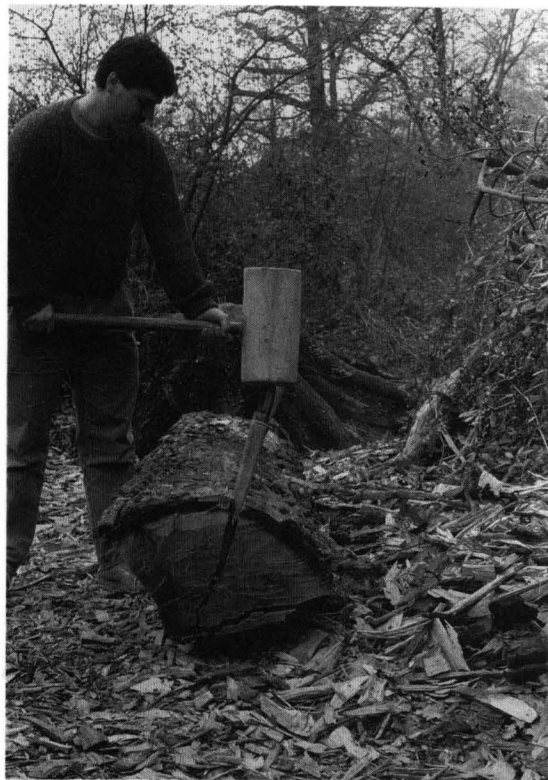
100. Cleaving boards using Saxon methods: this quartered oak log will be split into two, and then each section radially cleft in half again. This process produces c.30 boards from each tree.

The most common type of conversion for the thinner planks, often known as boards, was *radial cleaving* (Fig 100). This technique of converting a log relies on the availability of very straight-grained, relatively knot-free oak. The resultant boards, with a wedge-shaped cross-section and corrugated,

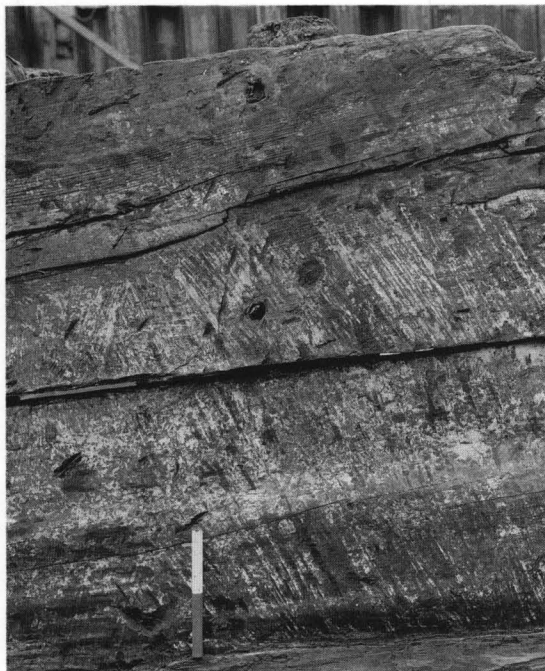
101. Billingsgate Lorry Park: a sawn plank from the 13th-century BG14 revetment. The diagonal saw marks preserved on the reverse face diverge either side of the 2 x 100mm scale, leaving the triangular signature characteristic of timber sawn on a single trestle, by the 'see-saw' method.

in some standing medieval buildings have been recorded on the Vintry, Thames Exchange and Billingsgate sites (Fig 101). These show that these 13th-century timbers were sawn on a trestle (the *see-saw* method: Fig 97g), a technique also used by the Romans (Goodburn 1990b). By the later 15th century, sawing over a pit seems to have become common, when references to '*putte saws*' appear in London documents (Clark 1984).

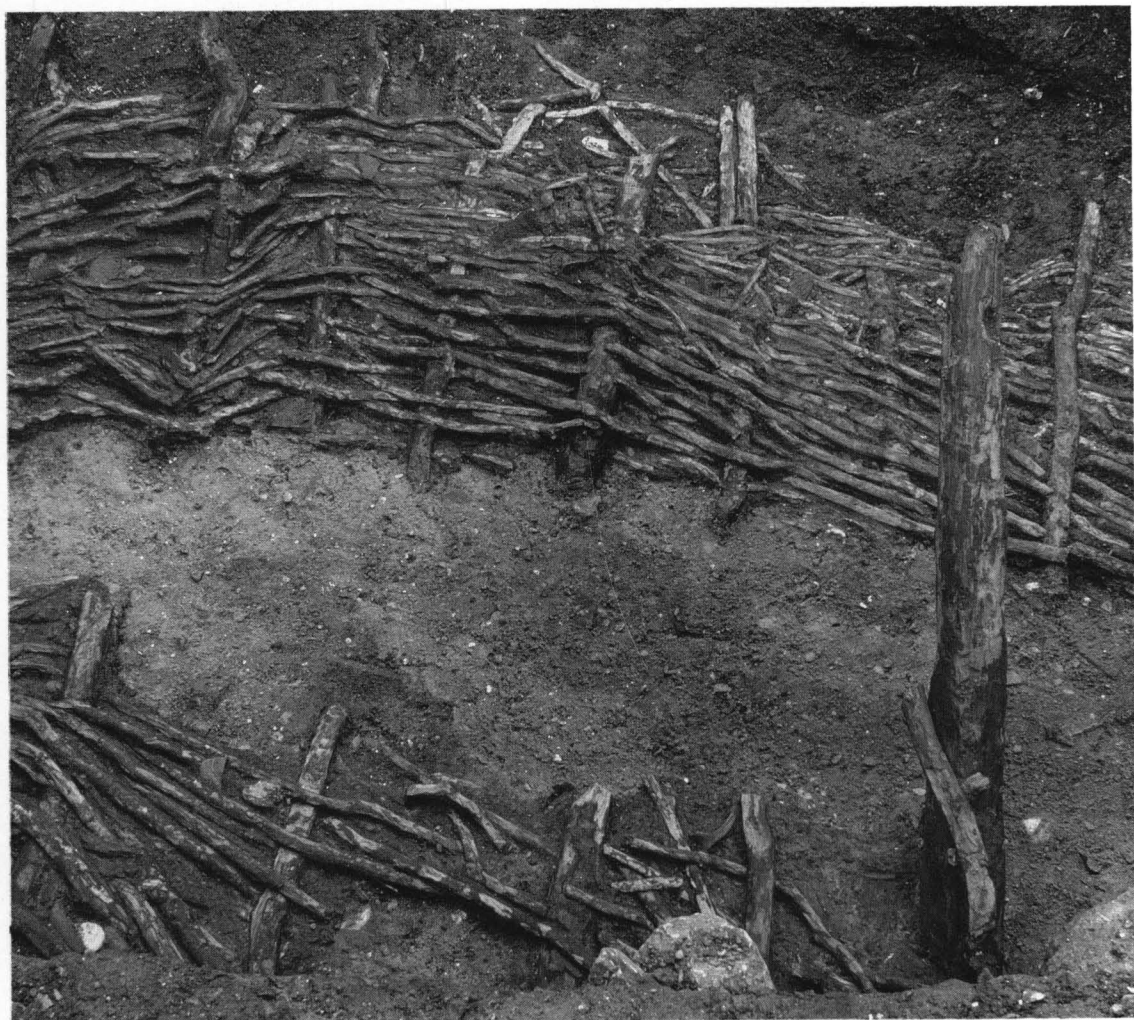
102a. Above: 10th-century wattle-work woven around collapsed earthfast posts on the foreshore on the Thames Exchange site, looking south (TEX88, 1512). The structures were traced for 17m.
