# Timber Building Techniques in London c.900–1400

AN ARCHAEOLOGICAL STUDY OF WATERFRONT INSTALLATIONS  
AND RELATED MATERIAL

London & Middlesex Archaeological Society  
Special Paper 15

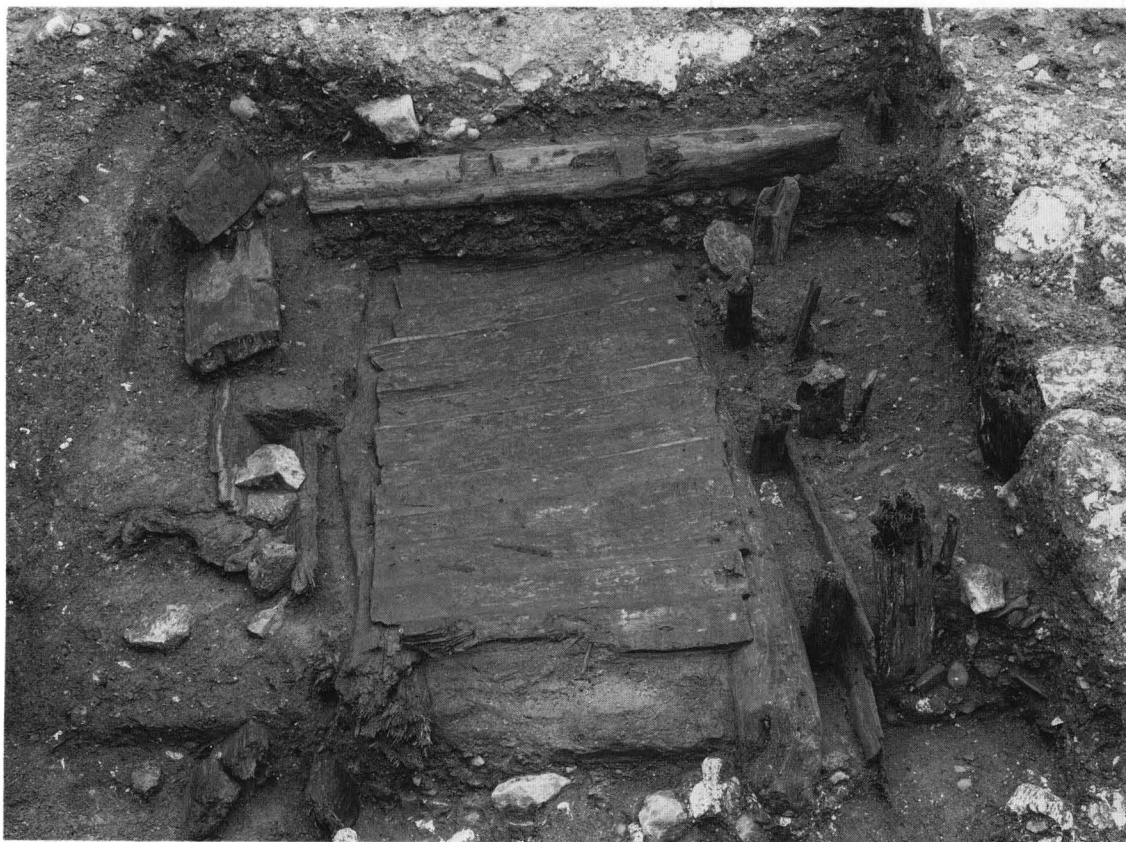
103. Above: late Saxon board walk excavated on the Thames Exchange site (TEX88, 3171), looking north. The 5 x 100mm scale rests in a machine cut trench which sliced through the feature, exposing the two joists onto which the cleft boards were pegged. Remains of a later structure can be seen in the section above the board walk to the north.

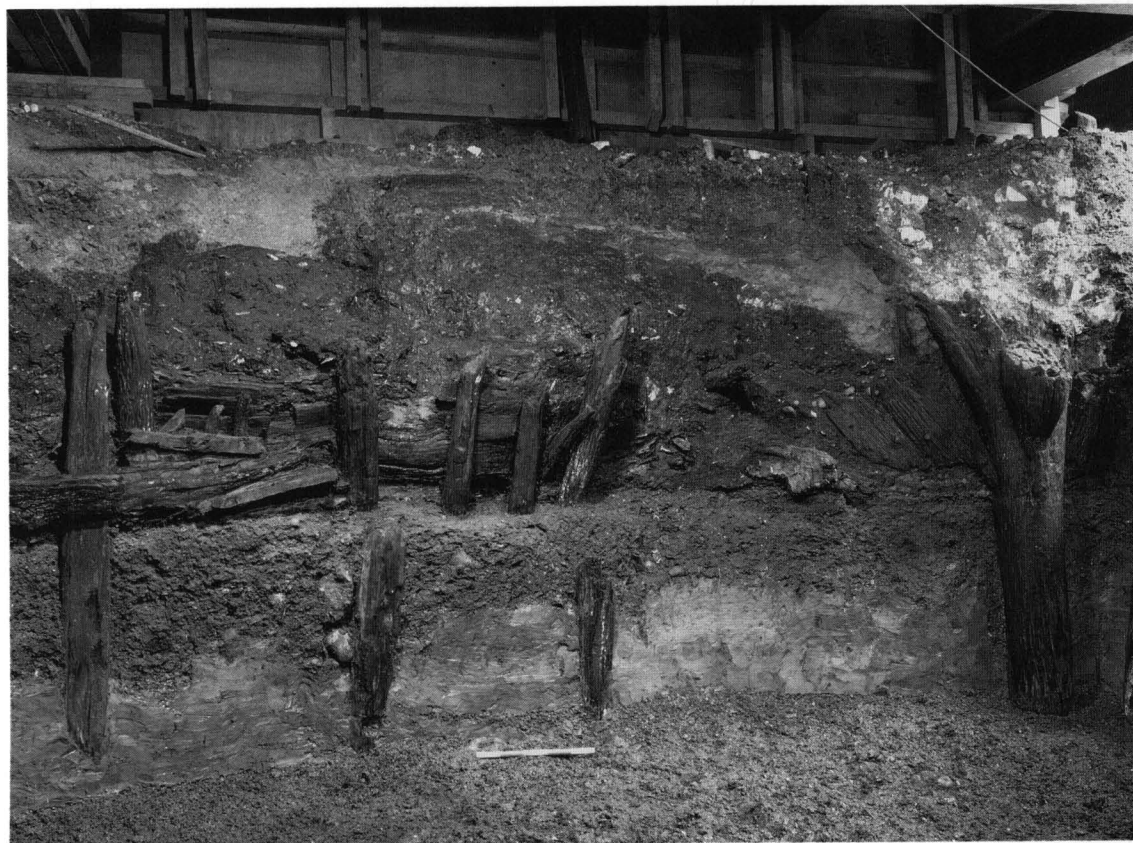
*119. Revetments, boats and buildings exposed on the London waterfront on the Vintry site in 1991. Part of the southern face of an 11th-century revetment (VRY89 786) comprising earthfast posts driven deep into the foreshore with a cladding of reused boat timbers to the left, and a reused house timber, the top of a late 10th-century aisle post, to the right. The 5 x 100mm scale rests on an arbitrary excavated level beneath the contemporary foreshore.*

Overlying the remains of the Roman quay were waterlaid deposits, suggesting a rapid rise in river level. Saxon wattle and clay embankments were replaced by a sequence of timber-revetted reclamation deposits which advanced the waterfront on either side of a major inlet. The reused material incorporated within the revetment structures (see Fig 119) included many boat and ship timbers as well as a post from a pre-Conquest aisled hall.
