# MEDIEVAL WATERFRONT DEVELOPMENT AT TRIG LANE, LONDON

An account of the excavations at Trig Lane, London, 1974–6 and  
related research

by  
GUSTAV and CHRISSIE MILNE

SPECIAL PAPER NO. 5  
LONDON AND MIDDLESEX ARCHAEOLOGICAL  
SOCIETY  
1982

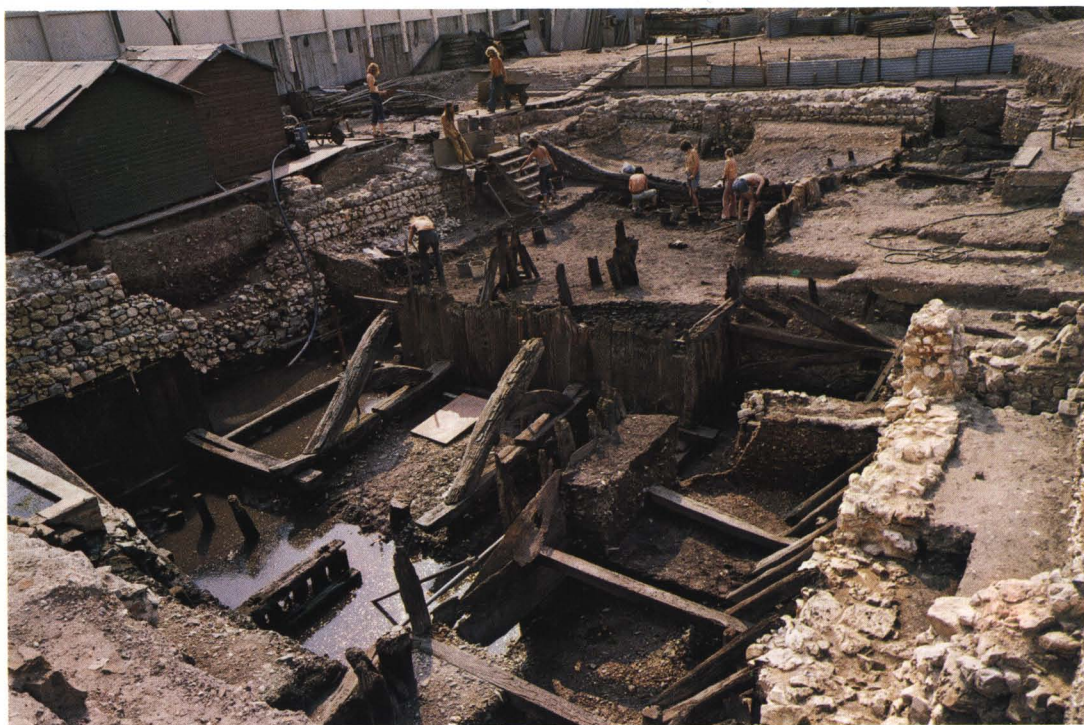
Trig Lane 1974-76: Excavations in progress at Trig Lane in 1975, removing the dumped deposits behind the mid-15th century river wall. To the right are the remains of the 14th-century timber revetments recorded in 1974. Note depth to which archaeological deposits survived. Diesel pump, modern concrete river wall to south, at the top of the picture.

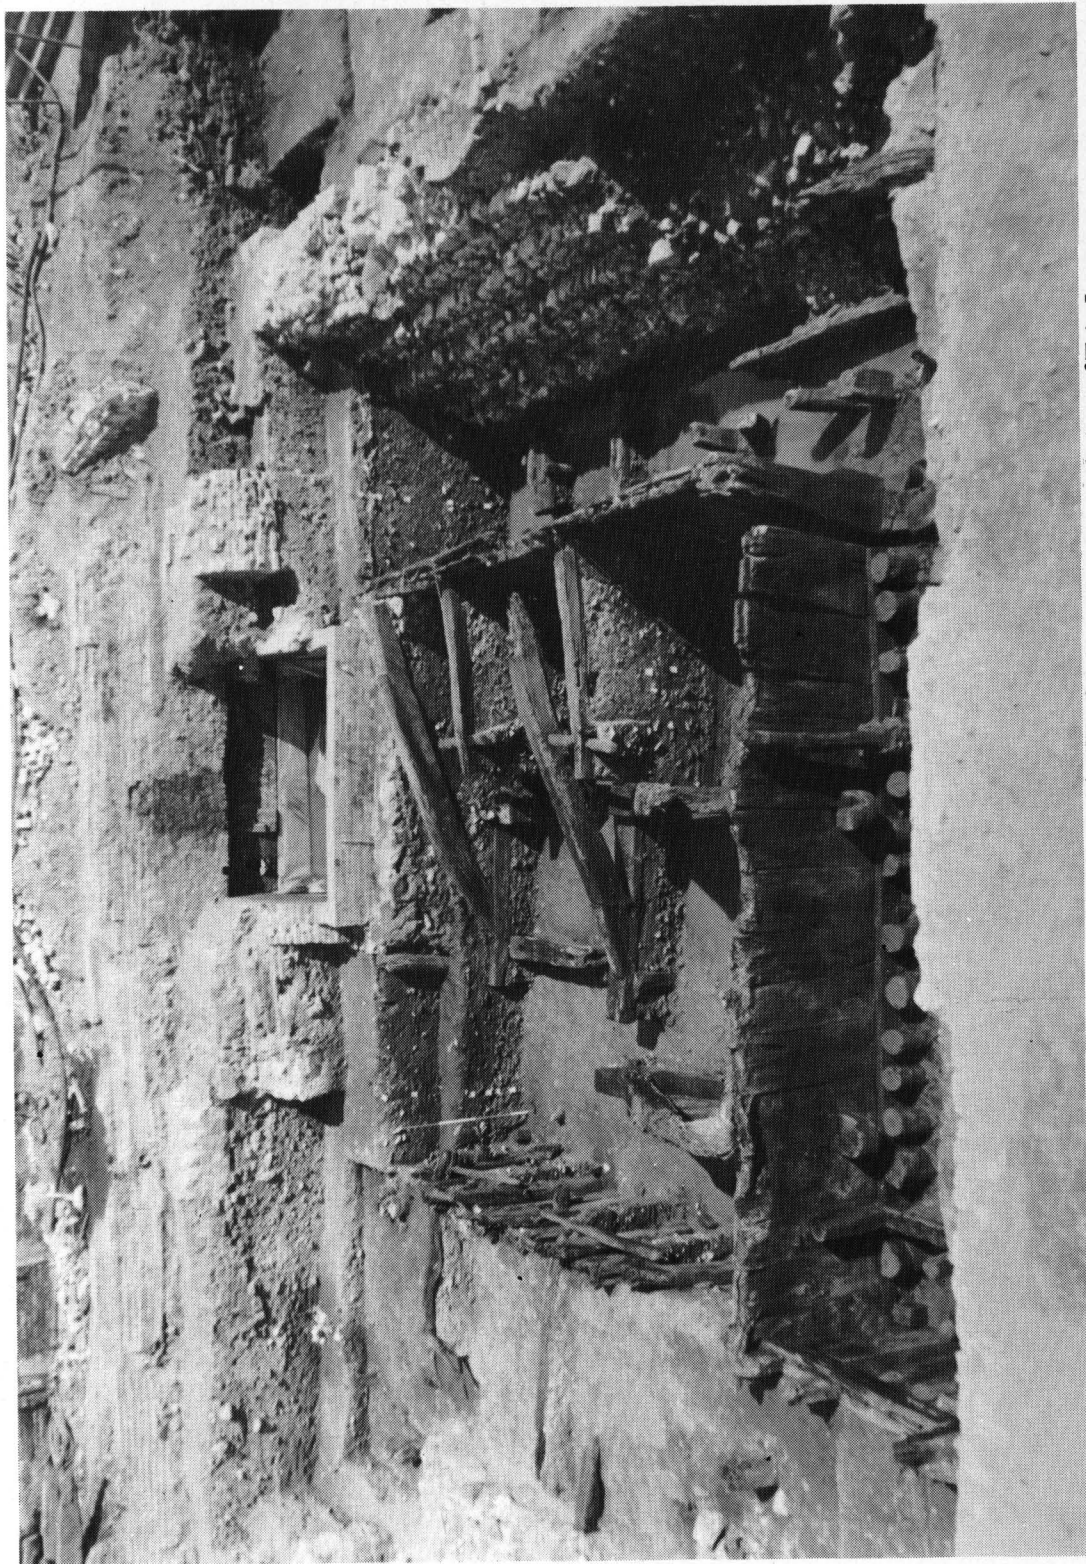
Plate 1. Trig Lane 1974-76: Medieval riverfront reclamation: general view of Trig Lane excavations in 1974 looking east, river to south. Left of the 4x500mm scale is the early 14th century Group 7 revetment superseded by the Group 11 structure to the right in *c.* 1380, and the Group 15 river wall in *c.* 1440. Cf. Fig. 3.

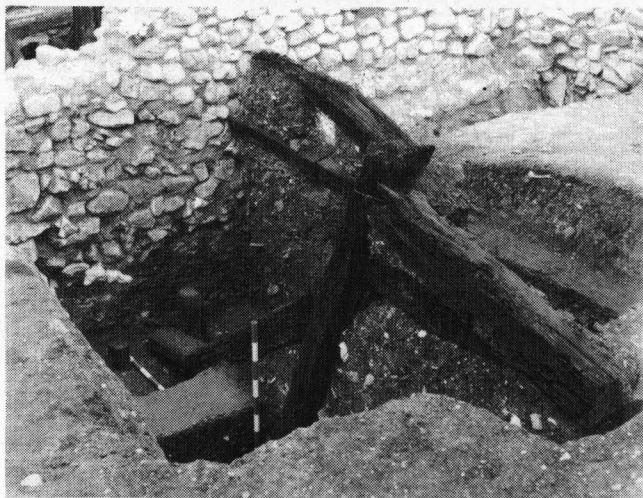
Plate 2. Trig Lane 1974-76: Group 1, Structure A, looking south-west. Note diagonal brace rising from base-plate (left), passing above vertical 10×100mm scale and lapping over the western face of post. To the north it has broken, but is still joined to remains of fourth member which was once tenoned to head of the post.

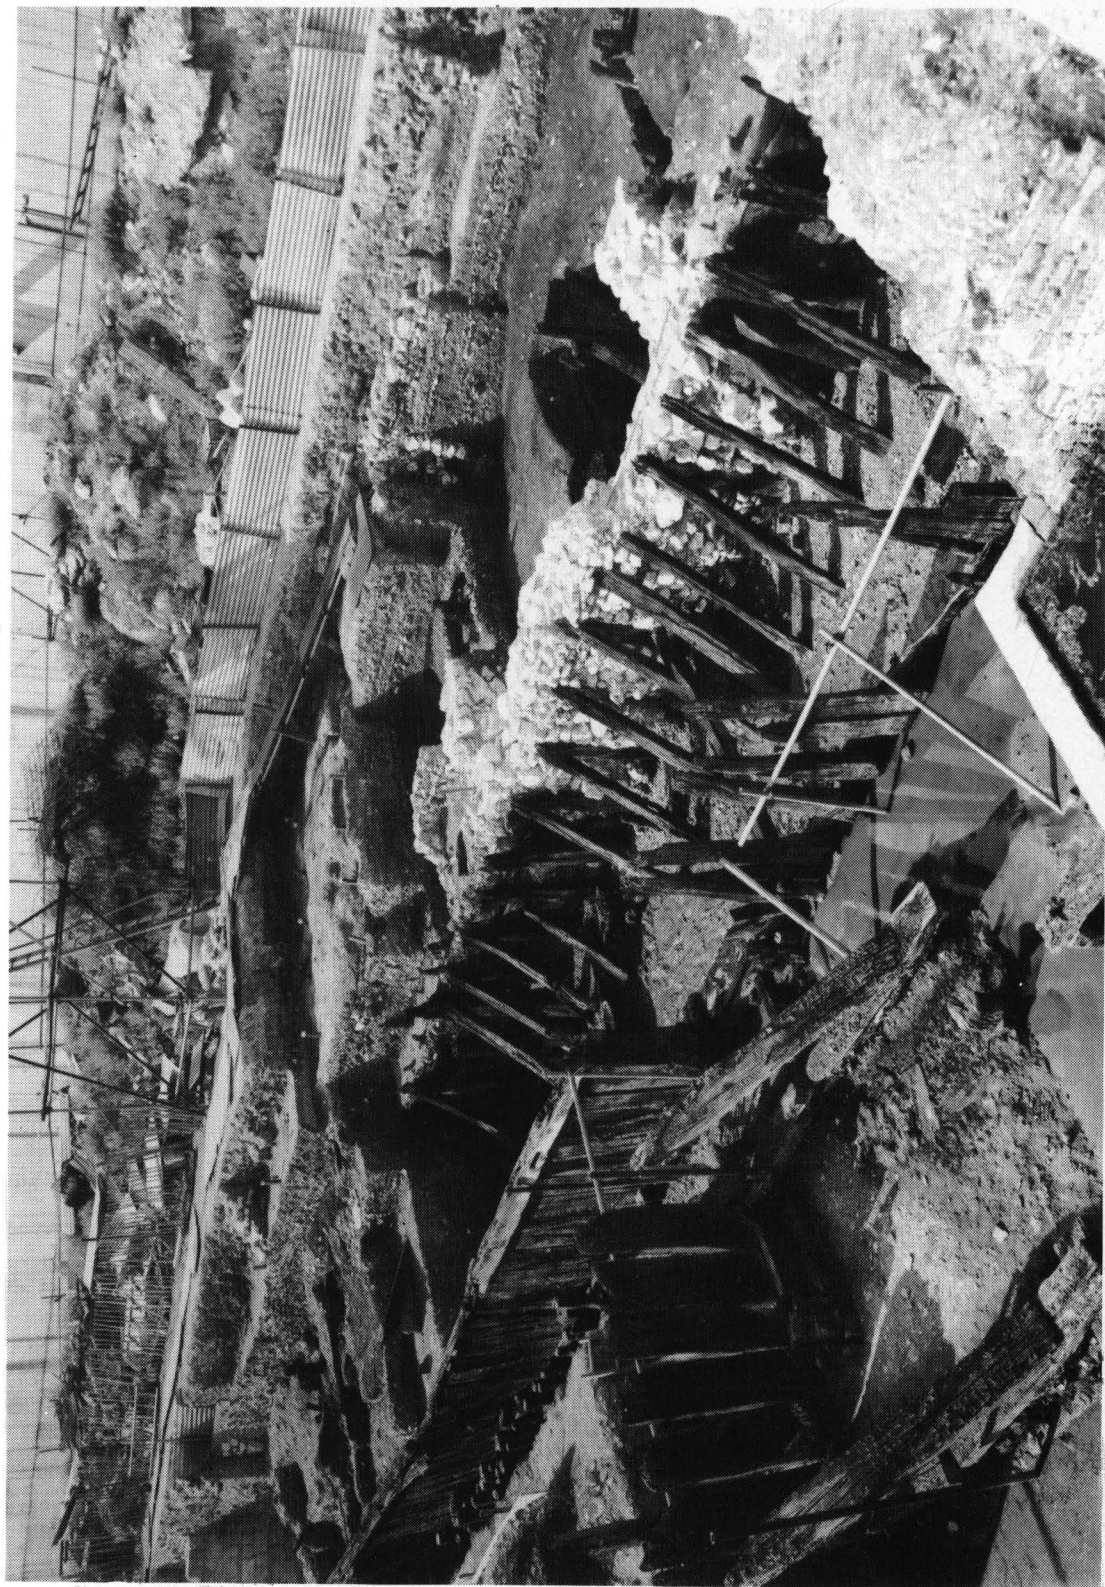
Plate 4. Trig Lane 1974-76: Front-braced Group 3 revetment cut by later chalk foundation, looking north-west, river to south. The subsidiary base-plates are buried beneath the foreshore which accumulated against the revetment's southern face. 4x500mm scale.

Substantial remains of the Group 3 revetment which replaced the Group 2 structure were recorded in the northern part of the site. It was traced for a distance of 16m (Fig. 8a) and survived in excellent condition to a height of over 2m in the central and eastern areas, where its southern face was fully exposed (Fig. 8b). Between these two areas, the later construction of a chalk building foundation<sup>6</sup> obscured the revetment face, and only the braces were visible (Pl. 4).

At the same time as the Group 7 revetment was being erected, the deep chalk foundations of the building visible on Pl. 4 were also being laid.

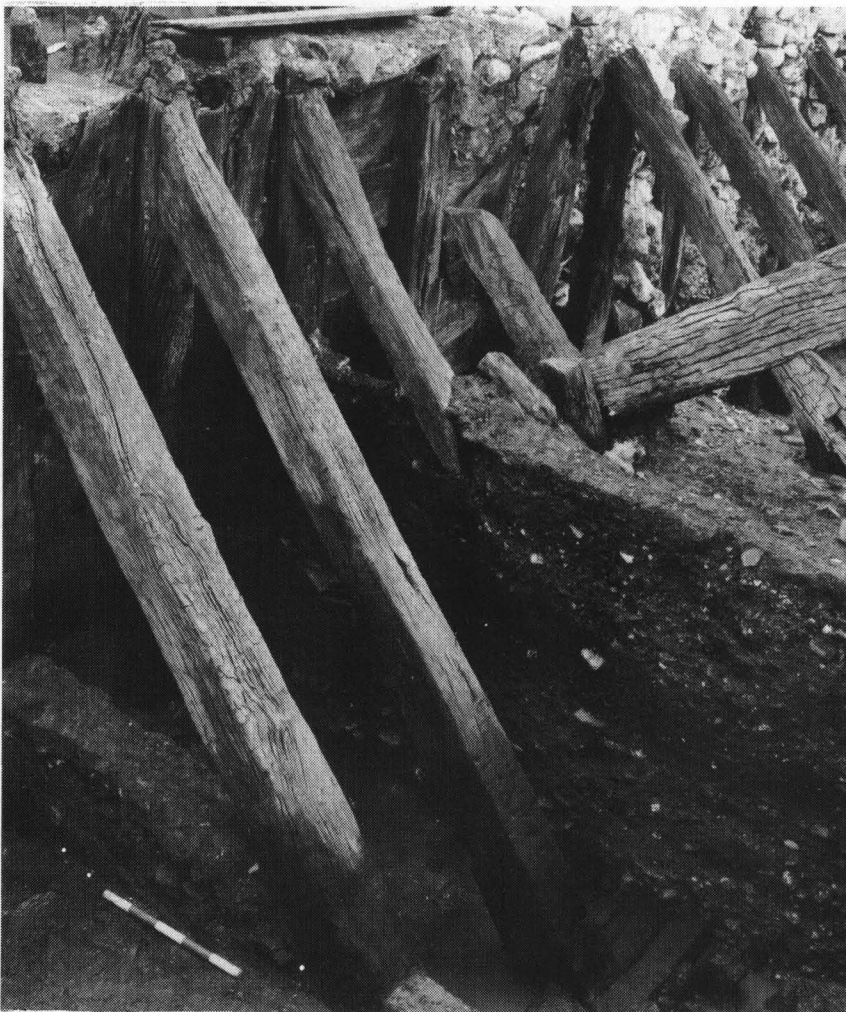
Plate 6. Trig Lane 1974-76: Group 3 revetment face showing 2.5m long diagonal brace running from head of post to subsidiary base-plate. Looking north-east, river to south, 5×100mm scale.

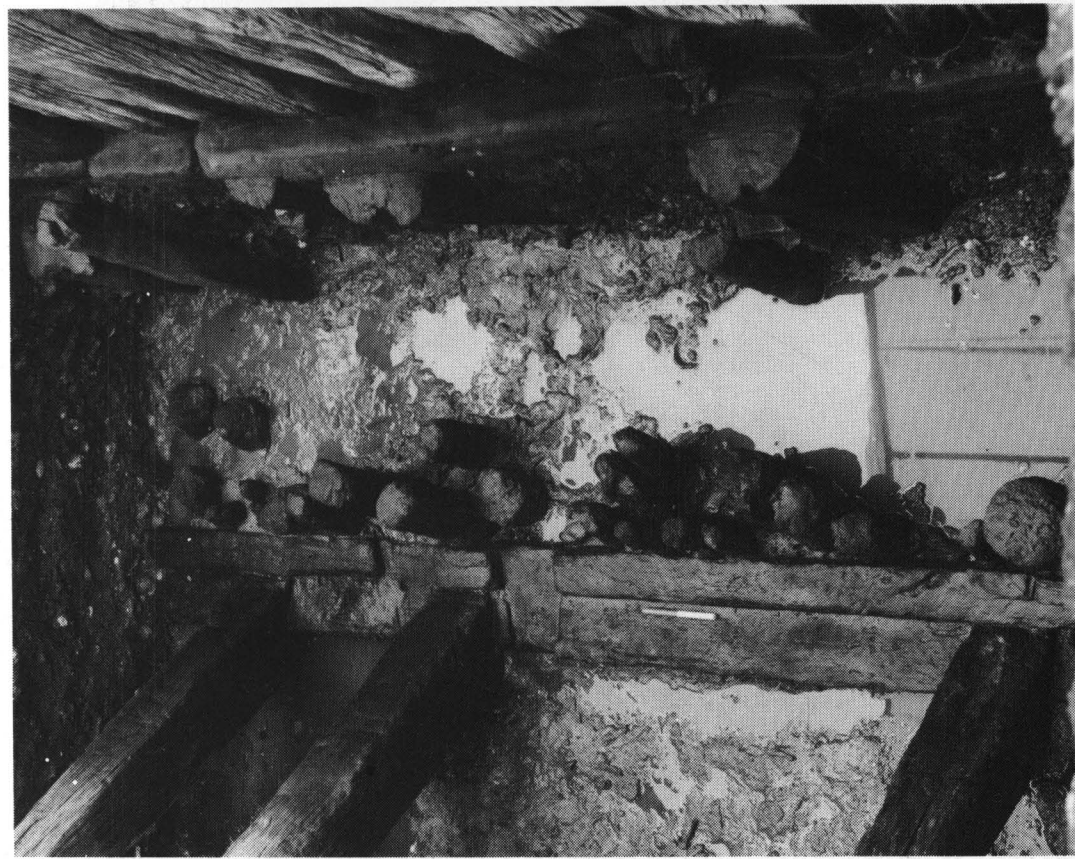
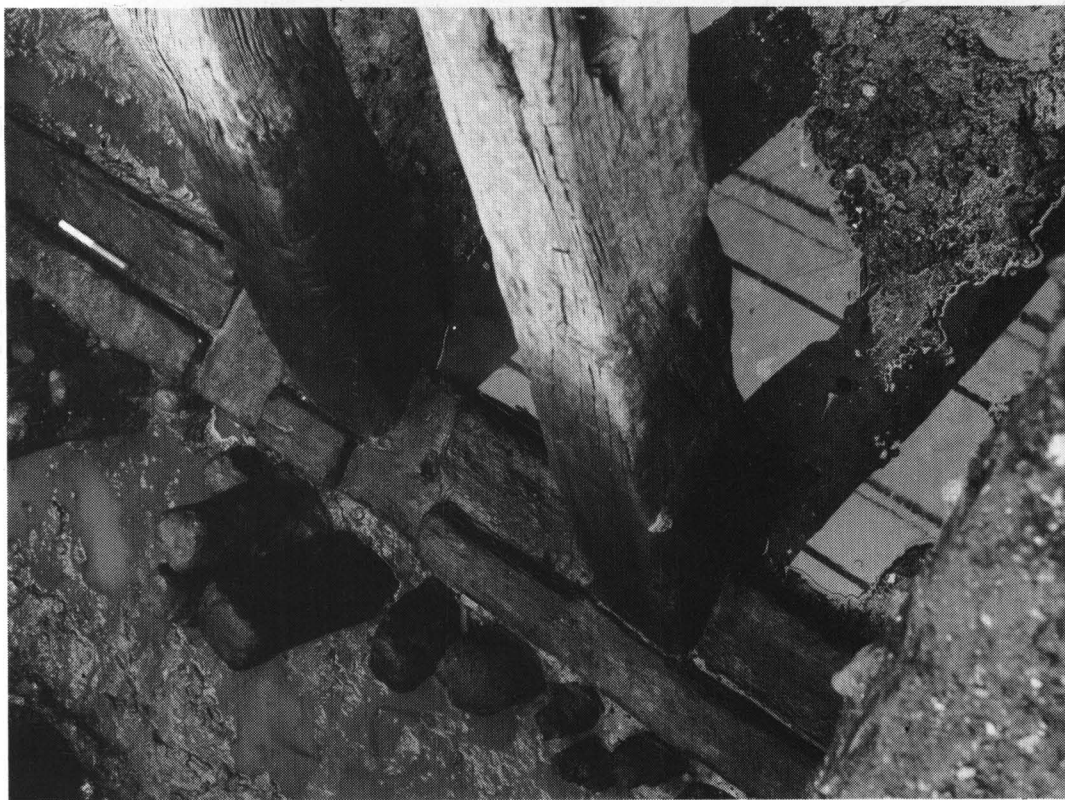
Plate 7, a and b. Trig Lane 1974-76: Group 3 subsidiary base-plate with 2x100mm scale looking east, river to south. Note retaining piles and bird's-mouth abutment at foot of braces, a joint which is neither tenoned nor pegged. Traces of dove-tail joint on base-plate show it was reused.

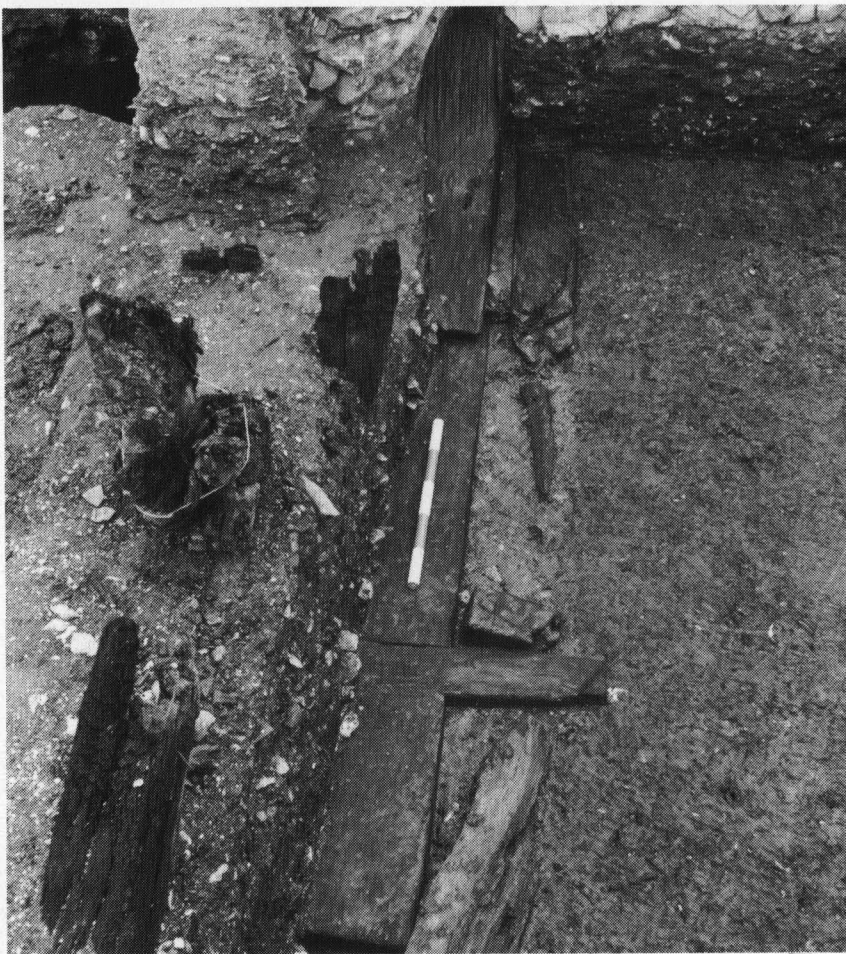
Plate 8. Trig Lane 1974-76: Group 3 revetment back-brace, looking south towards the river. The revetment face lies beyond intrusive stone wall. The cut into which the partially exposed Group 3 tie-back (with 5×100mm scale) was inserted is clearly visible, packed with timber fragments derived from earlier Group 1 structure B to east.

The top of Structure B was located while excavating a post-medieval pit. In the time available, it was only possible to reveal a further 1m of the structure, sealed as Structure A, by the Group 2 dumping. The section that was exposed, although damaged and decayed, indicated that this structure also comprised a vertical member with a pegged diagonal shore (Fig. 5; Pl. 8).

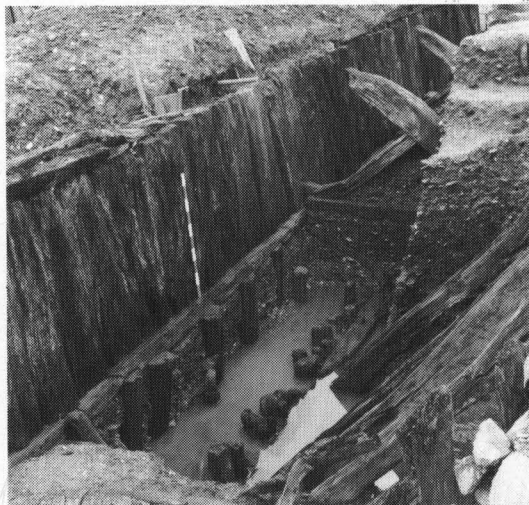
Plate 9. Trig Lane 1974-76: Back-braced Group 10 revetment with 10×100mm scale, looking west, river to south. To right of scale are remains of collapsed trestle tenoned into Group 3 subsidiary base-plate sealed beneath later back-brace.

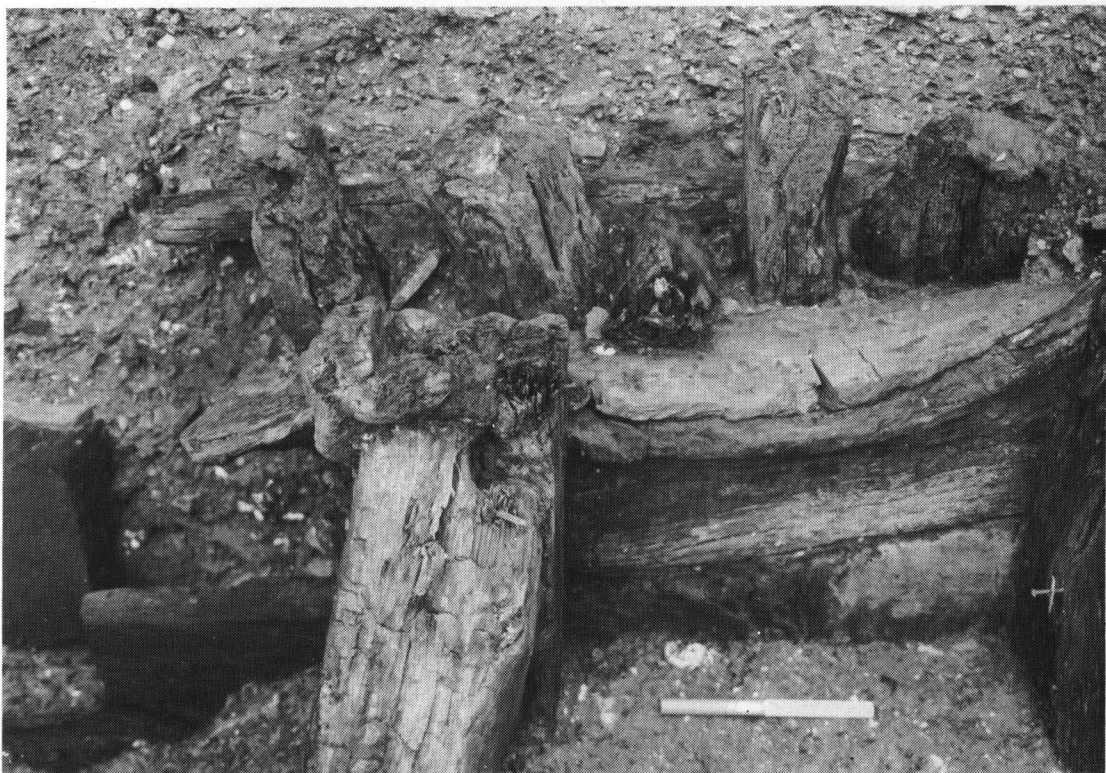
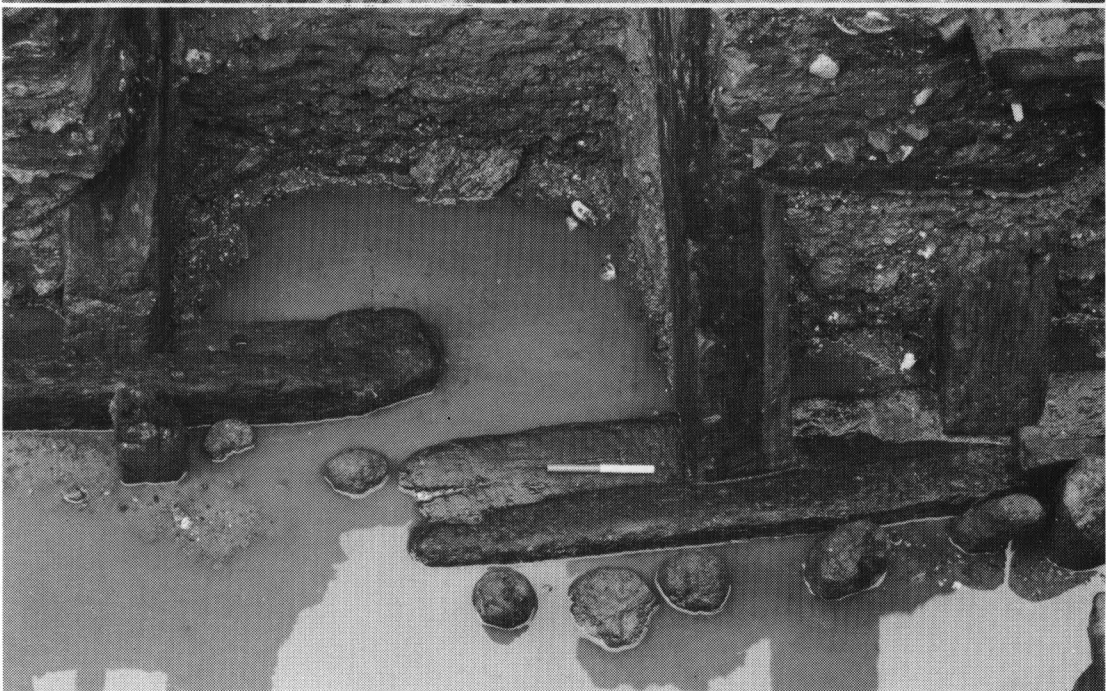
Plate 10, a (*upper*) and b. Trig Lane 1974-76: The Group 3 & 4 revetments were of similar though not identical construction, but must have functioned together as planking nailed to head of Group 3 post (to right of 2×100mm scale in a) also nailed to head of Group 4 post to left of scale. The feet of the same braces shown in a) meet different subsidiary base-plates in b), Group 3 with 2×100mm scale. Looking north, river to south.

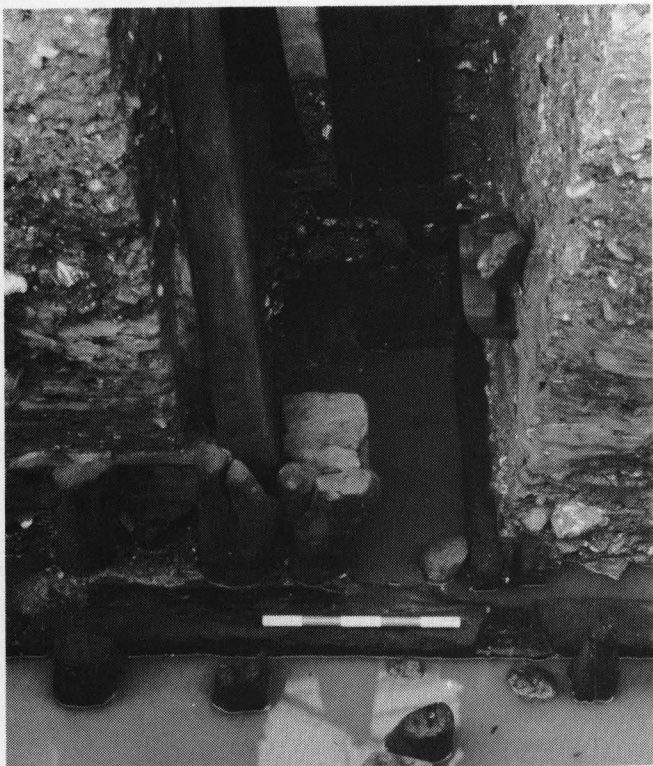
Plate 11. Trig Lane 1974-76: Junction of Group 4 & 6 revetments, looking north, river to south. The Group 4 subsidiary base-plate with 5×100mm scale set at lower level than later Group 6 plate. To right of scale is dove-tail which once accommodated the truncated Group 4 member to north.

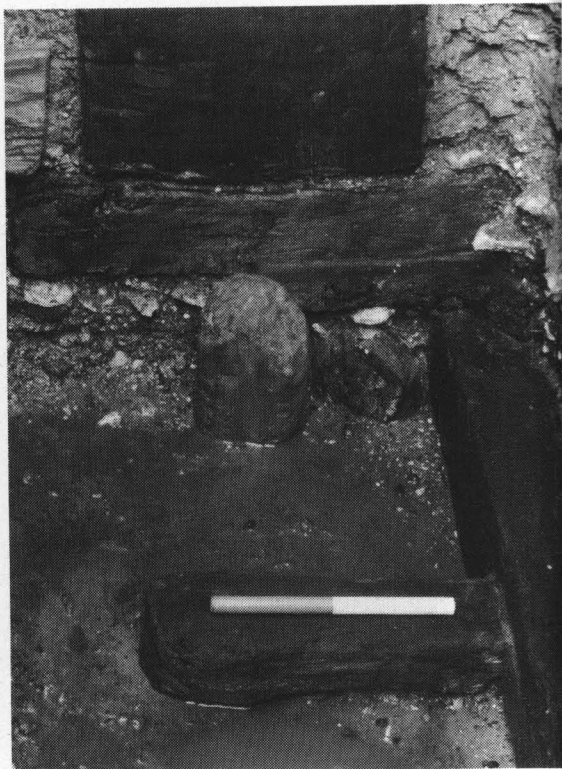
Plate 12 (*upper right*). Trig Lane 1974-76: Superimposed base-plates at junction of Group 6 (left) and Group 4 (right) revetments. Looking north, river to south, 2×100mm scale.

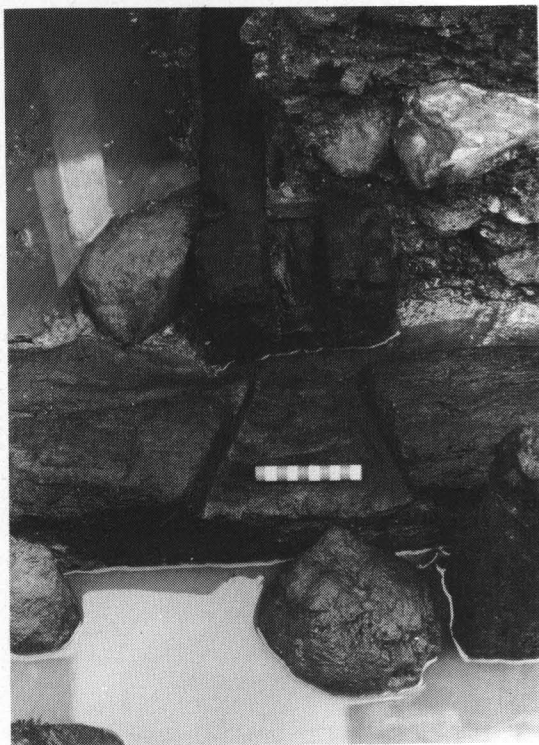
Plate 13. Trig Lane 1974-76: Dovetail joint on Group 4 subsidiary base-plate, looking north. To north of 10×10mm scale is broken mortise which once accommodated foot of Group 4 diagonal brace.

structure in that its subsidiary base-plate (onto which the feet of the braces butted) had three horizontally laid transverse members joined to it from the north, spaced at 2m intervals (Fig. 8a; Pl. 13); the joint is illustrated in Fig. 66 (f). A similar bracing technique was observed on one of the 14th-century structures from the Custom House site.<sup>7</sup>

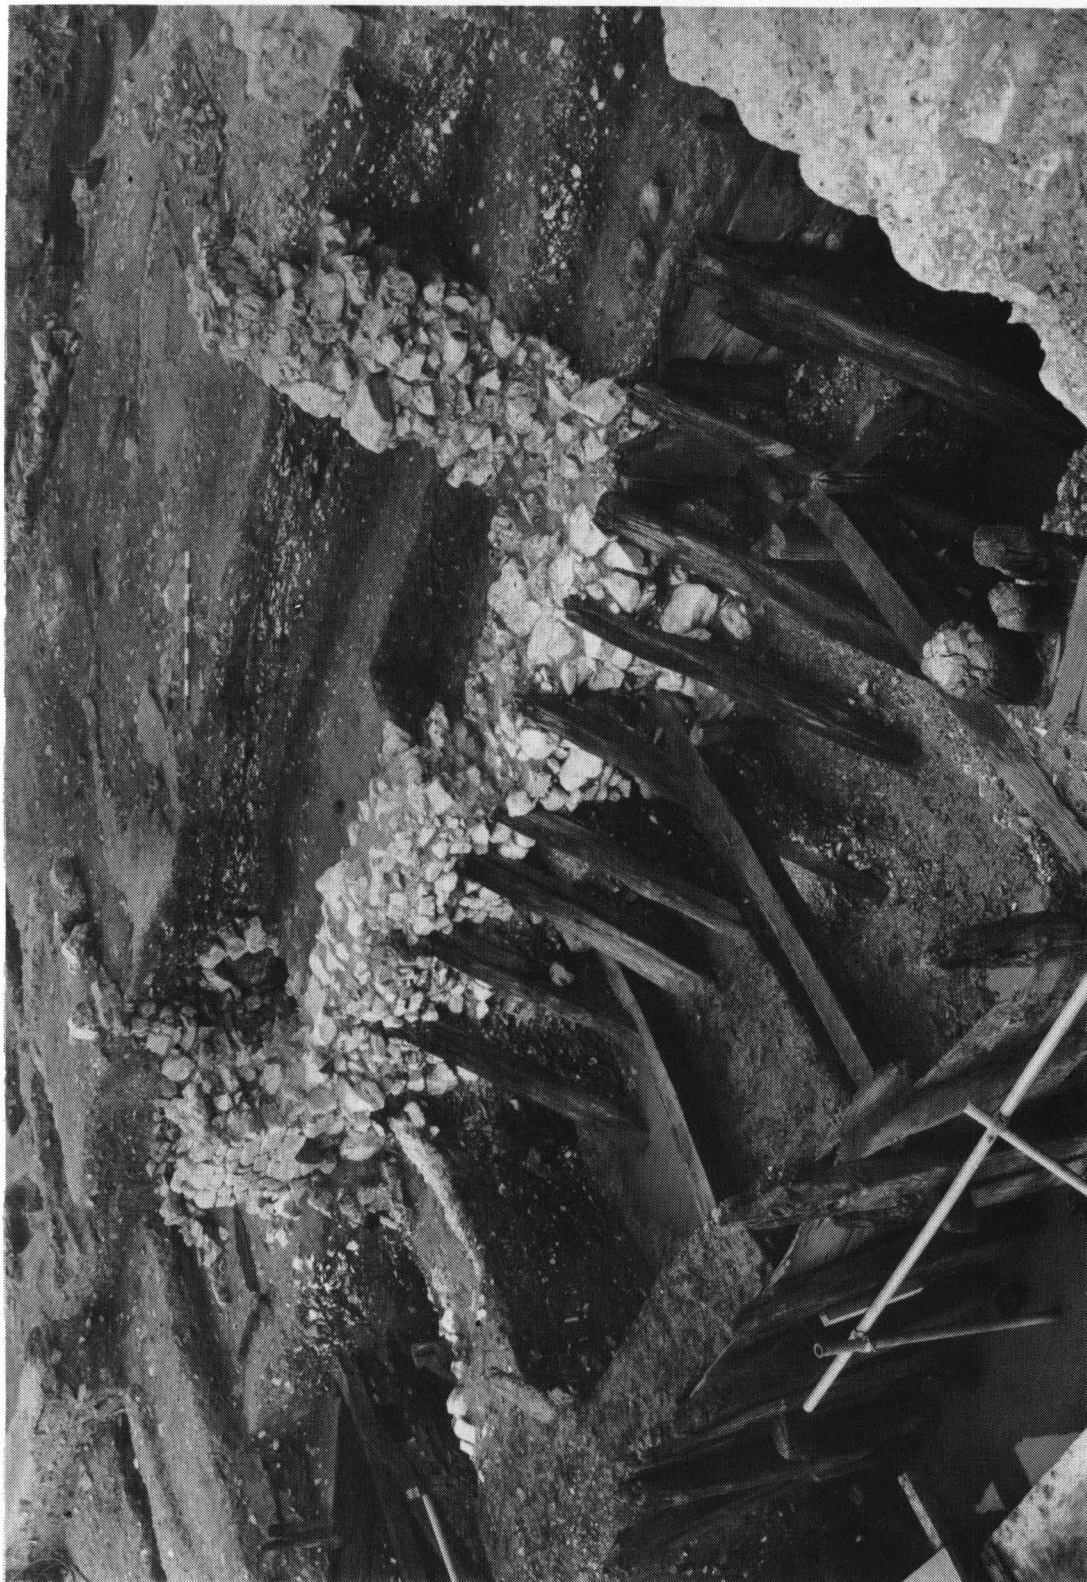
Plate 14. Trig Lane 1974-76: Group 7 revetment to left, looking north-west, river to south. Stone-founded building to north (with 10x100mm scale) contemporary with it. Close spacing of Group 3 revetment front-braces (centre, right) made positioning of Group 7 back-braces difficult.

The Group 7 structure was a back-braced, horizontally planked, revetment retaining dumps of contemporary refuse. It ran east-west across the site (Fig. 12a; Pl. 14), and had been built on top of the foreshore which had accumulated against the south face of the Group 3 revetment, *c.* 3m to the north. The western half survived only fragmentarily below the Group 10 structure which sealed it, but the eastern half was found to be virtually intact. It comprised at least two sections of a pile-founded and pile-retained base-plate, joined by an edge-halved scarf with squared vertical butts. Into it, a series of vertical posts with full or half tenons on their feet had been pegged.

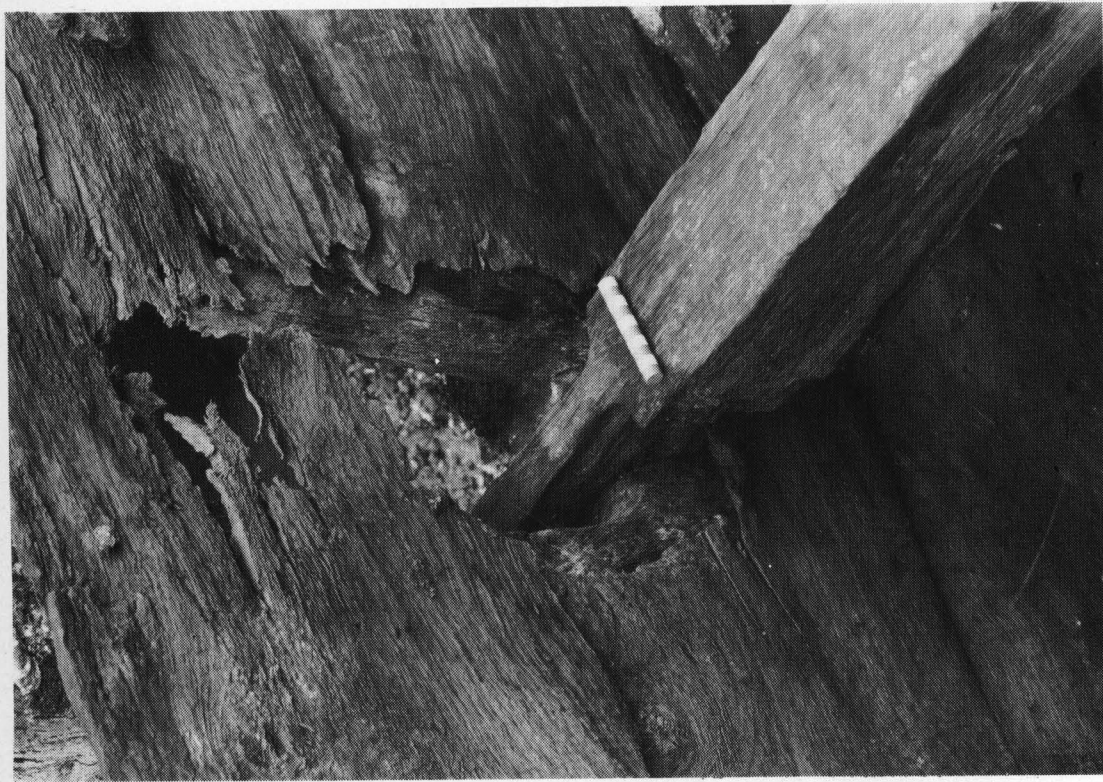
Plate 16. Trig Lane 1974-76: Group 7 tie-back pushed through crudely made hole in revetment planking. Looking south-west, river to south, 10x10mm scale.

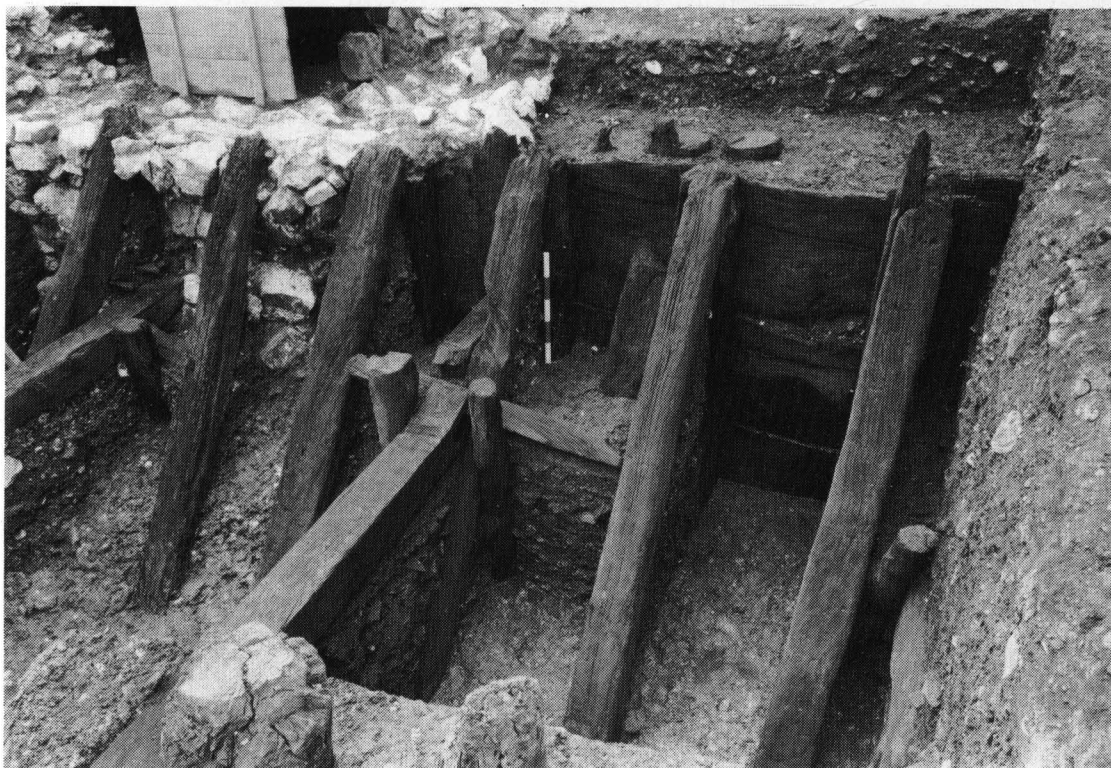
Plate 17. Trig Lane 1974–76: Relationship between northern end of horizontally laid Group 7 tie-backs (centre and left) and front-braced Group 3 revetment. Looking north, river to south, 5×100mm scale.

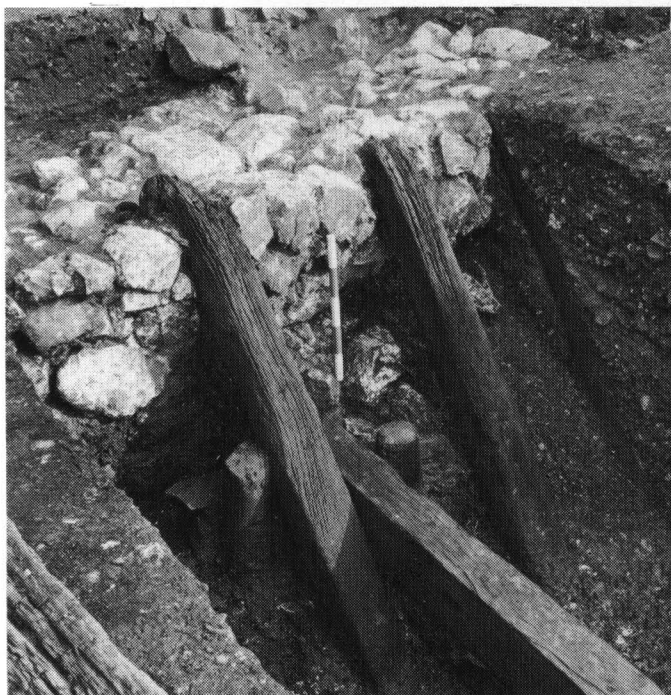
Plate 18. Trig Lane 1974–76: Group 7 revetment tie-back, cross-piece and earlier Group 3 revetment front braces partially encased in the stone foundation. Looking north-east, river to south, 5×100mm scale.

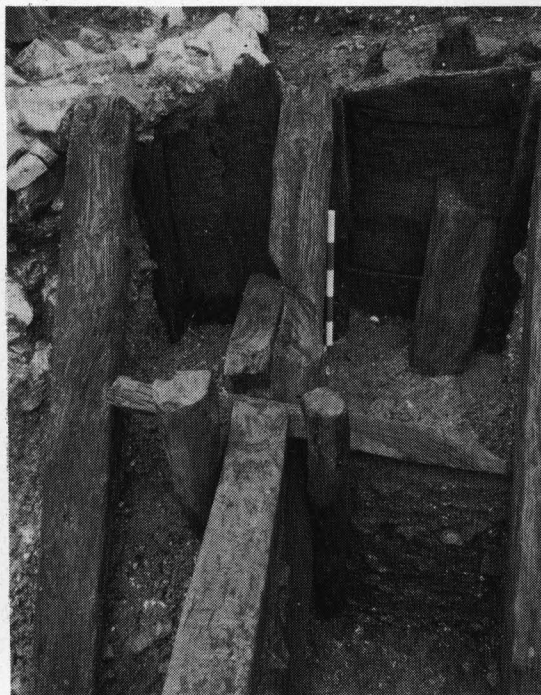
Plate 19. Trig Lane 1974–76: Group 3 revetment brace cut to accommodate later Group 7 revetment tie-back and pile retained cross-piece. Axe marks clearly visible to right of 5×100mm scale. Northern end of tie-back broken off. Looking north, river to south.

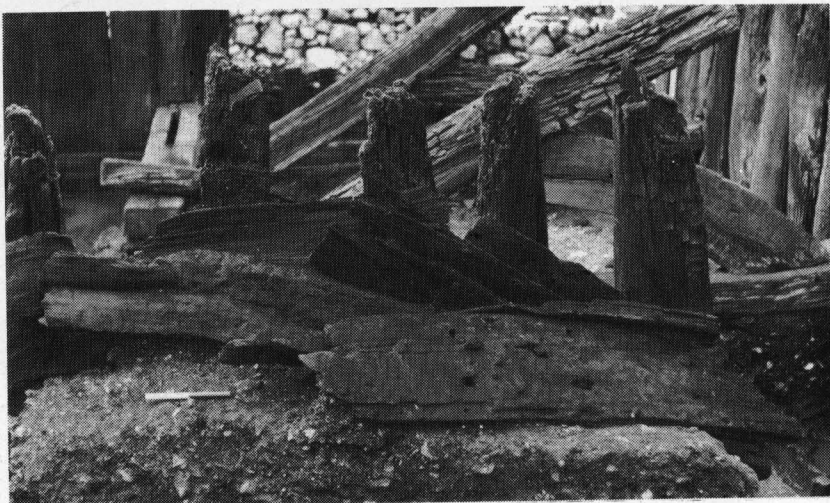
Plate 20. Trig Lane 1974-76: Internal face of Group 7 revetment showing rivetted overlapping strakes from clinker-built boat reused as cladding. Looking south towards river, 2×100mm scale.

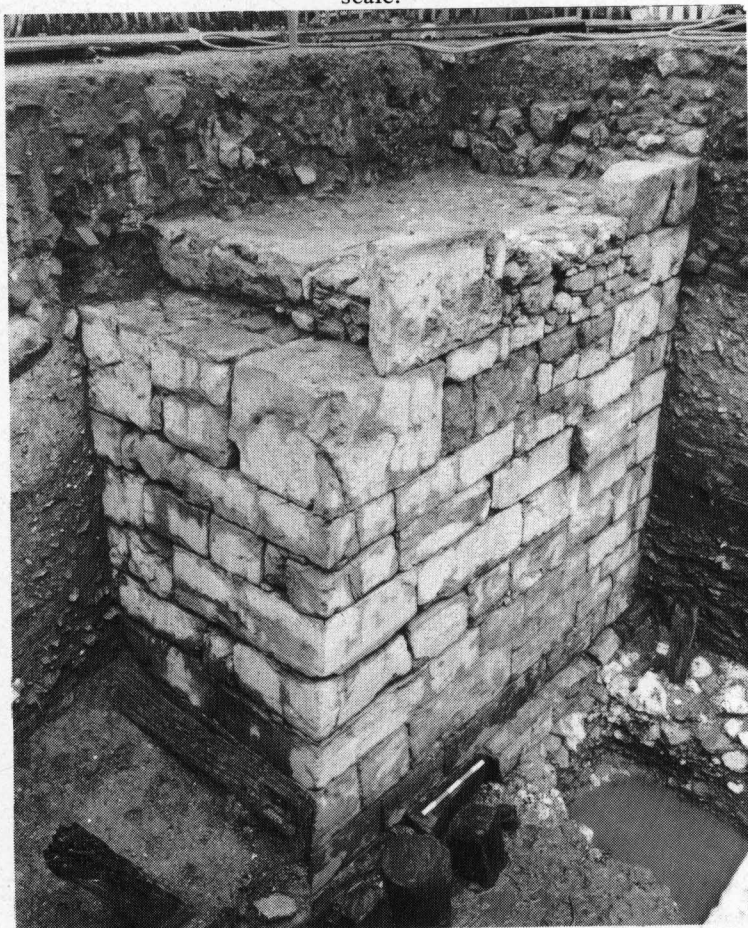
Plate 21. Trig Lane 1974-76: South-east corner of Group 8 river wall looking north-west, river to south and east. 5×100mm scale rests on timber capping beam, with offset foundation to north on chalk rubble raft shown half-sectioned. South face of wall partially obscured by foreshore which developed against it.

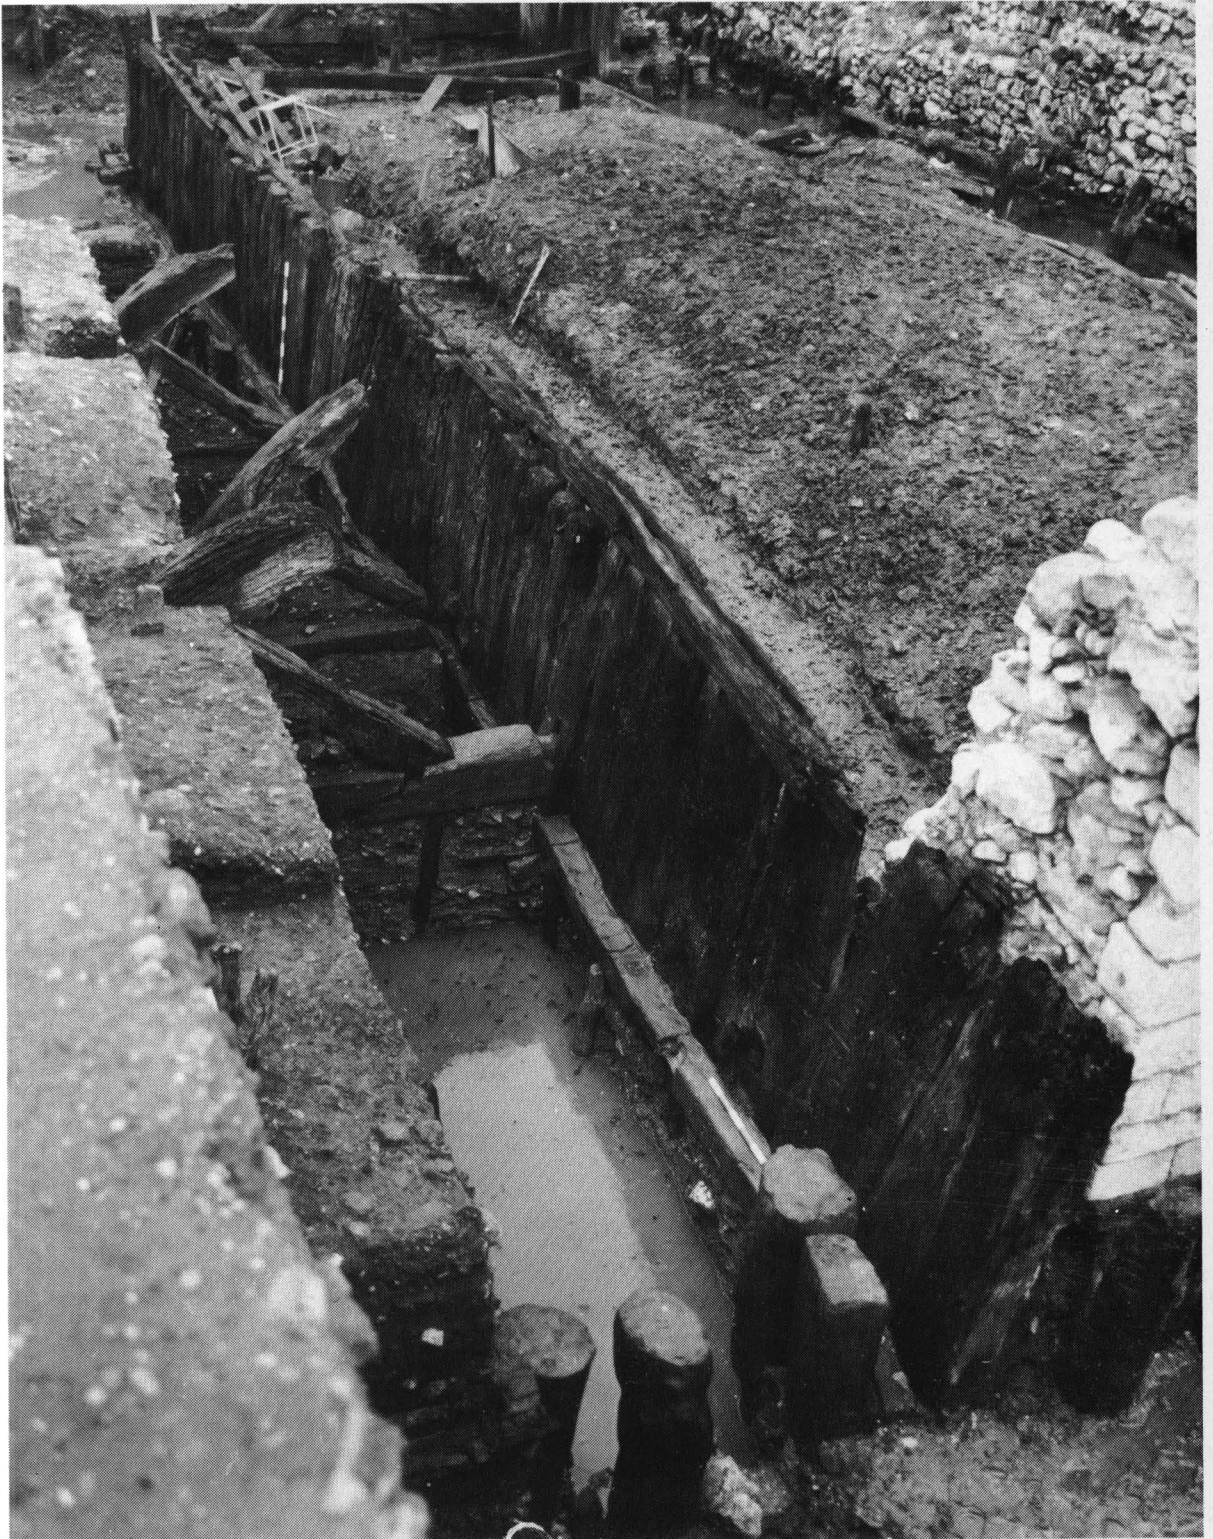
Plate 22. Trig Lane 1974-76: 16m length of the back-braced Group 10 revetment looking south-east, river to south and west. Piles which supported the north-south return wall in foreground. Two back-braces which supported the section beyond the vertical 10×100mm scale have been removed.

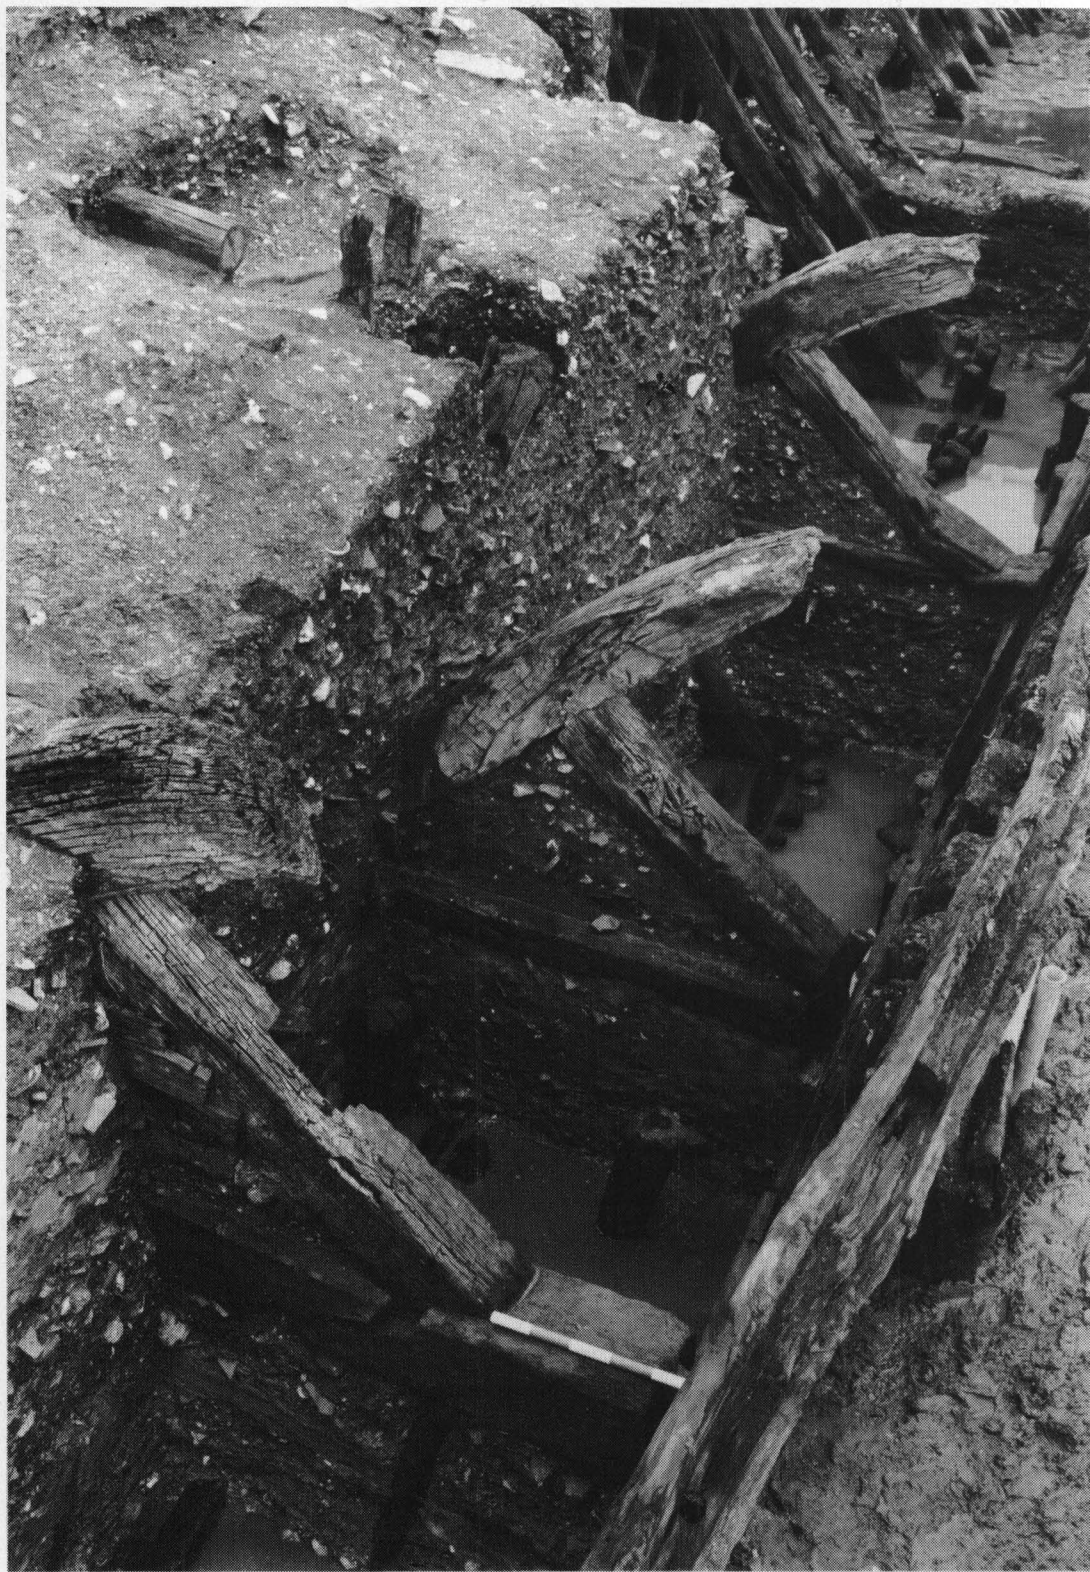
Plate 23. Trig Lane 1974-76: Group 10 back-braces laid on dumped deposits overlying foreshore sealing earlier Group 3 & 4 subsidiary base-plates. Looking north-east, river to south, 5×100mm scale.
