# MEDIEVAL WATERFRONT DEVELOPMENT AT TRIG LANE, LONDON

An account of the excavations at Trig Lane, London, 1974–6 and  
related research

by  
GUSTAV and CHRISSIE MILNE

SPECIAL PAPER NO. 5  
LONDON AND MIDDLESEX ARCHAEOLOGICAL  
SOCIETY  
1982

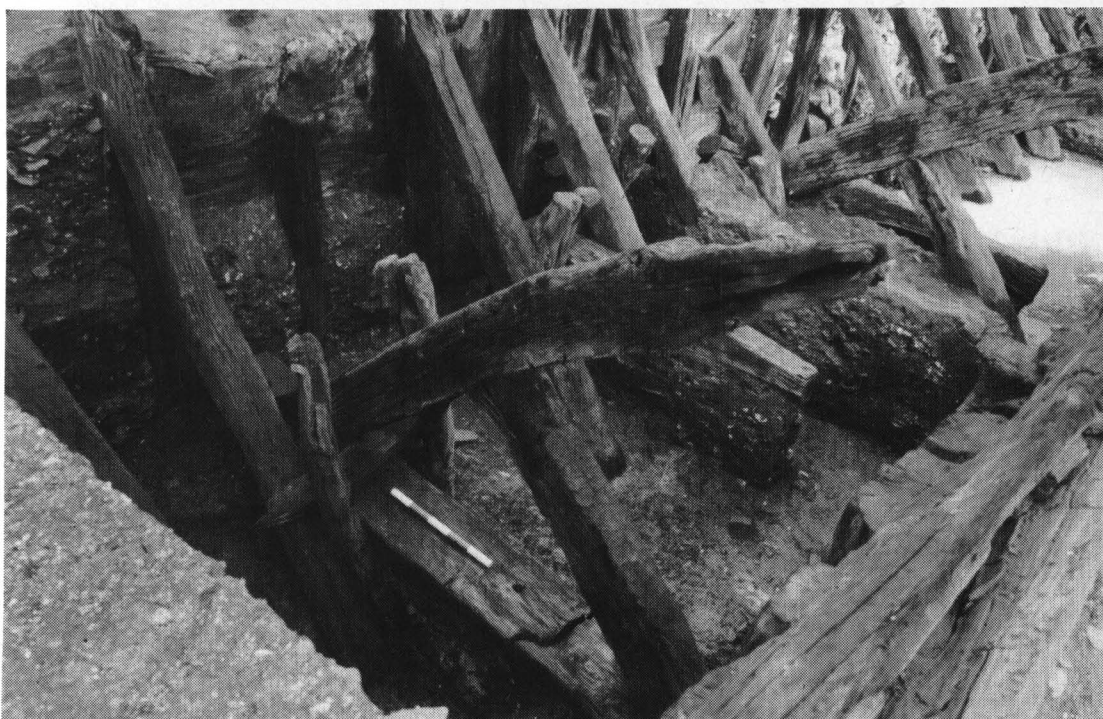
Plate 24. Trig Lane 1974–76: Group 10 revetment back-brace with 5×100mm scale supported by piles and cross-piece wedged against earlier Group 3 brace. Group 7 tie-back to east with southern end severed when associated revetment face replaced by stave wall to right. Looking north-east, river to south.

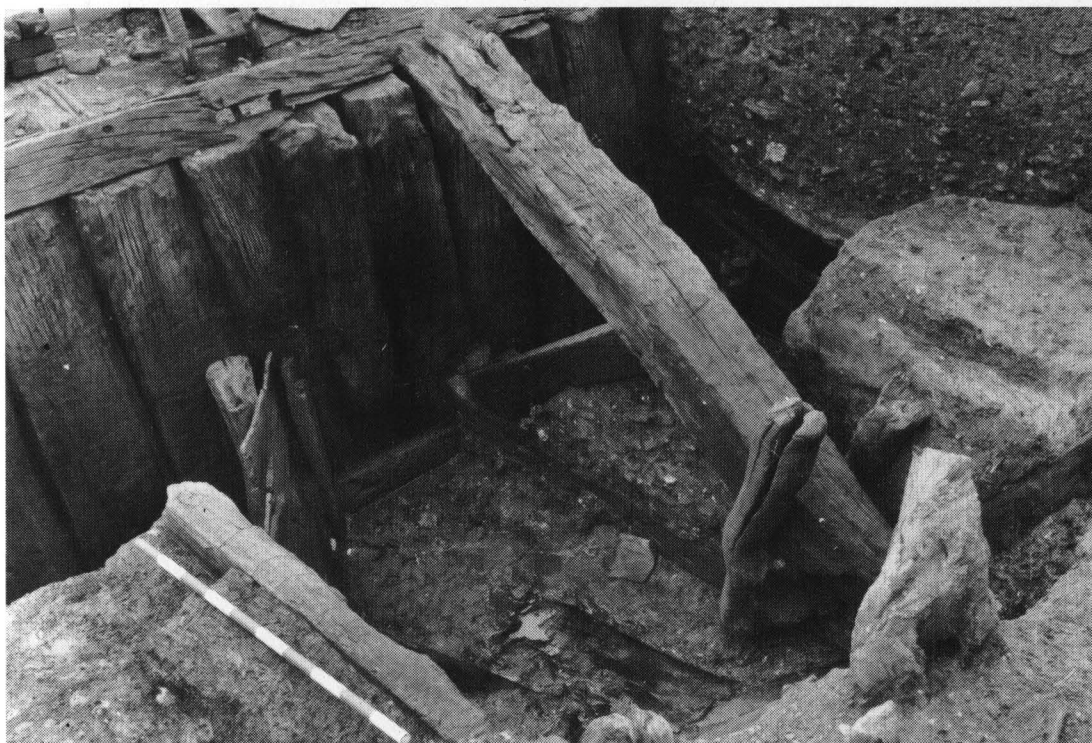
Plate 25. Trig Lane 1974–76: Group 10 revetment Brace 4, looking south-west towards river. The stave-built revetment replaced the Group 7 revetment. Right of the 10×100mm scale is a Group 7 tie-back *in situ* severed at its southern end by cut which removed its associated revetment. To its right is 2m wide cut through the Group 7 dumps in which Group 10 brace was erected. Note shuttering to east & west of brace enclosing an area which had to be backfilled before construction work could progress eastwards.

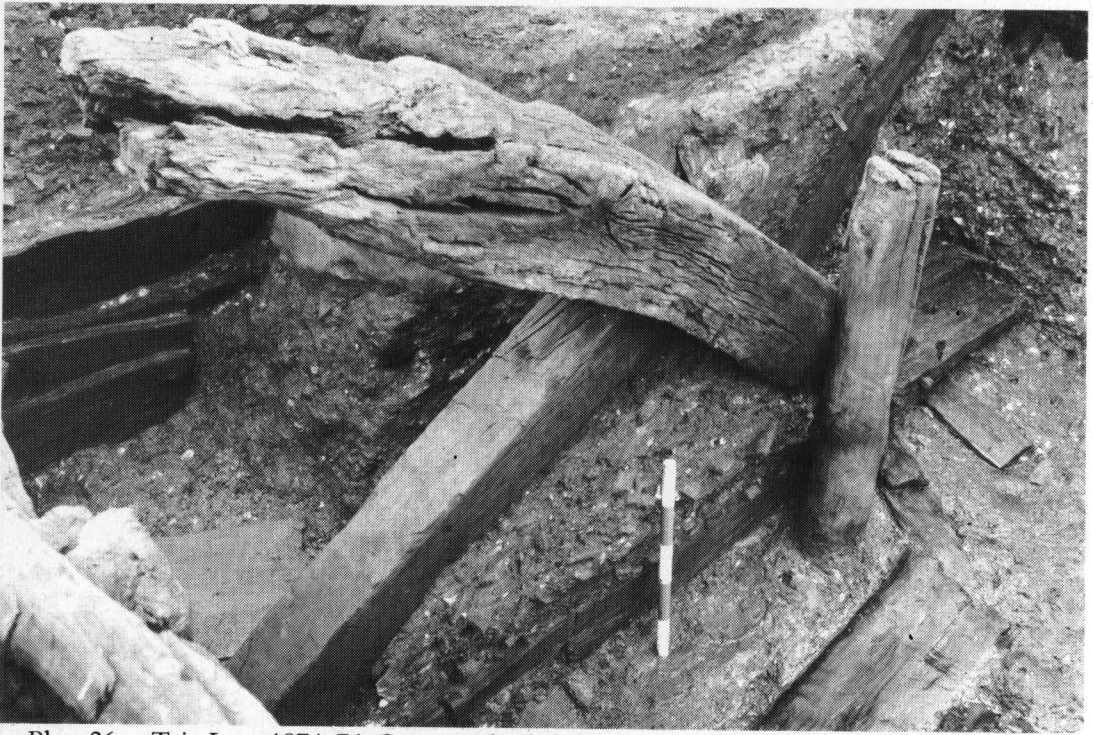
Plate 26. Trig Lane 1974-76: Group 10 back-brace with 5×100mm scale erected in deep cut through Group 7 dumped deposits (top centre). Note shuttering to left and fragments of Group 7 revetment planking on floor of cut. Looking north-west, river to south.

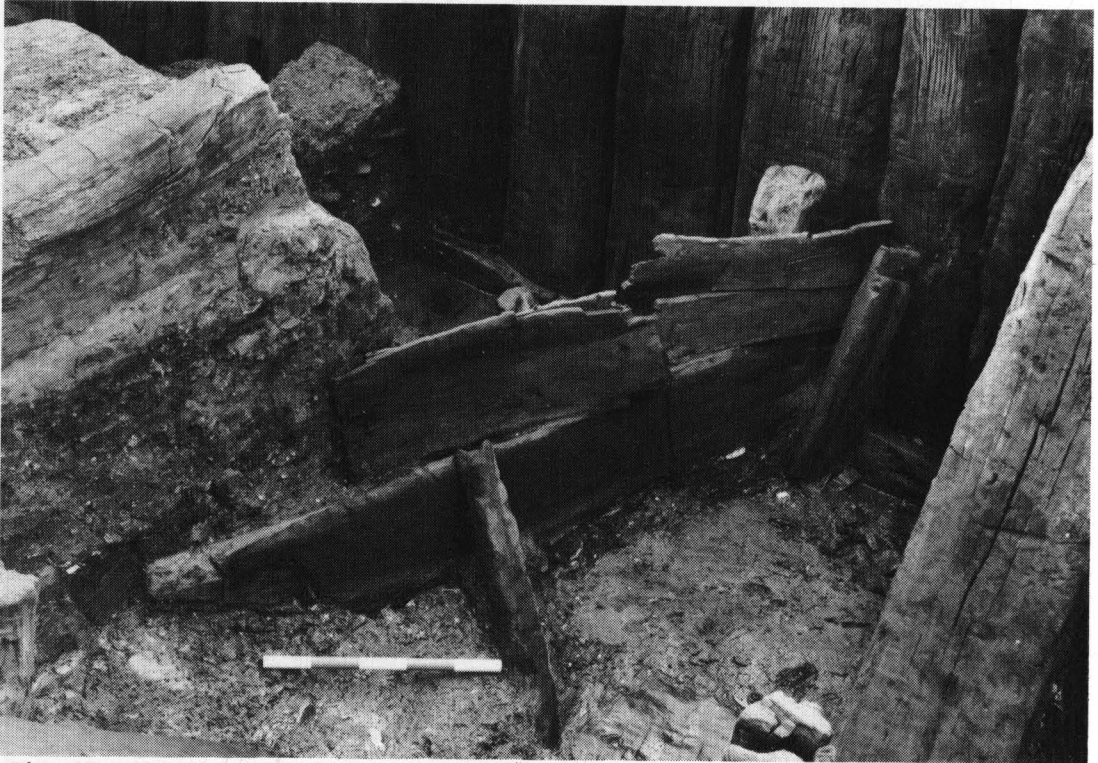
Plate 27. Trig Lane 1974-76: Shuttering behind the Group 10 stave wall, looking south-east. Baulk of Group 7 dumping with 5×100mm scale cut on southern and western sides. Shuttering probably comprised timbers removed from Group 7 revetment: post in south with tenon and groove may have been corner post.

Two small revetments, simple arrangements of planks and piles intended to retain material dumped from the west were also recorded in the eastern area (labelled 'shuttering' on Fig. 17a; Pls. 25; 26; 27), while at the extreme eastern end of the revetment, a 0.50m length of base-plate joined the Group 10 structure to the upstanding section of the Group 7 revetment (Fig 27; Pls. 28; 29). The presence of rivets and caulking on several of the horizontal planks used at this

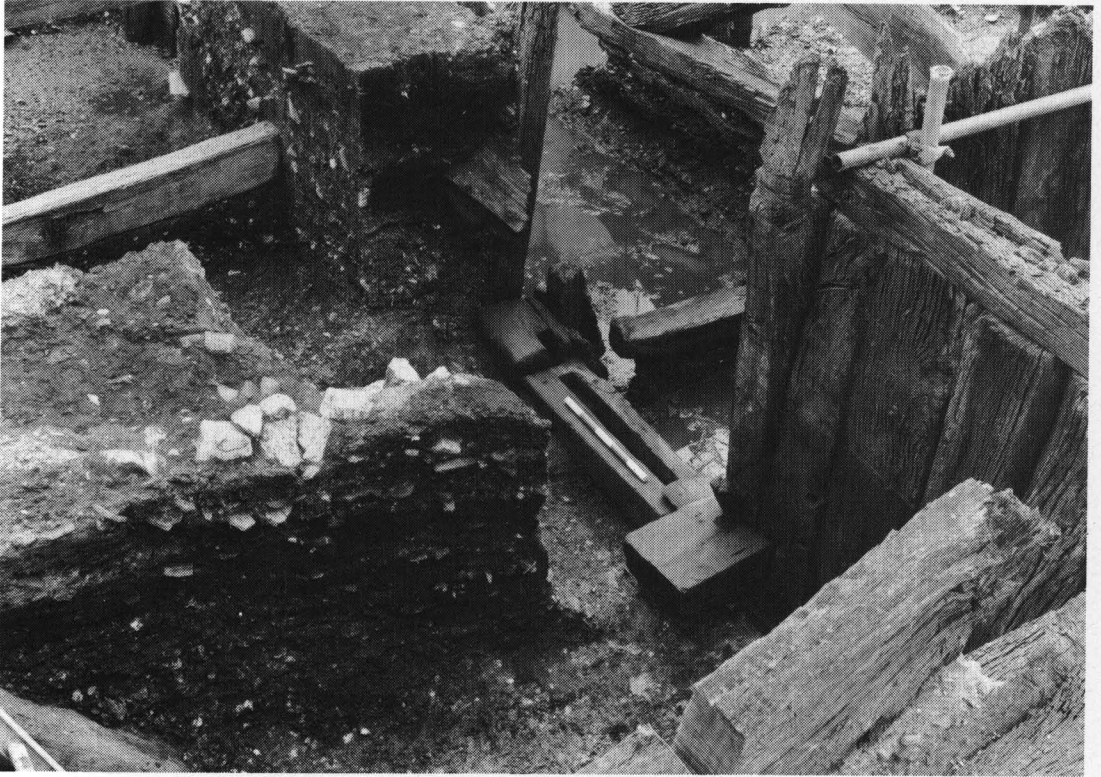
Plate 28. Trig Lane 1974-76: Junction of Group 7 and 10 (with 5×100mm scale) revetments looking south-east. Later Group 11 revetment to west, cutting Group 10 stave wall running south towards river. To east are posts, planks and tie-backs of Group 7 revetment.

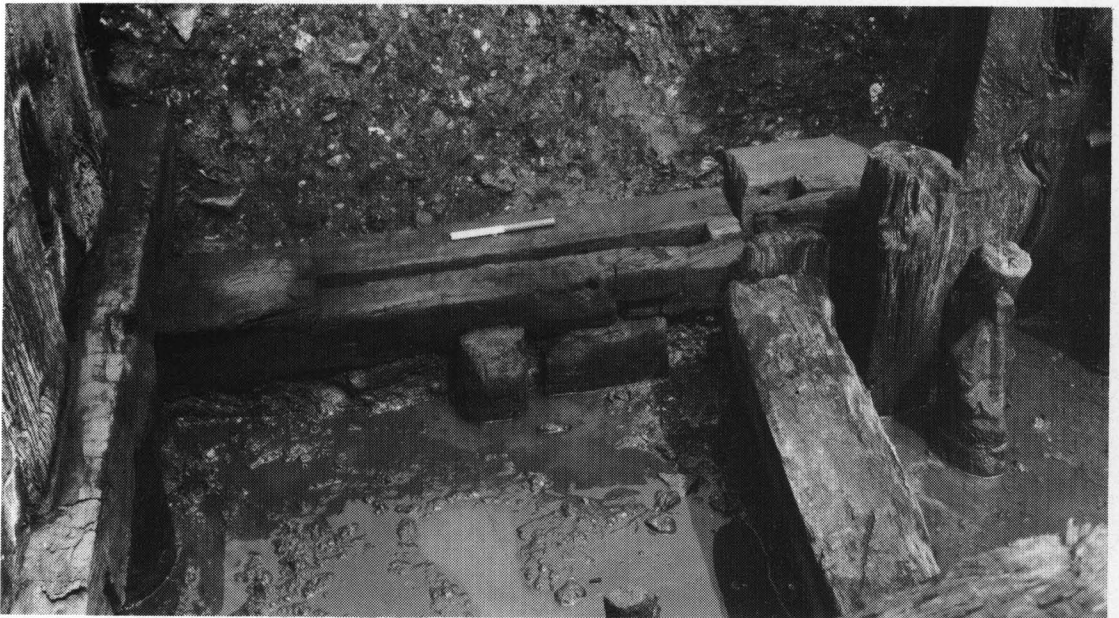
Plate 29. Trig Lane 1974-76: Junction of Group 7 & Group 10 revetments, looking north, river to south. Later Group 11 revetment visible in extreme left of picture. Group 10 base-plate (with 2×100mm scale) did not butt flush with Group 7 structure on right, so crudely scarfed timber used to fill gap. Note groove in Group 10 base-plate (and therefore associated stave wall) stops short of Group 7 revetment post. This gap was covered by reused boat timbers, just visible above plate.

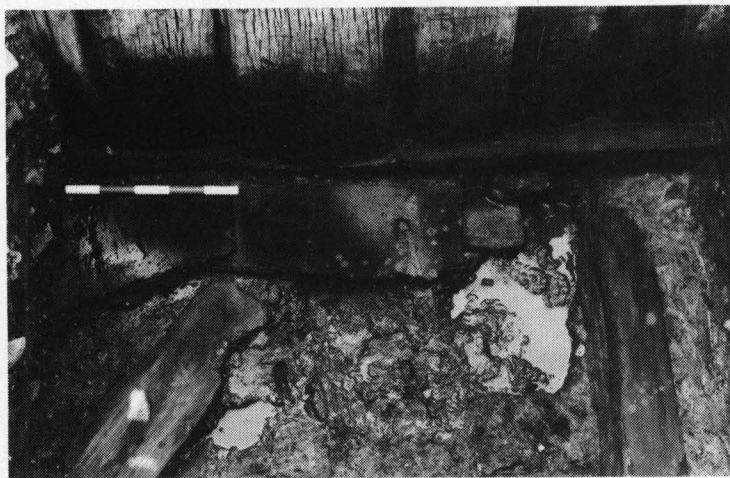
Plate 30. Trig Lane 1974-76: Planking presumably derived from the Group 7 revetment (with 5×100mm scale) reused as walk boards facilitating the construction of the Group 10 revetment, the internal face of which is visible at top of picture. Looking south.

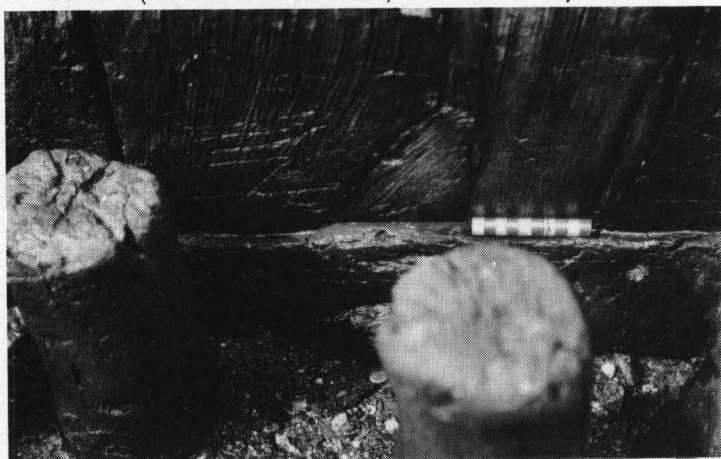
Plate 32. Trig Lane 1974-76: Carpenter's assembly mark, four horizontal lines above a crossed line over a half circle, incised upon the southern face of the Group 10 revetment. Looking north 10×10mm scale.

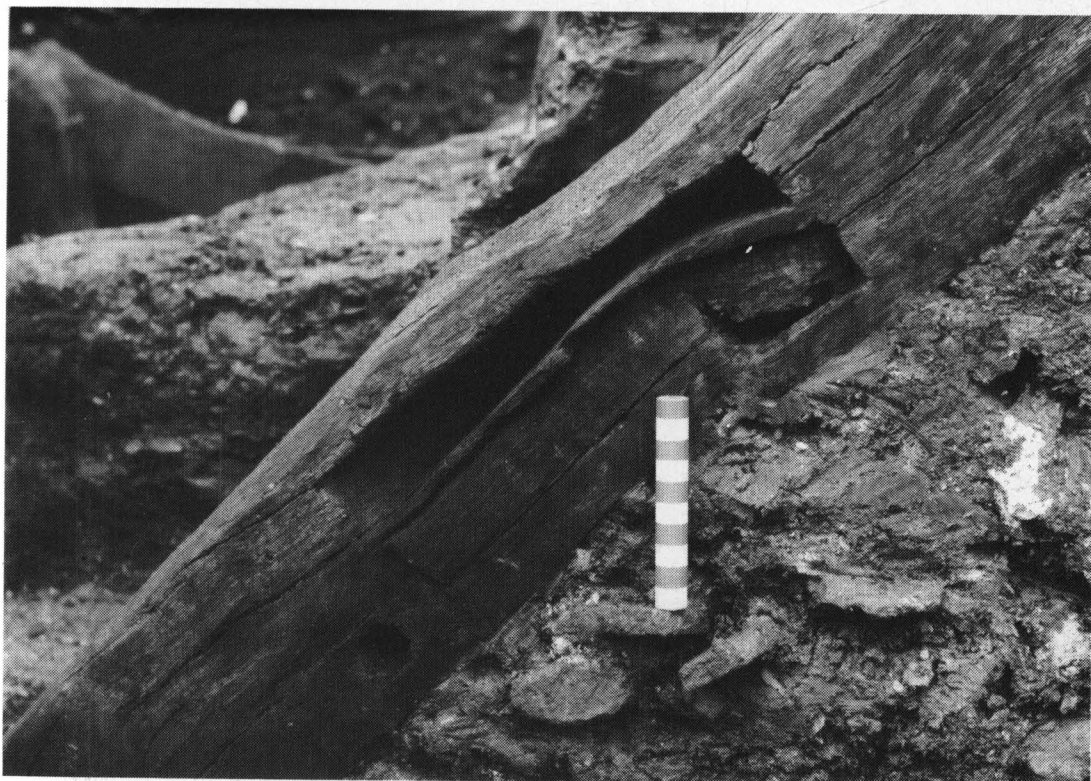
Plate 33 (*upper*). Chase mortises. 10×10mm scale.

Trig Lane 1974-76: Group 10 back-brace members looking west, showing timbers reused from earlier buildings.

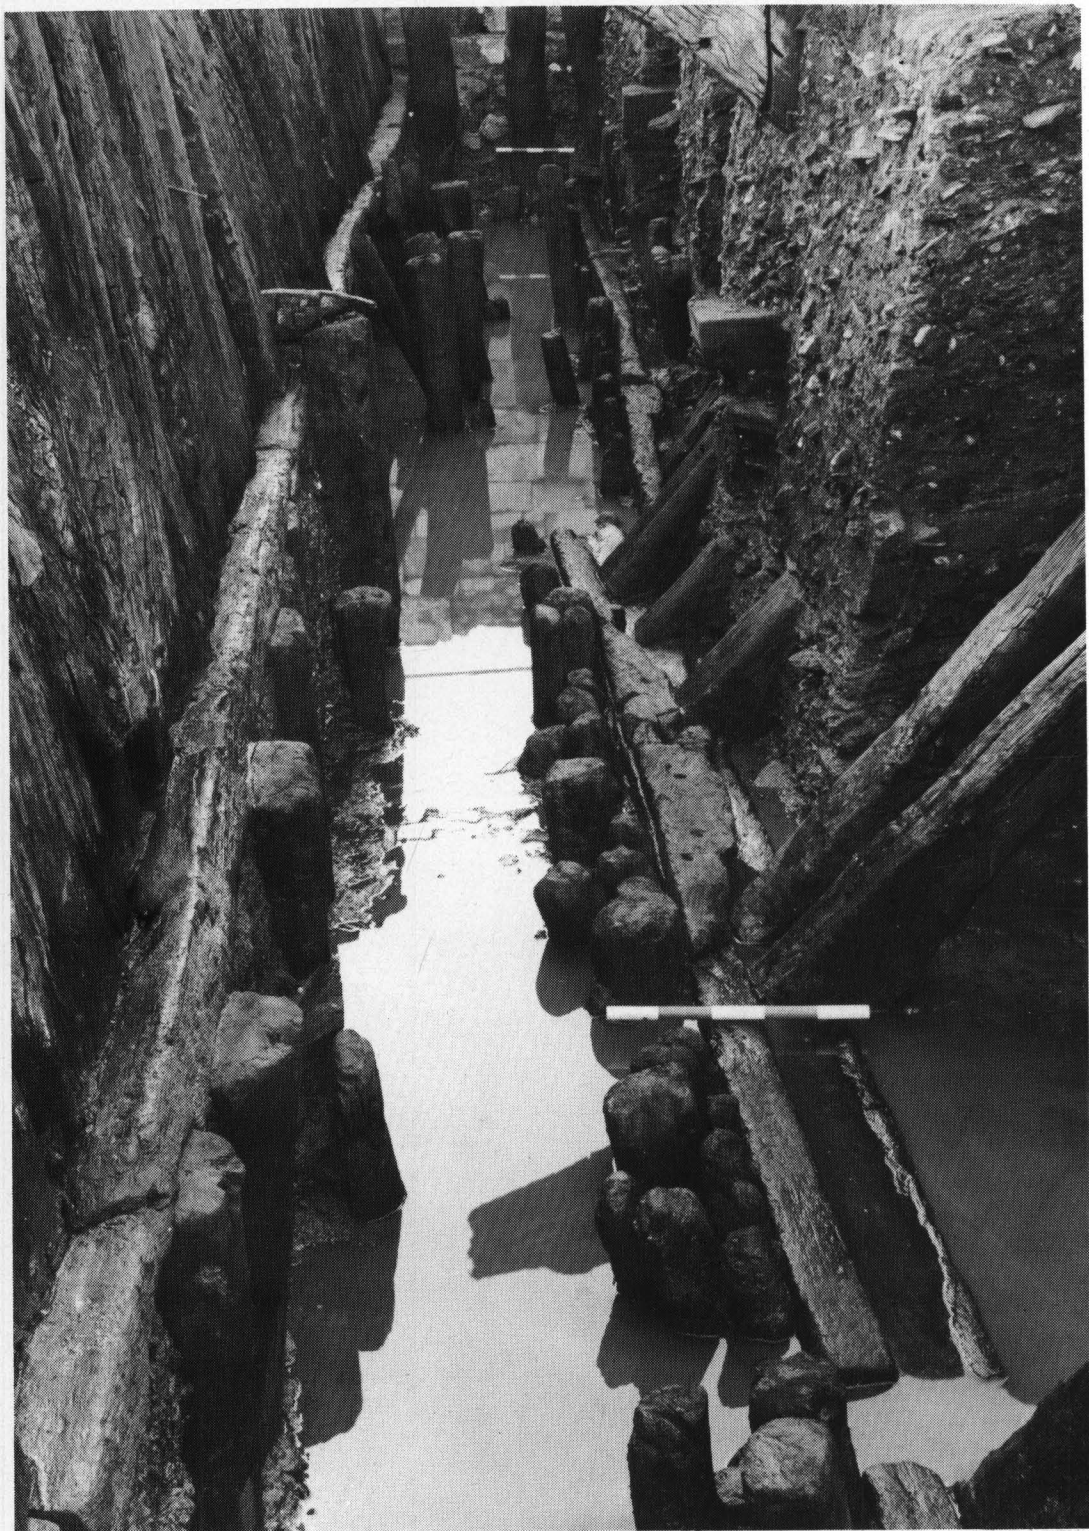
Plate 35. Trig Lane 1974-76: Internal face of Group 10 revetment, looking west. Note subsidiary base-plate of earlier Group 3 revetment (5×100mm scale) set at lower level.

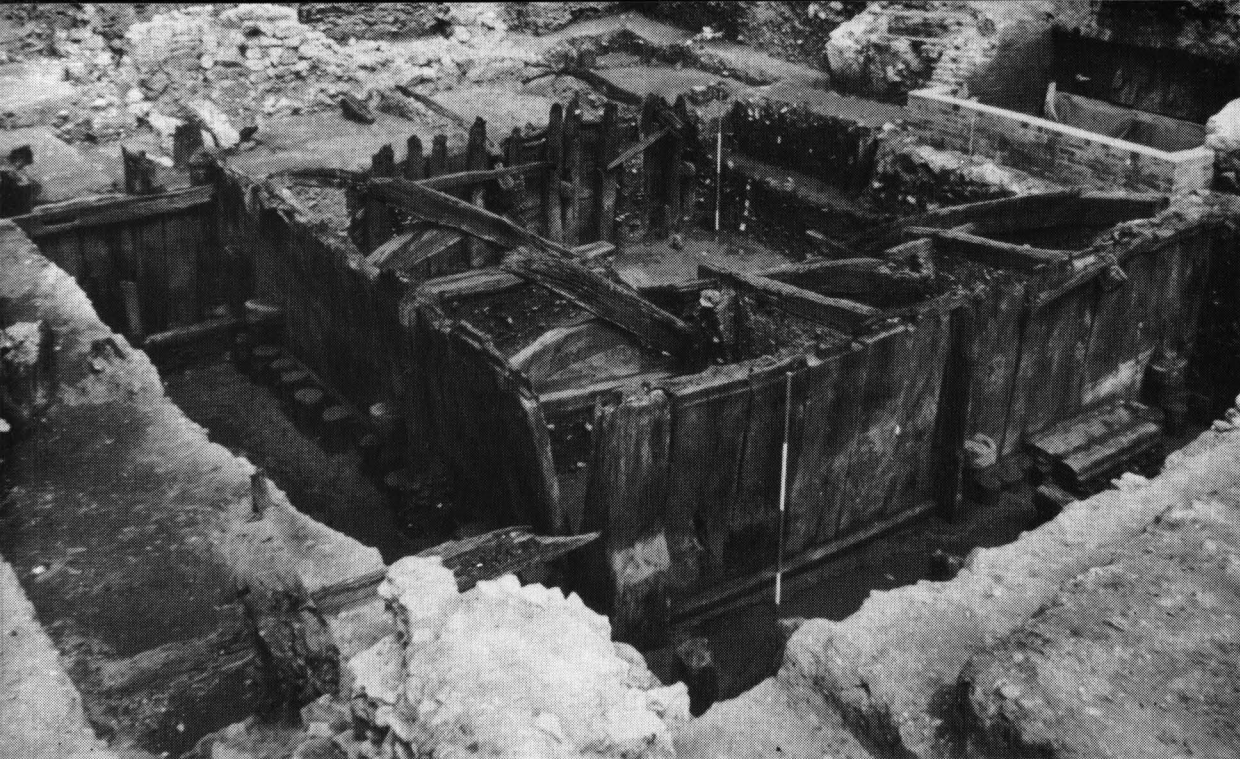
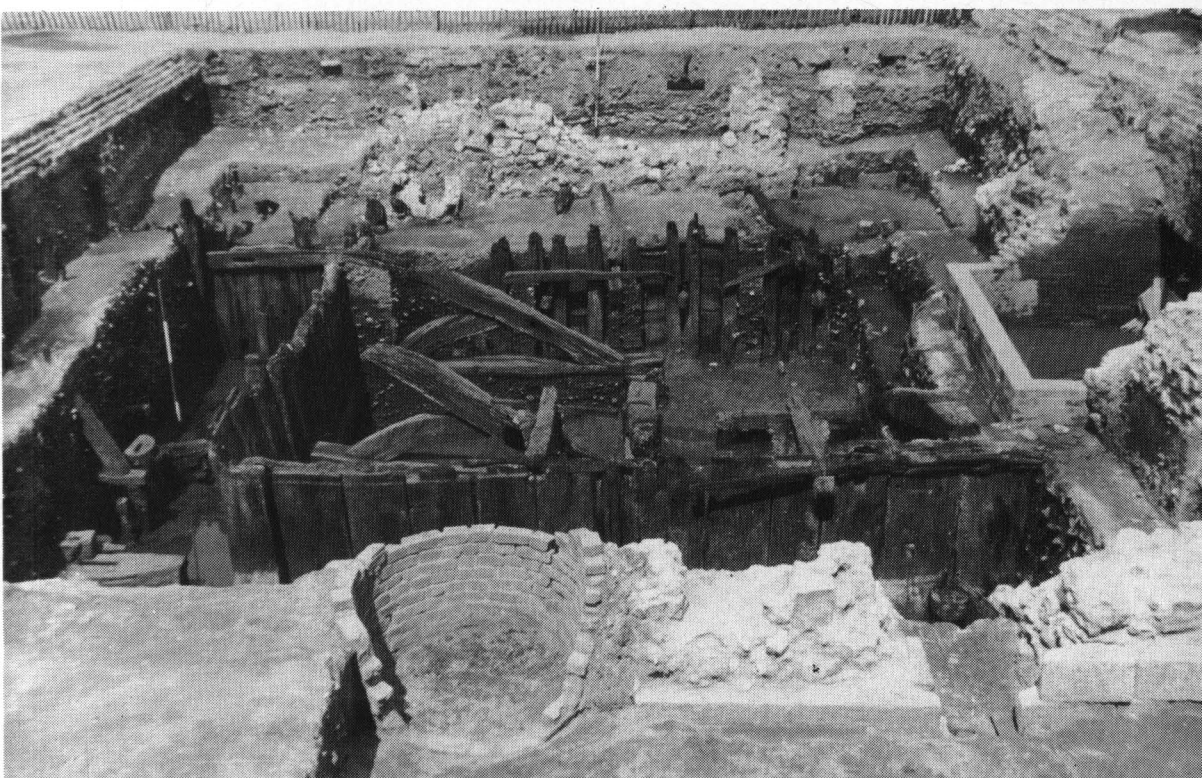
Plates 36 and 37. Trig Lane 1974–76: South and west walls of stave-built Group 11 revetment with infill material removed. River to south and west, 4×500mm scales.  
 a) looking north  
 b) looking north-east.

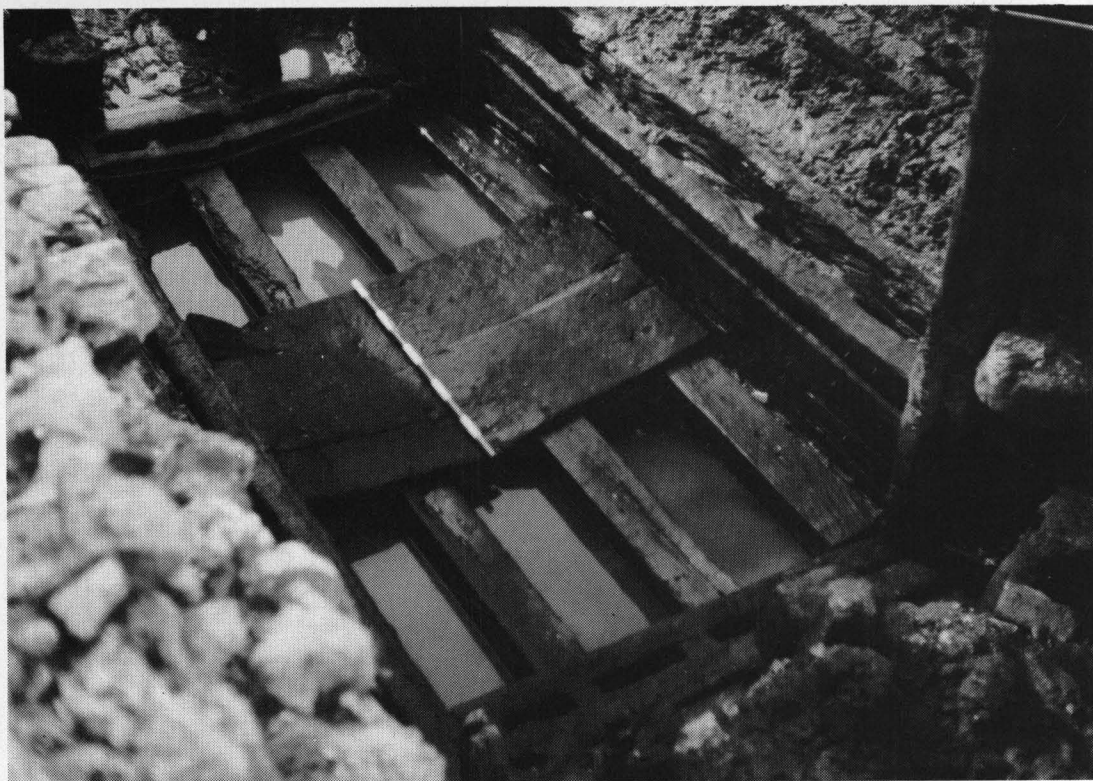
Plate 38. Trig Lane 1974-76: Platform feature on south-west corner of Group 11 revetment, looking north-west, with planking removed to reveal joists. Note mortises in frame members for a tank-like superstructure, and revetment stave on right tenoned into platform frame. 10×100mm scale.

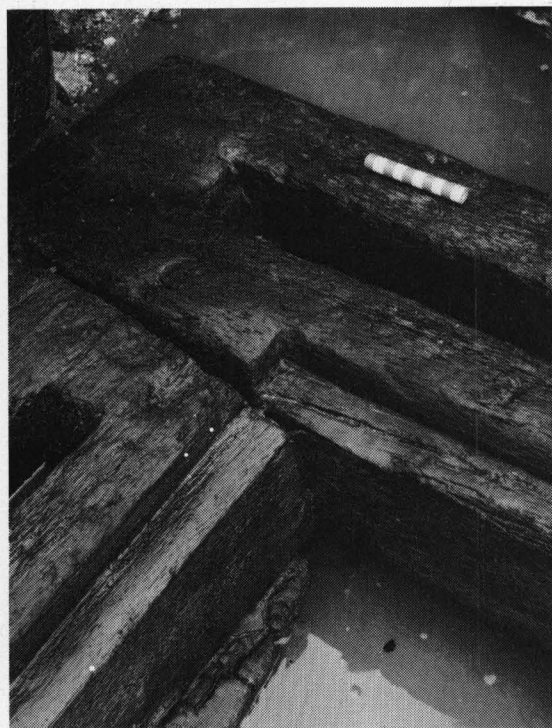
Plate 39. Trig Lane 1974-76: South-east corner of Group 11 platform feature, showing well-buttoed corner tenoned and pegged; mortises for superstructure; rebates to accommodate planking. 10×10mm scale.

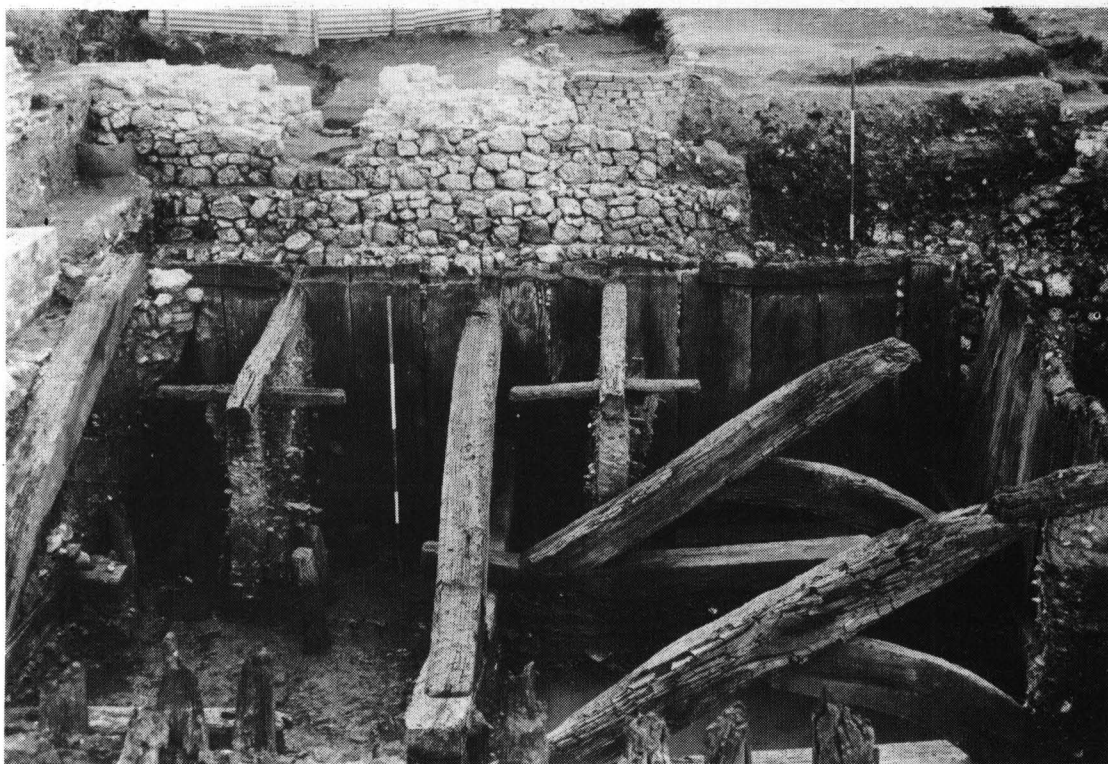
Plate 41. Trig Lane 1974-76:  
Internal face of Group 11  
revetment's southern wall, looking  
south towards the river. 4×500mm  
scale.

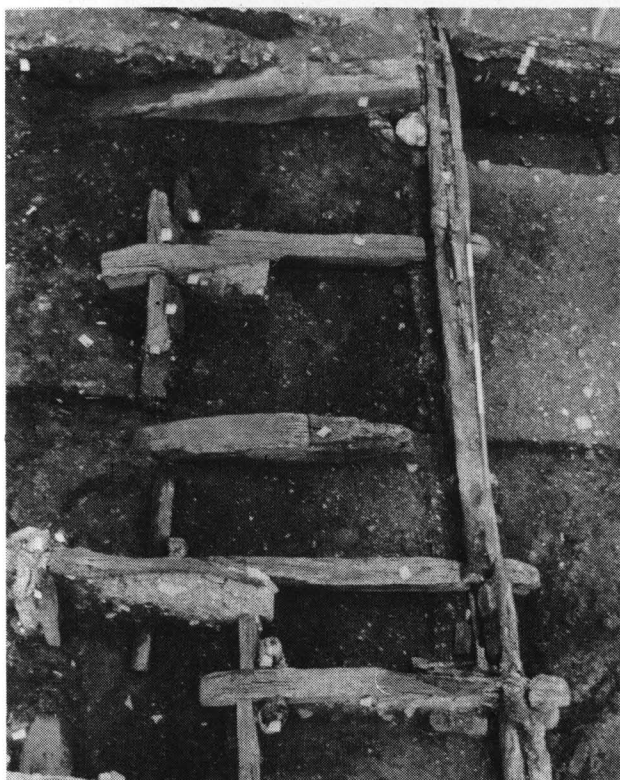
Plate 42. Trig Lane 1974-76:  
Upper level of Group 11  
revetment's south wall, looking  
east. The heads of two large  
back-braces can be seen, with two  
levels of horizontally laid tie-backs.  
4×500mm scale.

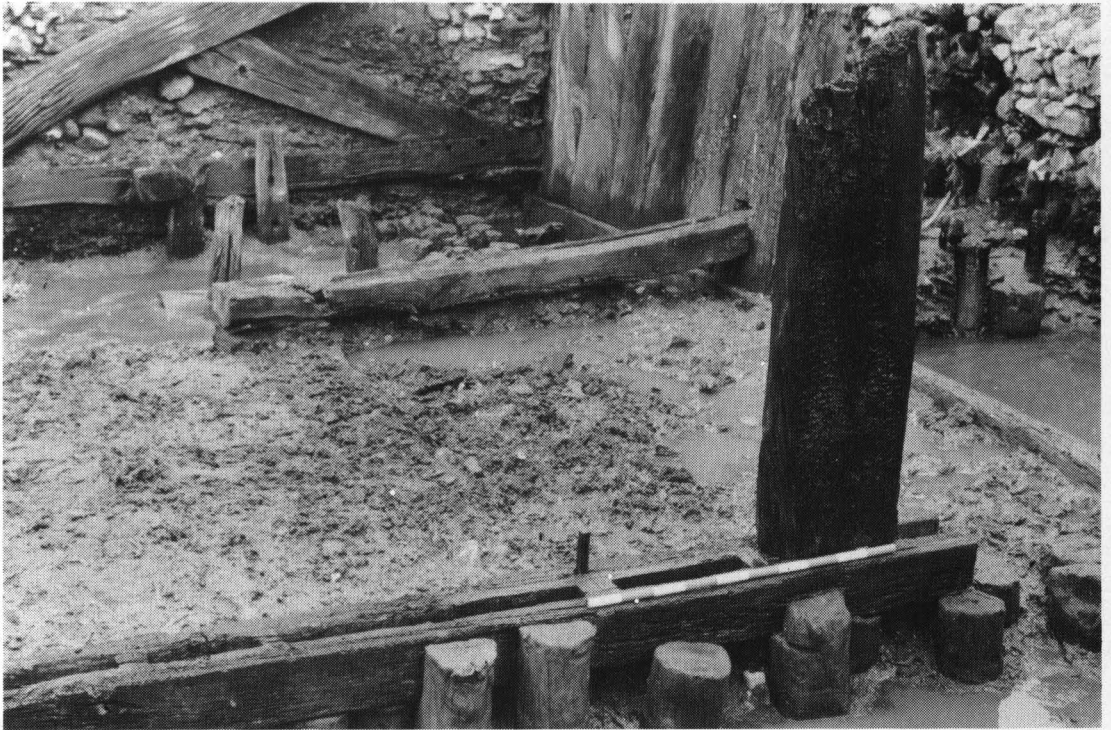
Plate 46. Group 11 revetment. First vertical member *in situ*, looking south-east. 10×100mm scale.

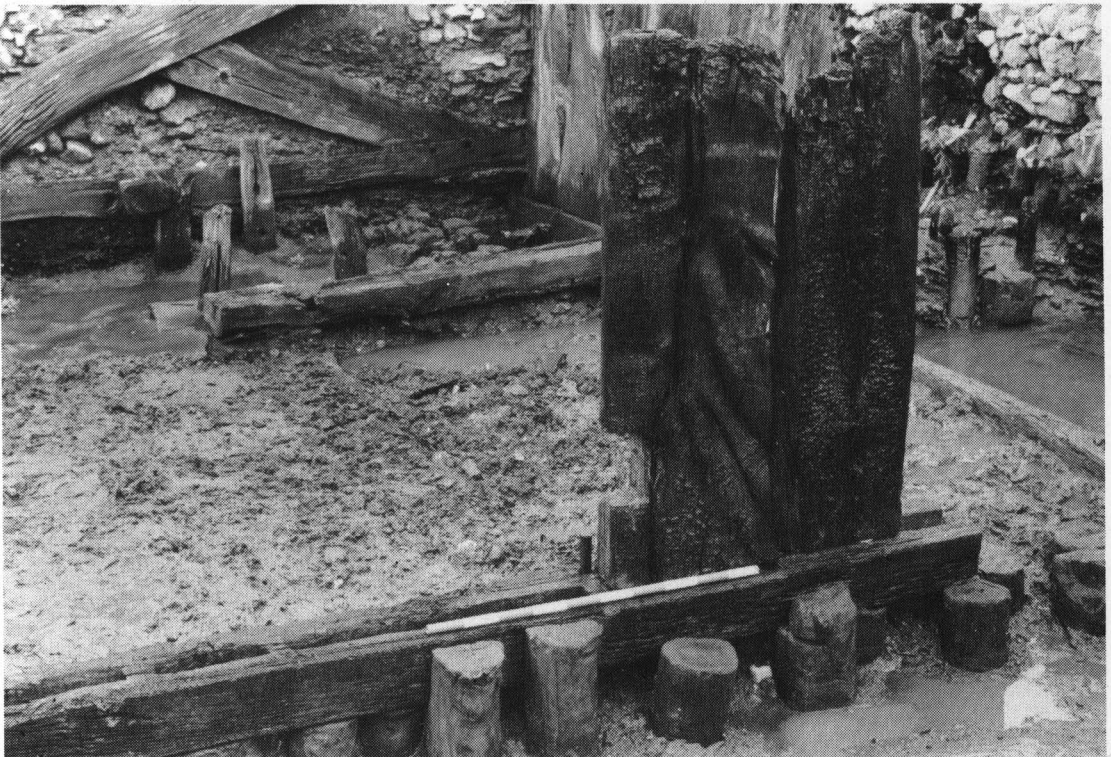
Plate 47. Group 11 revetment. Second vertical member *in situ*, looking south-east. Note trench on northern edge. 10×100mm scale.

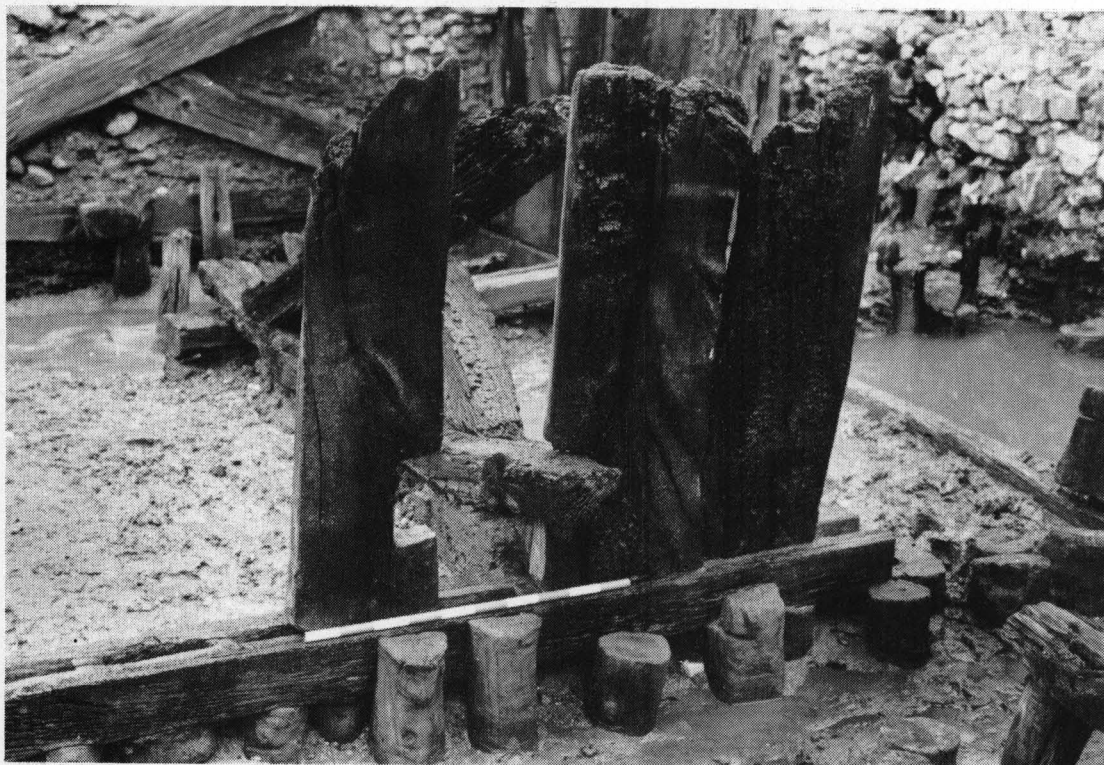
Plate 49. Group 11 revetment. Utilising the double-length mortise, the 3rd vertical member trenched on its southern edge, is slid into position. Looking south-east. 10×100mm scale.

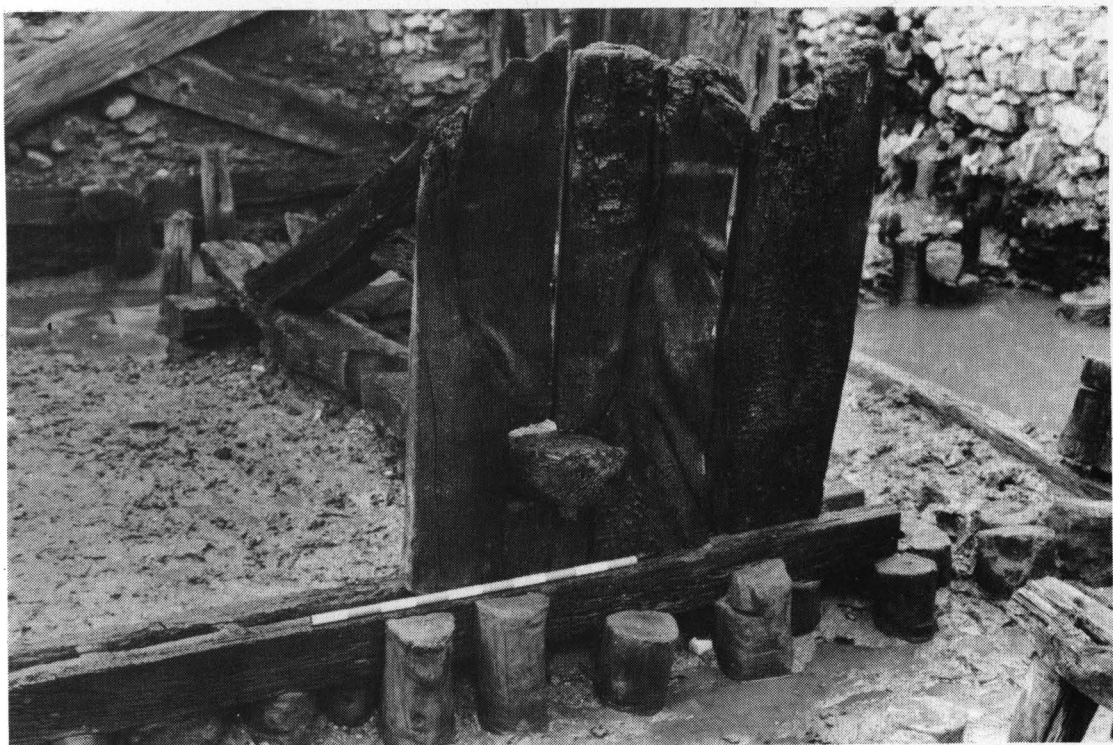
Plate 50. Group 11 revetment. 3rd vertical member in position. Looking south-east. 10×100mm scale.

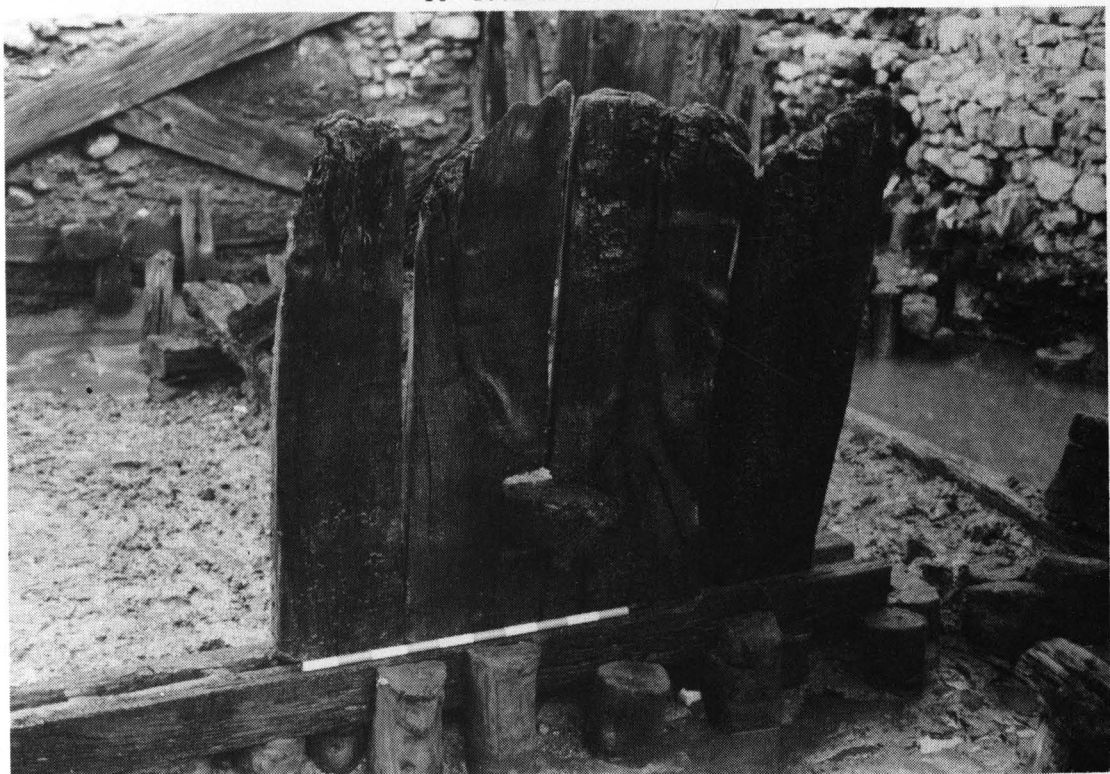
Plate 51. the fourth vertical member inserted into the northern end of the double-length mortise. Looking south-east. 10×100mm scale.

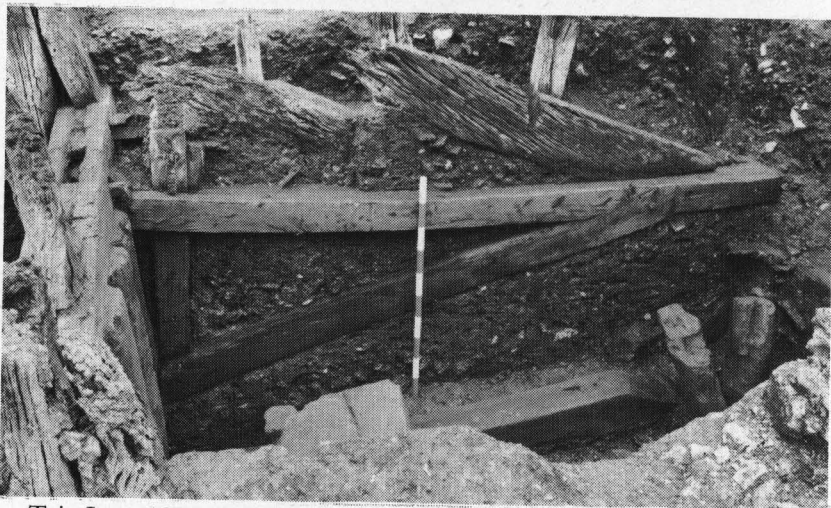
Plate 52. Trig Lane 1974-76: Group 12 revetment back-brace looking west, river to south.  
Note pegged squint lap. 10×100mm scale.

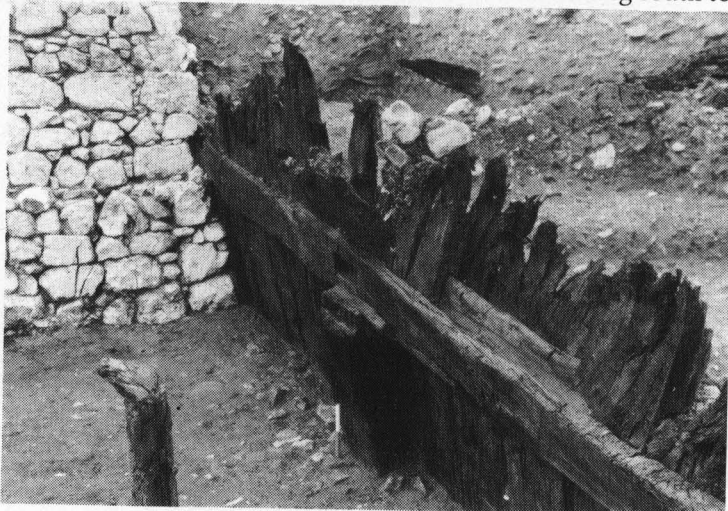
Plate 54. Trig Lane 1974-76: Group 12 revetment second-storey members in west of site.  
Note groove in upper face of plate; bare-faced tenons on vertical members; repair timbers set  
behind plate. Looking north-west, river to south, 2×100mm scale.

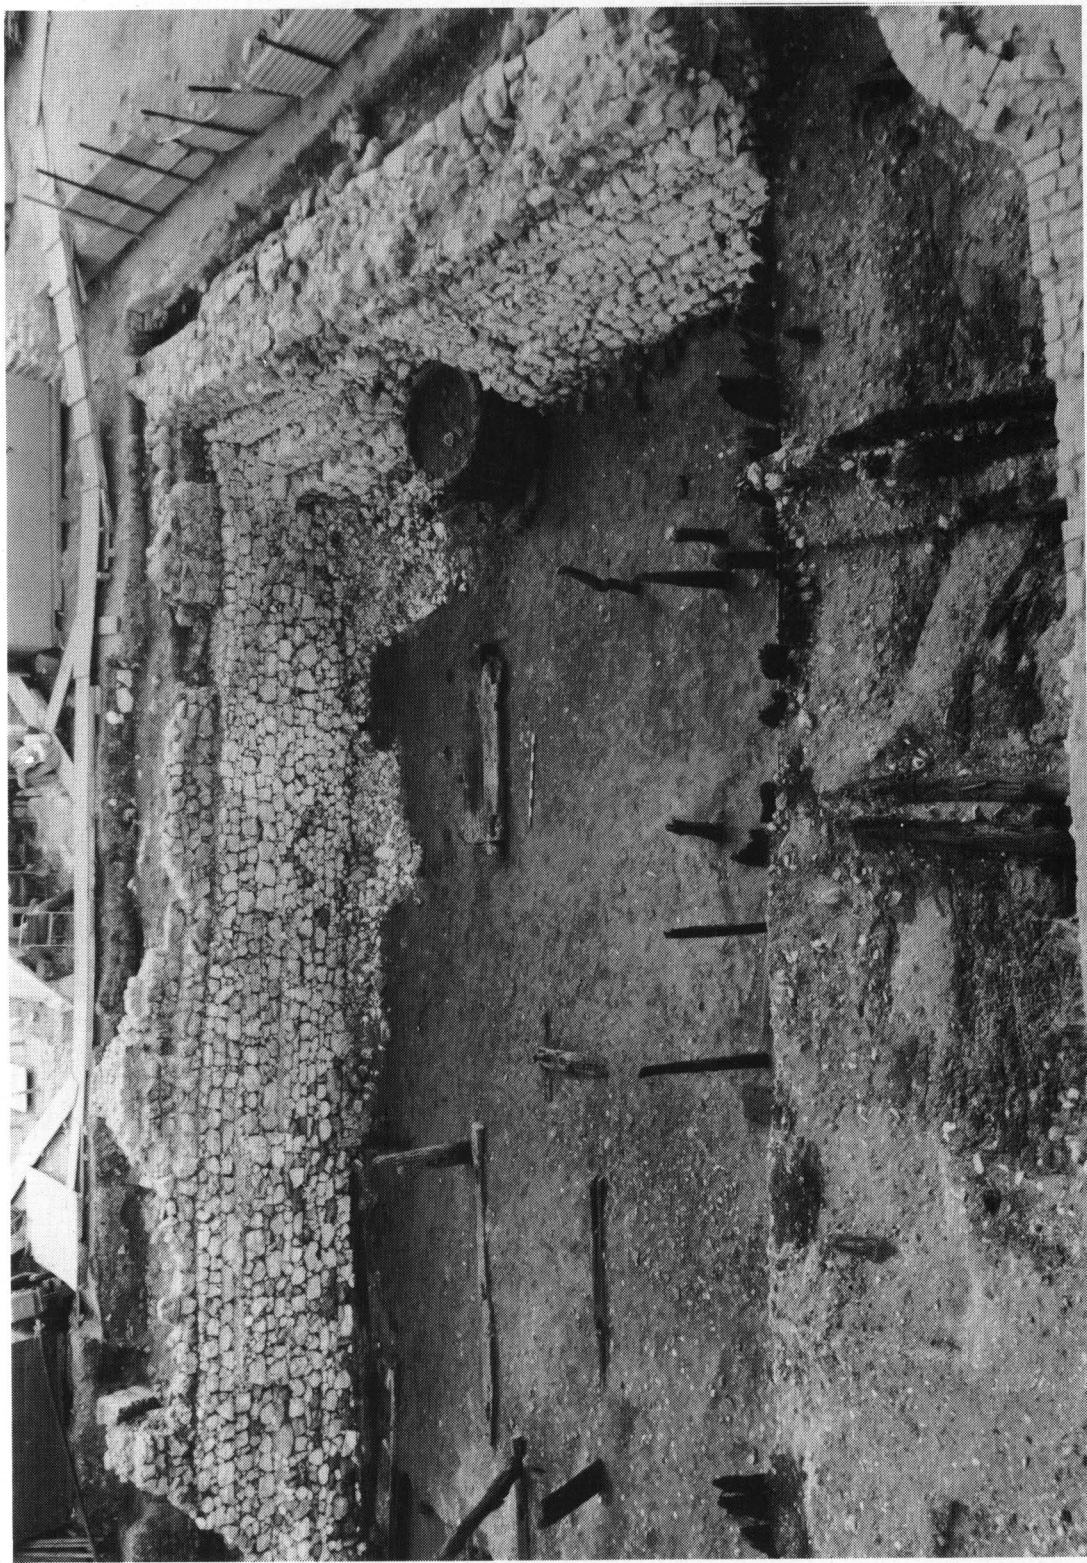
Plate 55. Trig Lane 1974-76: Internal face of Group 15 river wall, looking south, river to south and west. Note remains of river stairs on foreshore behind wall. 10×100mm scale.

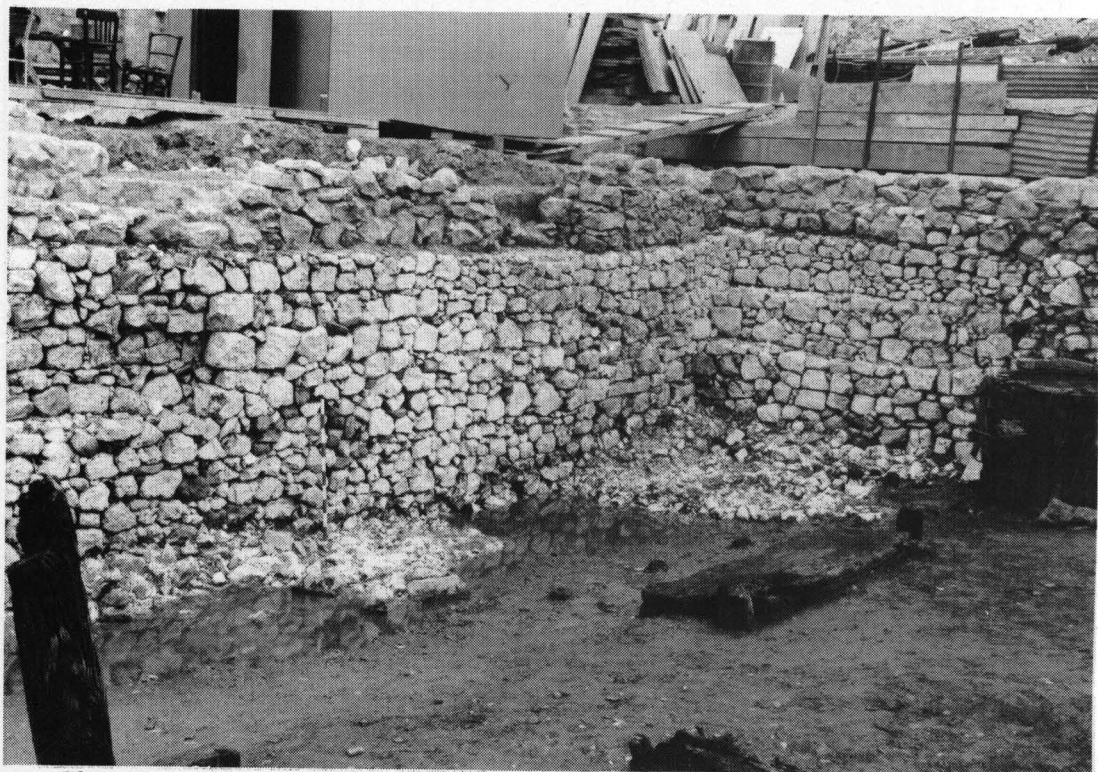
Plate 56. Trig Lane 1974-76: Internal face of Group 15 wall, showing construction of south-west corner. Looking south-west. 10×100mm scale.

No shoring was used in the excavation since the southern and western limits were revetted by solid 15th-century stone walling (Pl. 56), and the northern by 13th- and 14th-century timberwork, while the east was rendered safe by the cutting of a series of off-sets.

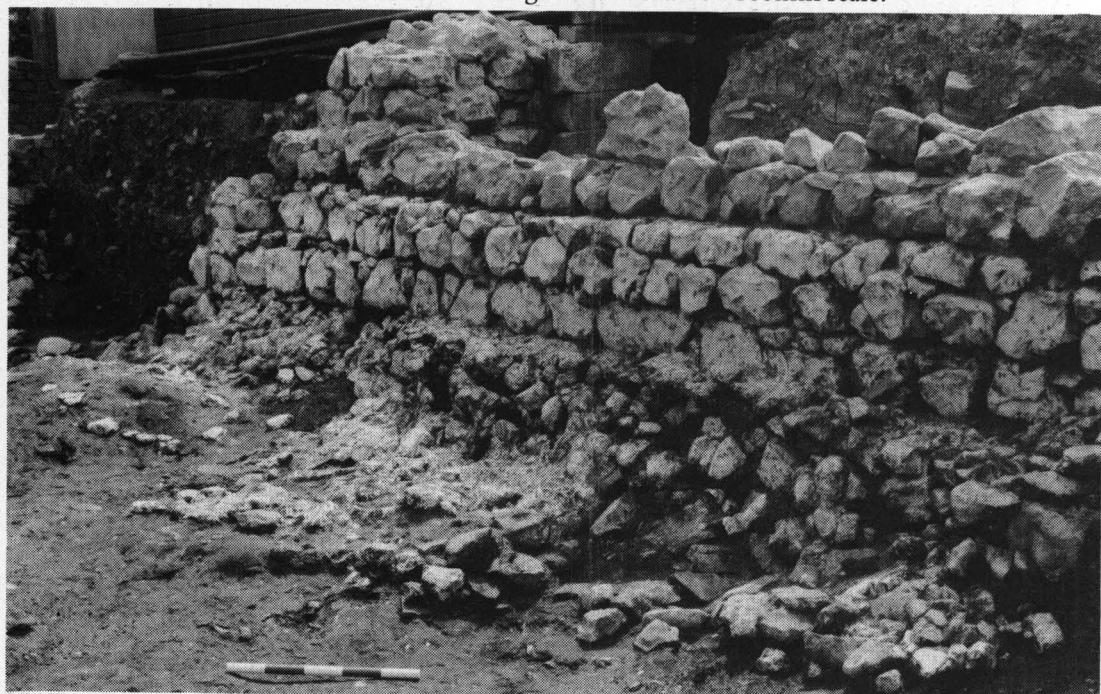
Plate 57. Trig Lane 1974-76: Massive dumps of refuse covered the internal face of the lower  $\frac{2}{3}$  of the Group 15 river wall before this chalk and mortar surface associated with the construction of the uppermost courses of the wall could spread horizontally northwards. Looking south-east, river to south, 5×100mm scale.

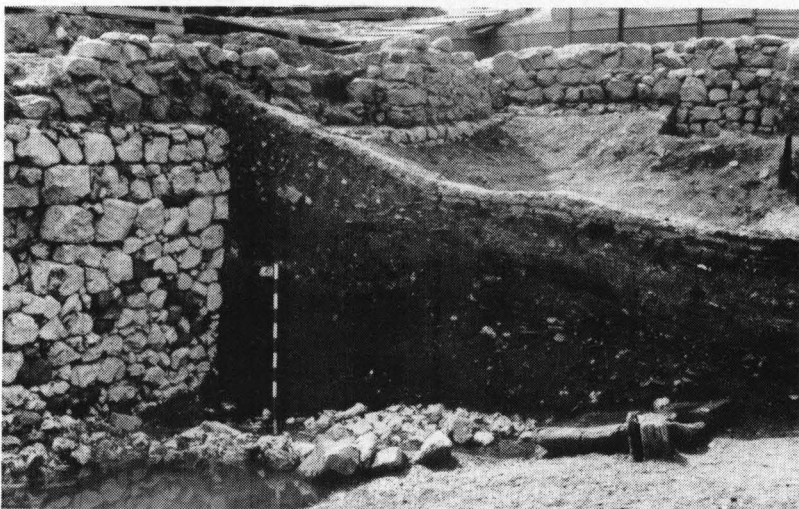
Plate 58. Trig Lane 1974-76: Internal face of Group 15 river wall, looking south-west, river to south. Note exclusive use of ragstone on upper courses; half sectioned dumps sealing chalk rubble raft. 10×100mm scale.
