# MEDIEVAL WATERFRONT DEVELOPMENT AT TRIG LANE, LONDON

An account of the excavations at Trig Lane, London, 1974–6 and  
related research

by  
GUSTAV and CHRISSIE MILNE

SPECIAL PAPER NO. 5  
LONDON AND MIDDLESEX ARCHAEOLOGICAL  
SOCIETY  
1982

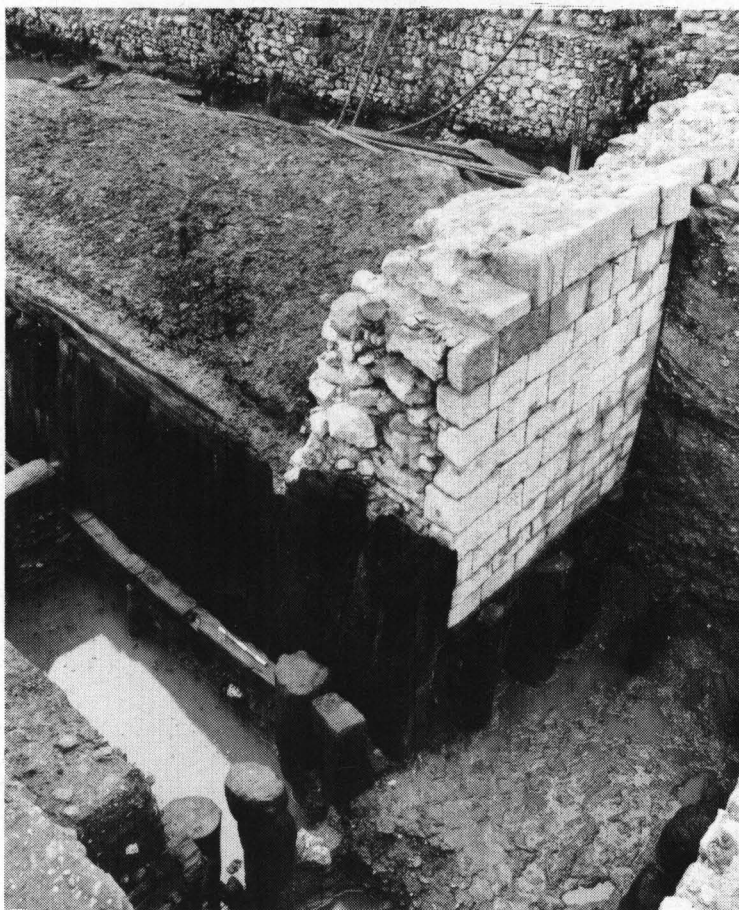
Plate 59. Trig Lane 1974-76: Dressed ragstone on external face of Group 15 river wall, looking south-east, river to west. The wall is built on foreshore which accumulated against Group 10 revetment, with 5×100mm scale.

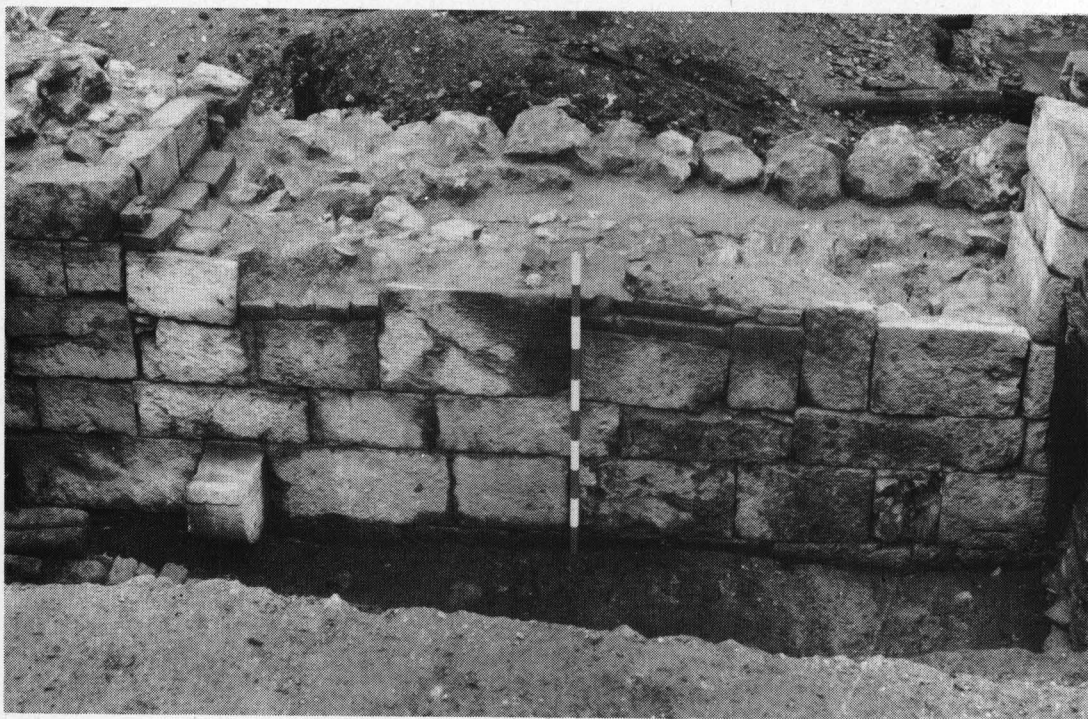
Plate 60. Trig Lane 1974-76: Partially exposed external face of Group 15 river wall showing blocked stair head above corbel. Looking north, river to south, 10×100mm scale.

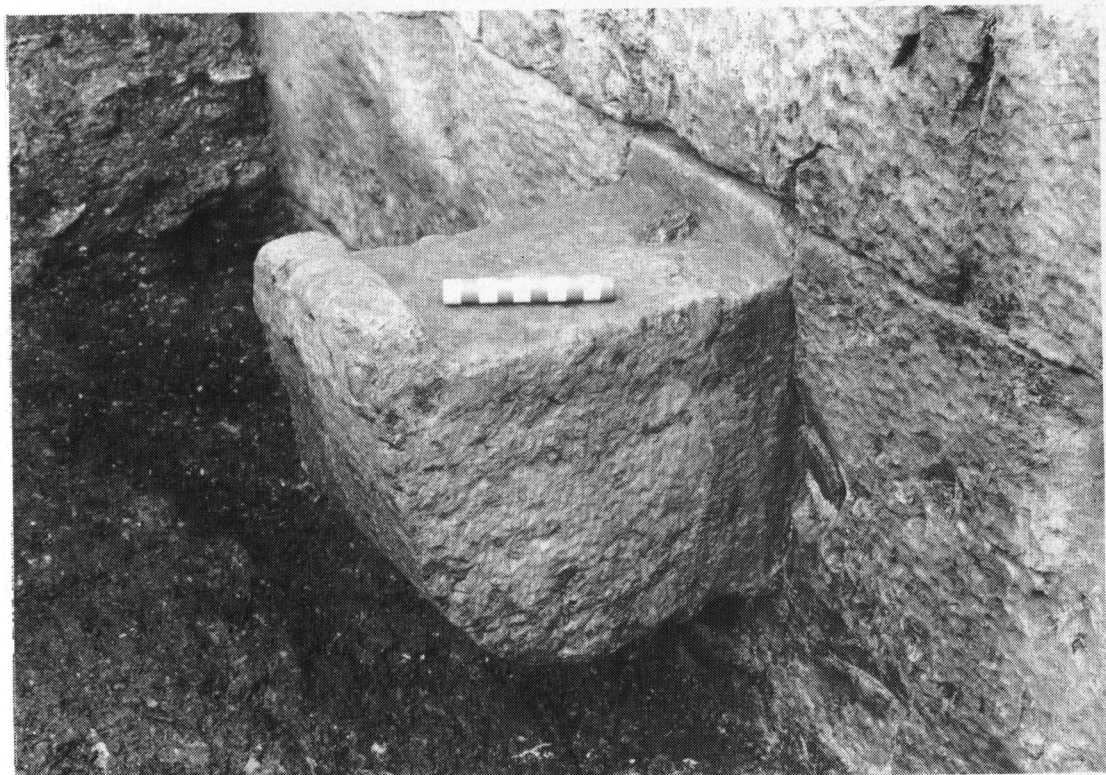
Plate 62. Trig Lane 1974–76: Corbel from Group 15 river wall which supported timber stair to foreshore. Note (?) bolt to north of 10×10mm scale. Looking west, river to south.

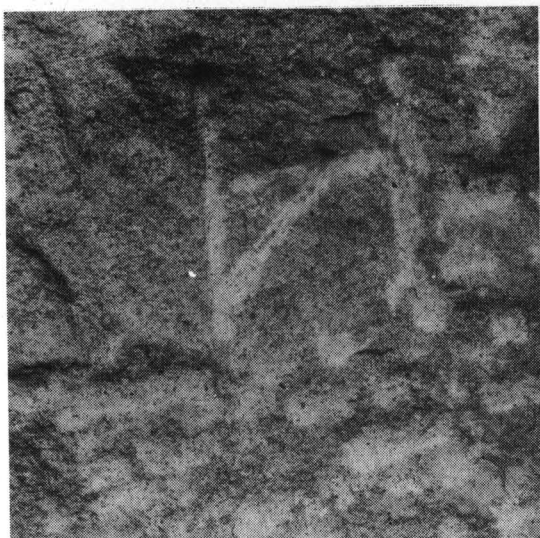
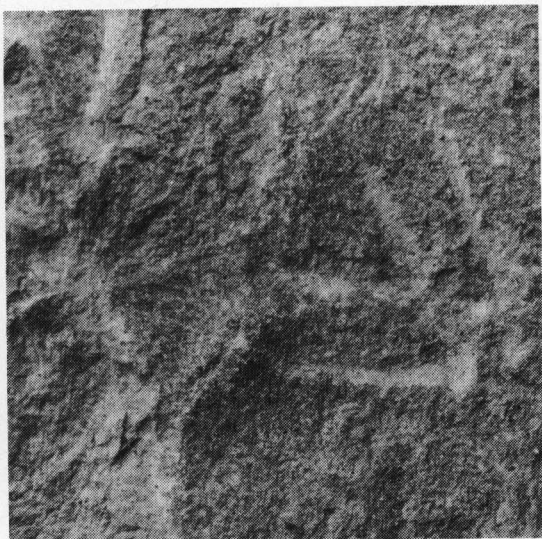
Plates 63 and 64. Mason's marks incised on external face of Group 15 river wall. Approx. 50mm across.

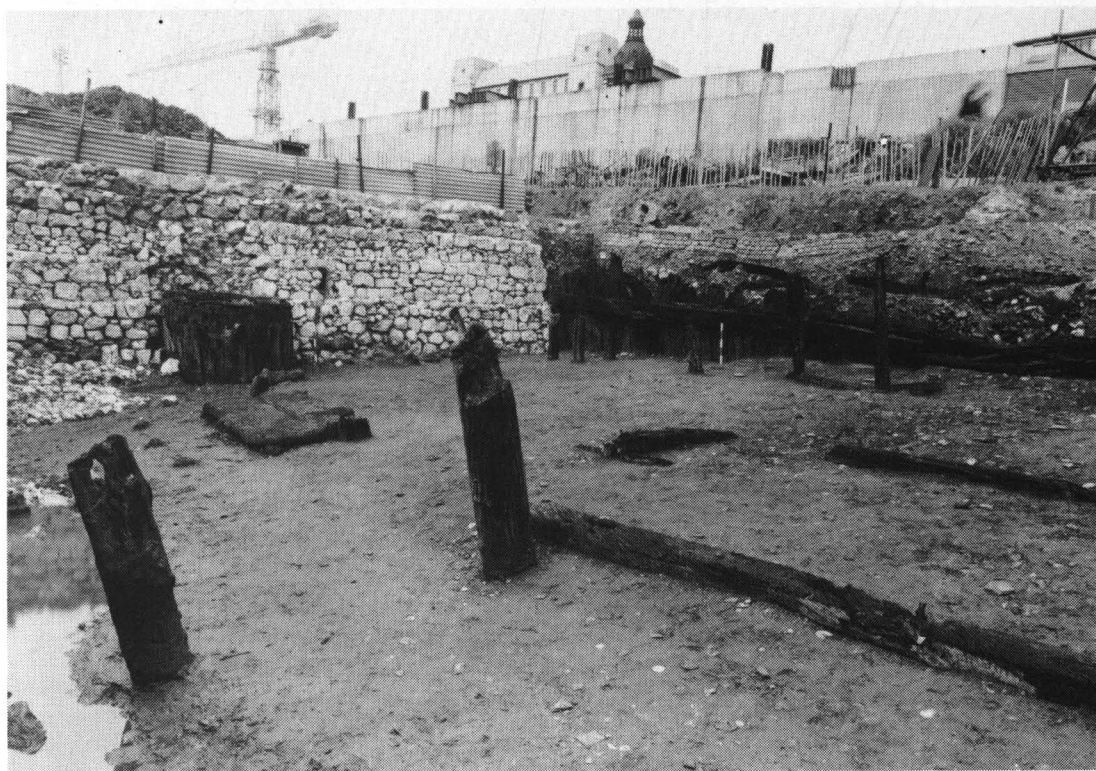
Trig Lane 1974–76: Timber features *in situ* on the foreshore, looking north-west towards the land:

Plate 66. pile-laid platform, visible between two mooring posts on left, would have been set at the foot of a river stair to the north. 5×100mm scale.

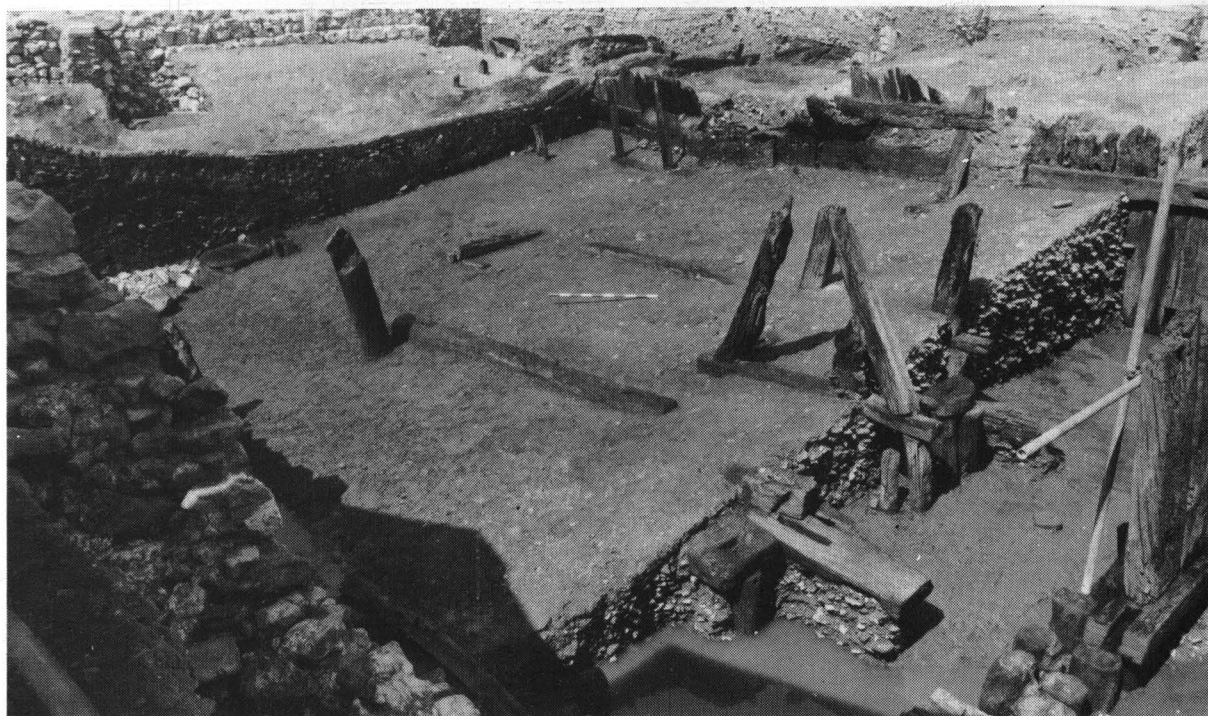
Plate 67. to the right of the 10×100mm scale are remains of trestles which once supported a jetty.

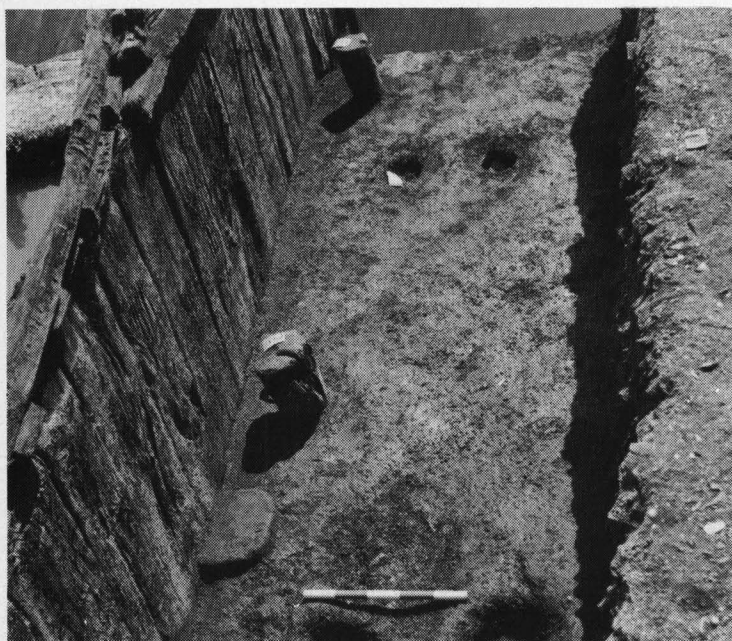
Plate 68 (left). Trig Lane 1974-76: External face of Group 10 revetment left of 10×100mm scale, looking east, river to south. Note post holes associated with contemporary river stair cut into foreshore to south.

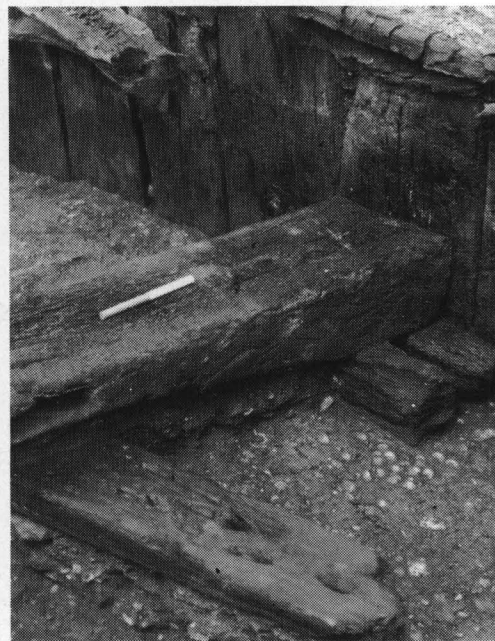
Plate 69. Trig Lane 1974-76: One of a pair of levelled timbers found *in situ* on the foreshore to south of Group 10 revetment. Part of base of river stair. Looking north-west towards the land, 2×100mm scale.

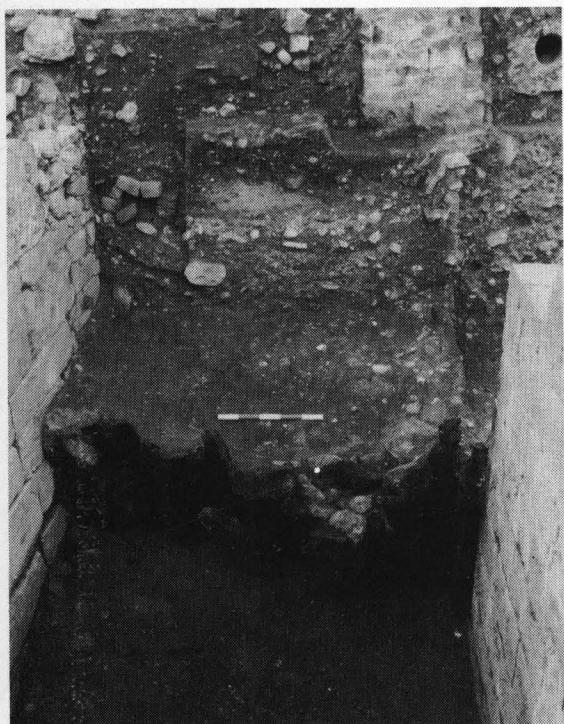
Plate 70 (left). Trig Lane 1974-76: Inlet between Group 8 river wall (left) and Group 15 wall (right), looking north, river to south. The top of the Group 14 rubbish dump (with 5×100mm scale) is clearly visible.

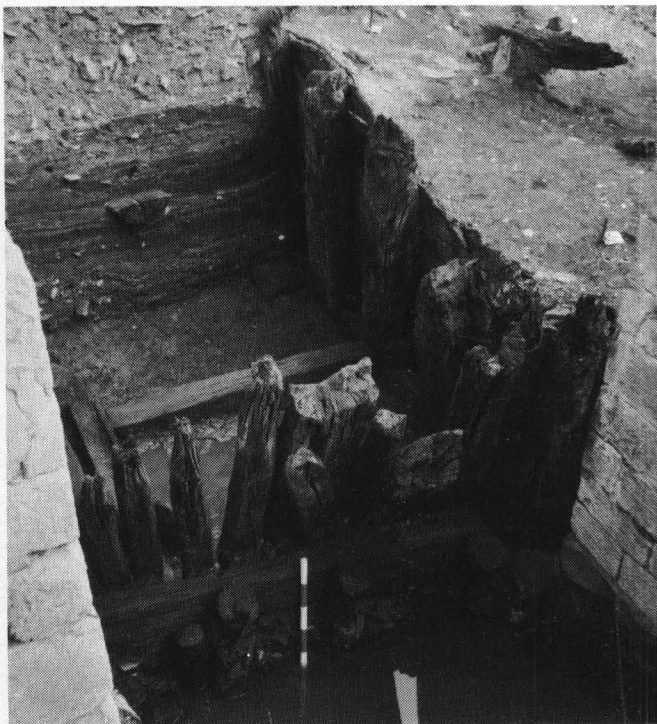
Plate 71. Trig Lane 1974-76: The Group 14 revetment after removal of refuse dumped behind it, looking north, river to south, 5×100mm scale.

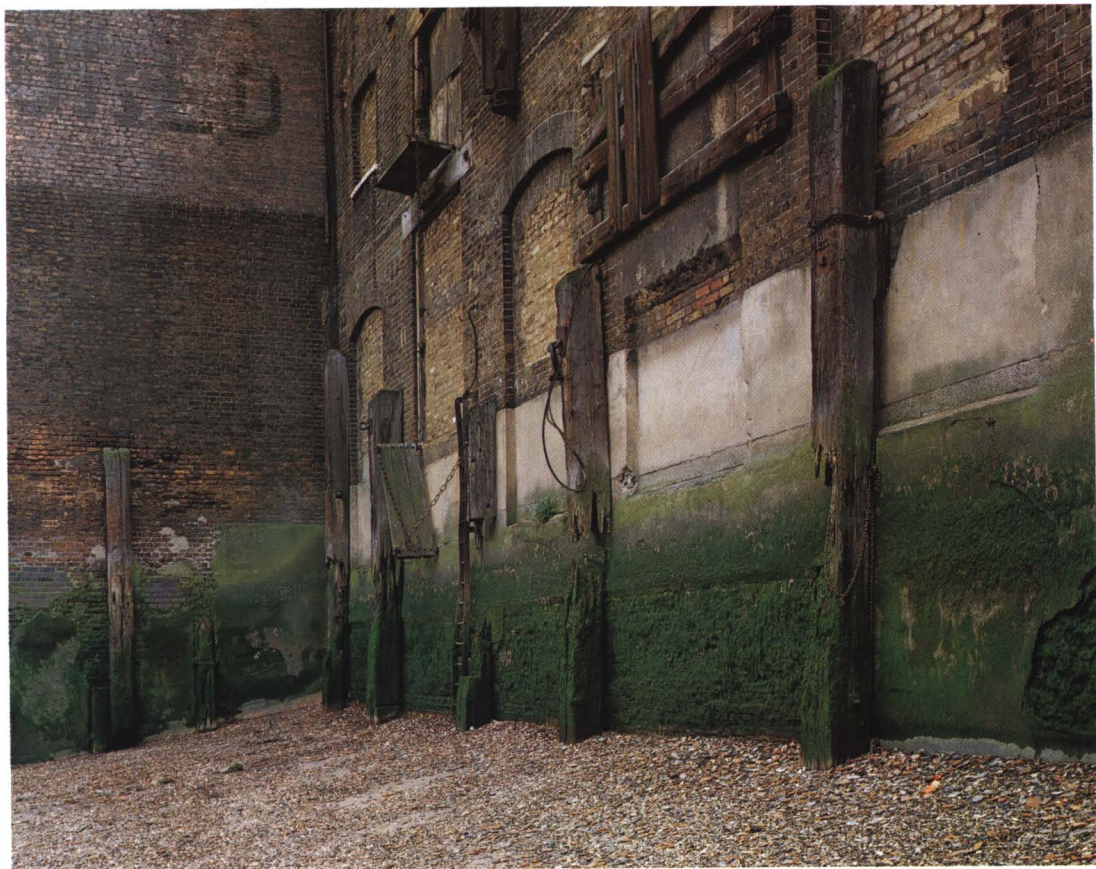
Plate 72. Trig Lane 1974-76: Rubbing posts decaying on the line of the Mean High Water Neap tides on present day Thames Foreshore. The timber above and below this level is sound. Note position of scarf joints.
